Home Inspection Report

From Home Inspection Carolina

Address: 123 Sample Street, Charlotte, NC

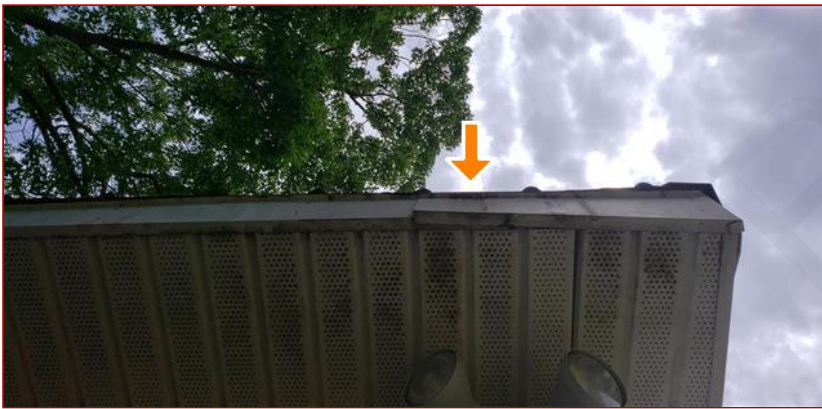
1. The metal roofing is installed too short along the drip edge/fascia and needs to be replaced or extended to prevent water penetration behind the fascia.

Roofing too short

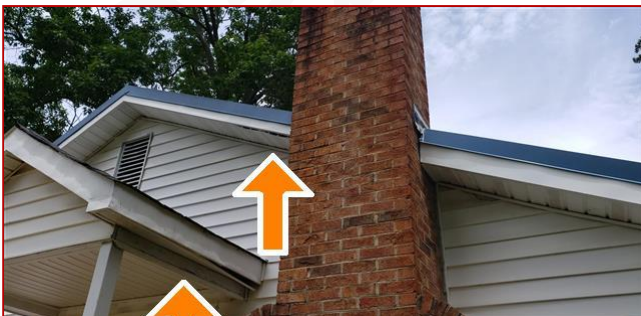
2. The soffit is loose above at the front porch and needs to be corrected to prevent rodent or insect intrusion.
 3. The electrical mast boot is split and needs replacement to prevent water penetration.

Loose Soffit

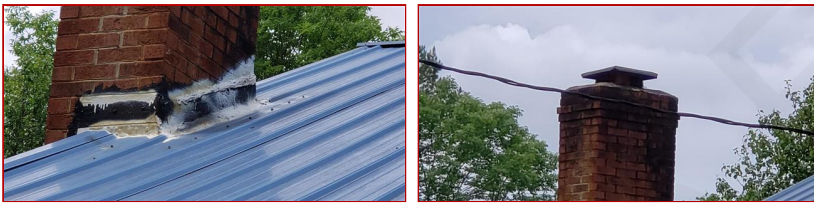
6. The following items(s) is/are in need of repair/replacement. Have a qualified licensed contractor further evaluate and make any additional repairs as needed or deemed necessary.
1. The mortar has cracks and is deteriorating at the top of the chimney cap/crown. The mortar needs repair to prevent water penetration. This usually consists of pointing up (adding more mortar). The chimney cap/crowns function is to keep water from entering the masonry brick joints that can cause deterioration.
 2. The flashing at the chimney appears to have been repaired several times with improper or non-typical construction methods. Proper corrections are needed to prevent water penetration. Staining was noted along the wall in the attic indicating a previous or active leak.
 3. The chimney needs to be sealed properly where it meets the fascia at the exterior of the home to prevent water penetration.

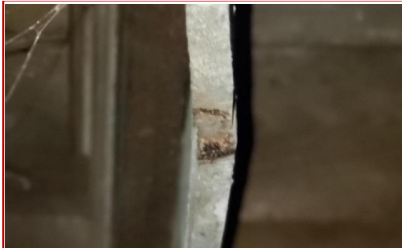
1. There are broken crass bracing that needs correction above the attic stairs. Corrections are needed to prevent possible movement.
 2. Bolts are missing at the attic stairs corrections are needed to ensure safety.

Broken Cross Bracing

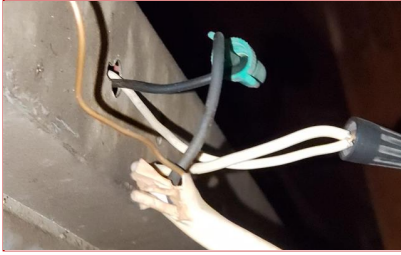
8. There are several open junction boxes found throughout the home, in the attic and crawl space. Proper corrections are needed to secure exposed wiring.

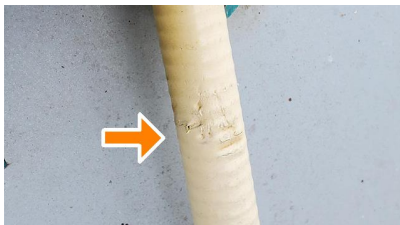
14. The CSST piping gas line was observed to have damaged to the rubber coating at the tank and where it attaches to the heating unit. The damaged areas need to be sealed or covered with the proper and/or approved tape to prevent corrosion and/or rusting. Consult with a qualified licensed contractor to fully understand the extent of the repairs needed and determine if corrective actions are required.

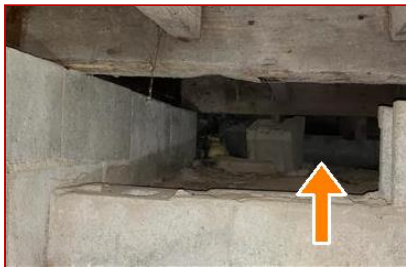
19. Efflorescence was noted on the crawl space wall along the right side. This is an indication of water penetration.

Moisture on right wall along with Efflorescence

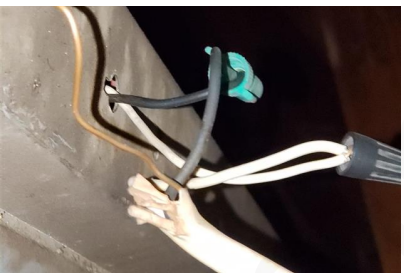
8. There are several open junction boxes found throughout the home, in the attic and crawl space. Proper corrections are needed to secure exposed wiring.

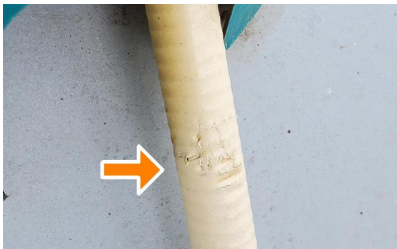
The CSST piping gas line was observed to have damaged to the rubber coating at the tank and where it attaches to the heating unit. The damaged areas need to be sealed or covered with the proper and/or approved tape to prevent corrosion and/or rusting. Consult with a qualified licensed contractor to fully understand the extent of the repairs needed and determine if corrective actions are required.

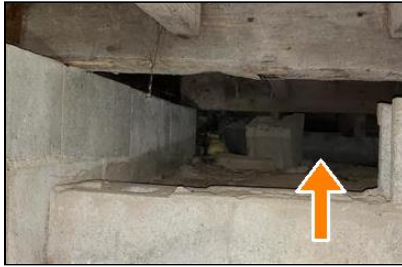
Moisture on right wall along with Efflorescence
