INSPECTION REPORT

## 123 Sample Street

Anytown, NC

INSPECTION DATE 8/14/2026

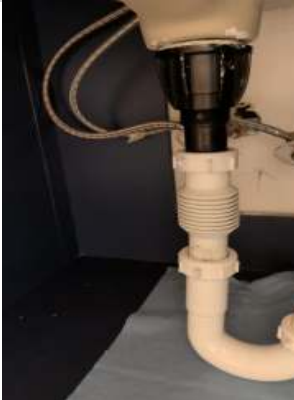
primary vanity

The flexible drain pipe under the primary bathroom vanity needs to be replaced with solid pipe to prevent the pipe from clogging.  
Consult with a qualified licensed contractor to fully understand the extent of the repairs needed and determine if corrective actions are required.

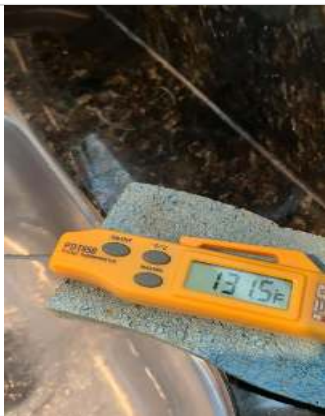
Please Note: Water temperatures above 125 degrees can burn or scald. This is a safety hazard. The temperature needs to be adjusted to below the current setting.

**The water temperature at the time of inspection was 131 degrees.**

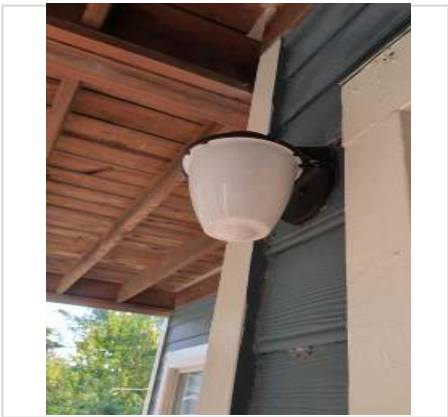
**The exterior light has a missing bulb(s) and/or a bulb that did not function when tested.** Due to the height or disassembly required the bulb could not be replaced and tested at the time of inspection.

Consult with a qualified licensed contractor to evaluate the area(s) of concern and make any additional repairs as deemed necessary during their evaluation.

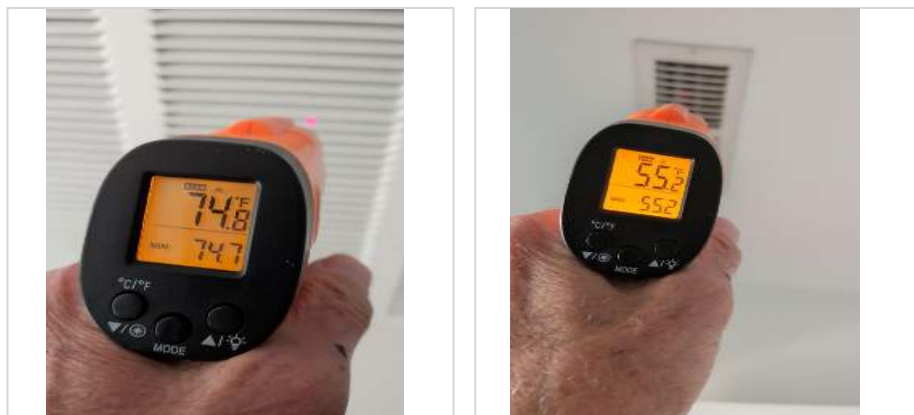
**primary unit differential** - The primary unit is producing an adequate air temperature drop. The temperature differentials when tested should be between 14 and 24 degrees. The differentials at the time of inspection were at 19 degrees.

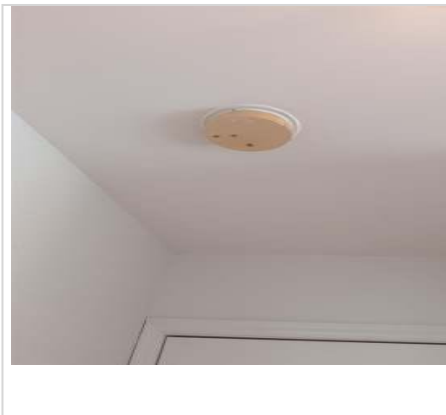
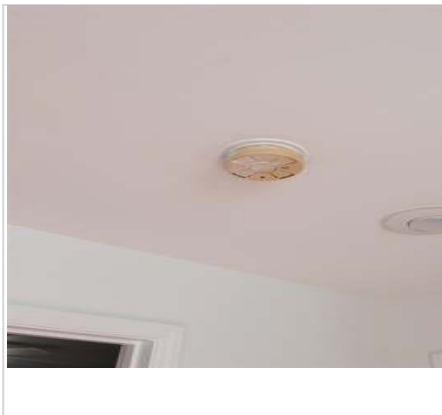
(1) The following items(s) need repair or replacement to prevent continual damage. Please consult with a qualified licensed contractor to evaluate the following areas of concern and make any additional repairs as deemed necessary during their evaluation.
- a. The smoke detectors need to be replaced due to the age of the detectors to ensure that the smoke detectors function properly.
  - b. Smoke detectors need to be installed in the bedrooms in accordance with today's standards for safety.

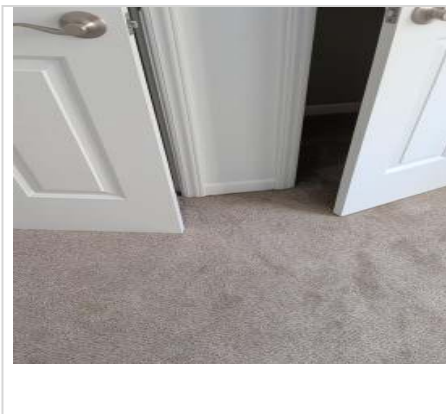
(2) The rear bedroom closet doors rubbed at the frame/flooring and need adjustment and/or repair for the door(s) to open and close properly without rubbing it will cause damage to the doors and carpet.

Consult with a qualified licensed contractor to evaluate the area(s) of concern and make any additional repairs as deemed necessary during their evaluation.

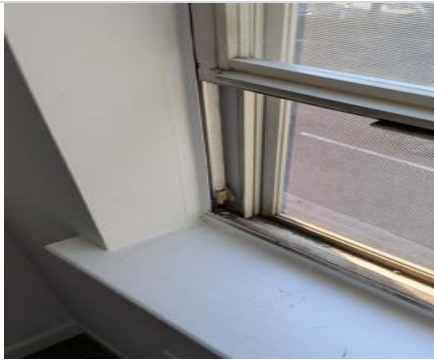
rear bedroom

(1) **The following window(s) have a bad reverse tension spring(s) or weights.** This prevents the window from staying up when opening. If the spring or rope is bad, the window will slide back down when operating. Corrections and/or repairs are needed so the windows will stay up or function properly: rear bedroom, dining area

Consult with a qualified licensed contractor to evaluate the area(s) of concern and make any additional repairs as deemed necessary during their evaluation.

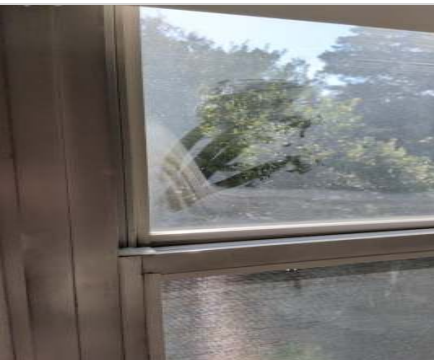
(2) **The dining area window and/or sash was found to have a bad or broken thermal seal.** When a bad or broken thermal seal is found, it is possible there may be more that cannot be found at the time of inspection. Because of this it is recommended that all windows be evaluated to prevent heating and air loss.

Consult with a qualified licensed contractor to evaluate the area(s) of concern and make any additional repairs as deemed necessary during their evaluation.

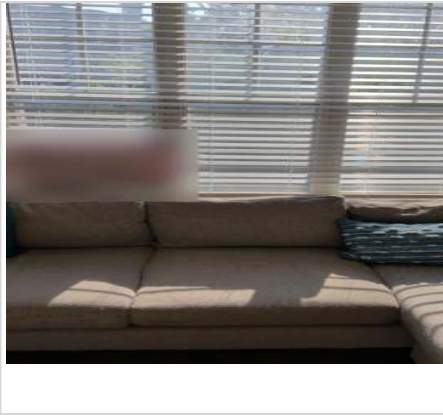
Unable to test the living rooms windows due to the furniture blocking the windows preventing access or operation at the time of inspection.

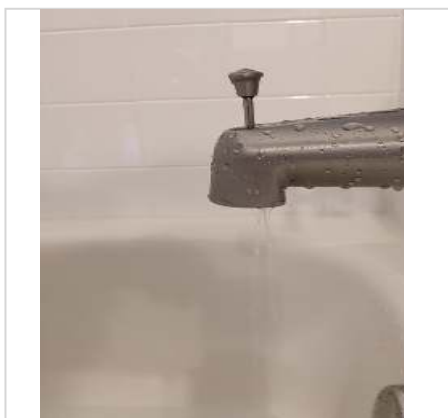
**The shower diverter is not functioning properly and needs repair/replacement.** The diverter still allows water to flow out at the tub faucet when switching to the showerhead. Corrections and repairs are needed.

Consult with a qualified licensed contractor to evaluate the area(s) of concern and make any additional repairs as deemed necessary during their evaluation.

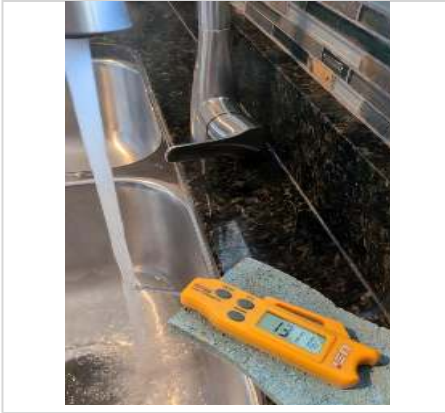
**The hot and cold are reversed at the kitchen faucet.** When pulling the faucet handle towards you, the water should be cold. This is needed due to a small child turning on the water; their initial reaction is to pull the faucet handle forward.

Consult with a qualified licensed contractor to evaluate the area(s) of concern and make any additional repairs as deemed necessary during their evaluation.
