INSPECTION REPORT

**123 Sample Street**

Anytown, NC

INSPECTION DATE 9/16/2026

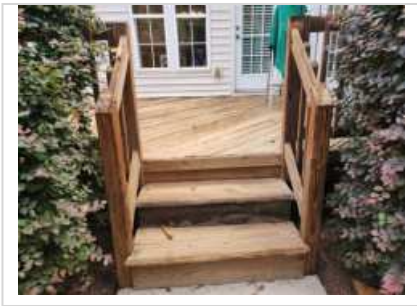
(1) There are loose railing(s) that need to be secured properly to prevent continual movement and/or a possible hazard at the Rear deck

Consult with a qualified licensed contractor to evaluate the area(s) of concern and make any additional repairs as deemed necessary during their evaluation.

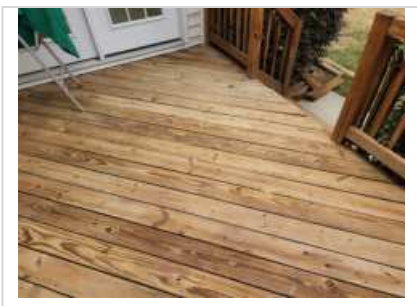
(2) Loose deck boards were noted at the rear deck. The boards need to be properly secured to prevent further movement and possible damage at multiple locations.

Consult with a qualified licensed contractor to evaluate the area(s) of concern and make any additional repairs as deemed necessary during their evaluation.

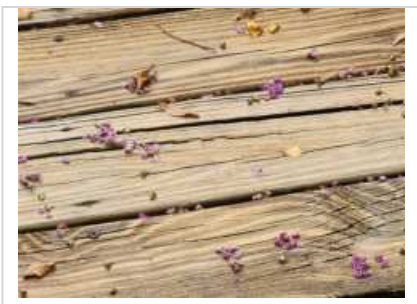
(3) Cracking, splitting and/or general deterioration was noted throughout the deck surface, railing and stairs. Further damage may occur.

Consult with a qualified licensed contractor to evaluate the area(s) of concern and make any additional repairs as deemed necessary during their evaluation.

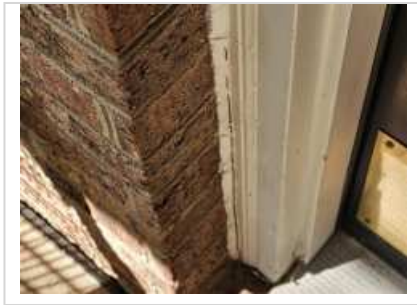
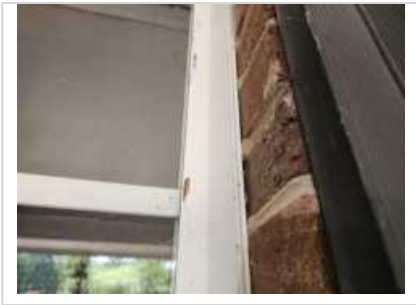
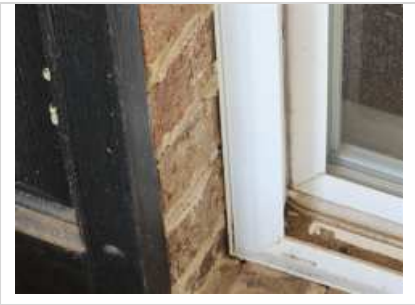
Spacing or gaping was observed at the trim where it intersects with various materials at multiple locations around the home. It is important to address this issue by adequately sealing the trim to effectively safeguard against potential water penetration and associated damages within the home environment.

Consult with a qualified licensed contractor to evaluate the area(s) of concern and make any additional repairs as deemed necessary during their evaluation.

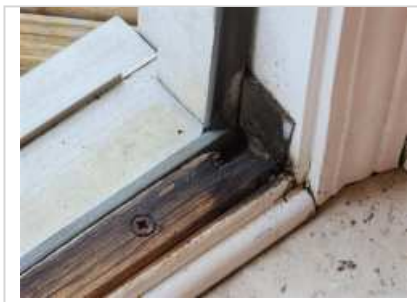
Wood rot has been observed at the trim where it intersects the threshold of the sunroom rear exterior door. A more thorough assessment is required to ascertain the extent of repair or replacement necessary.

Consult with a qualified licensed contractor to evaluate the area(s) of concern and make any additional repairs as deemed necessary during their evaluation.

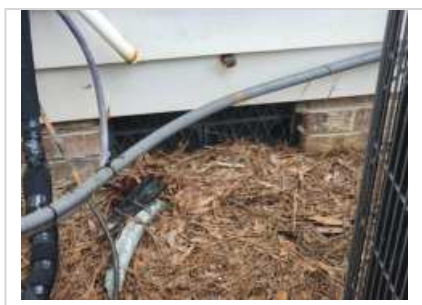
The crawl space vents were at or below grade and need to have a vent well(s) added. When vents are below grade, rain and runoff water are likely to enter the crawl space, which can attract wood destroying organisms or lead to fungal issues such as rot or organic growth. If vents are far enough below grade, the dirt can block the openings so air will not circulate and the vents will not ventilate. When foundation vent wells are installed, the grade should be dug a minimal of 2" below the foundation vent itself. Another issue is that often people block the vents in an unconditioned crawl space. This can lead to high moisture levels and it is recommended that the foundation vents be left open year round.

Consult with a qualified licensed contractor to evaluate the area(s) of concern and make any additional repairs as deemed necessary during their evaluation.

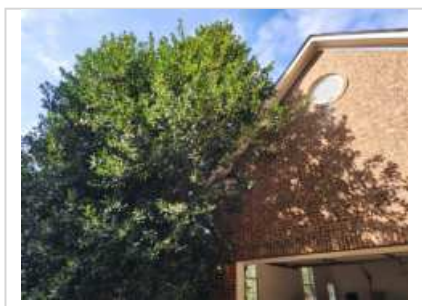
Trees are touching or overhanging the roof at the Left side of the home. Continual maintenance is needed to prevent further or possible damage.

Consult with a qualified licensed contractor to evaluate the area(s) of concern and make any additional repairs as deemed necessary during their evaluation.

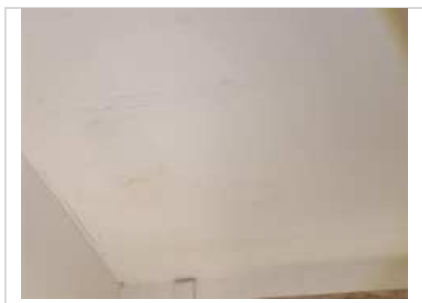
Stains were noted on the ceiling in the garage. Unable to determine if an active leak exists at the time of inspection. Ask the seller the history of the stains and if repairs have been made to correct any leaks that may have caused the stain. If the sellers aren't aware of the stain or the home is vacant, then the stain should be treated as active. Water penetration into the ceiling can lead to problems if left unattended.

Consult with a qualified licensed contractor to evaluate the area(s) of concern and make any additional repairs as deemed necessary during their evaluation.

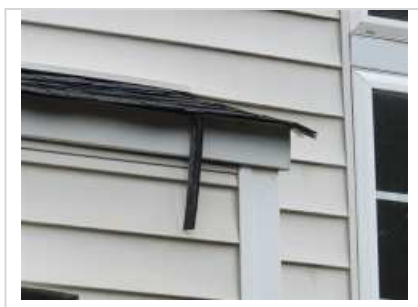
Loose drip edge flashing and or shingles were noted at the fireplace bump out roof. Repair is needed. Consult with a qualified licensed contractor to evaluate the area(s) of concern and make any additional repairs as deemed necessary during their evaluation.

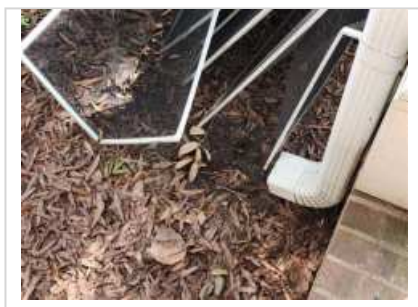
(1) A splash block is needed to properly direct water away from the foundation of the home under multiple gutter down spouts around the home.

Consult with a qualified licensed contractor to evaluate the area(s) of concern and make any additional repairs as deemed necessary during their evaluation.

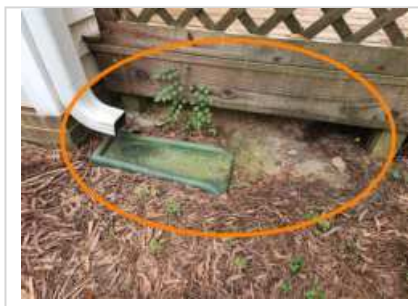
(2) The gutter at the rear right corner of the home needs to be redirected away from the foundation of the home and prevent water from pooling under the rear deck.

Consult with a qualified licensed contractor to evaluate the area(s) of concern and make any additional repairs as deemed necessary during their evaluation.

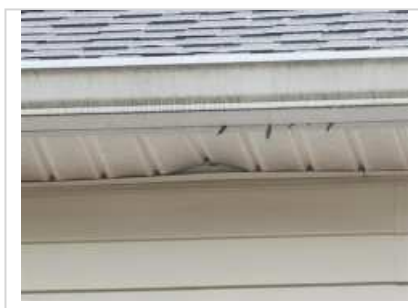
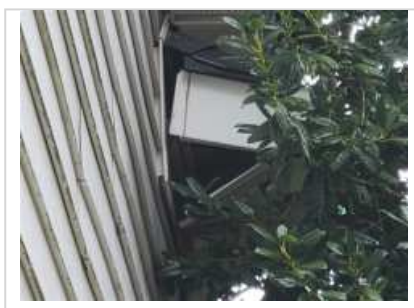
There are loose piece(s) of fascia and/or soffit that need to be re-installed and/or secured properly to prevent water penetration and/or possible damage at the Rear and left side of the home.

Consult with a qualified licensed contractor to evaluate the area(s) of concern and make any additional repairs as deemed necessary during their evaluation.

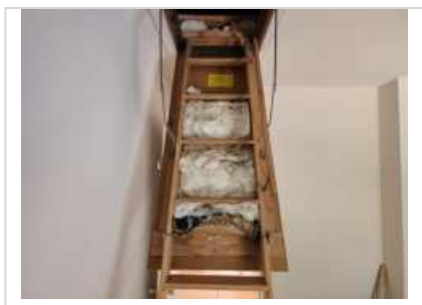
(1) There is damaged insulation installed on the back of the attic stairs. This can result in a large source of heating and air loss, installation of new insulation and weather stripping is needed to prevent heating and air loss.

Consult with a qualified licensed contractor to evaluate the area(s) of concern and make any additional repairs as deemed necessary during their evaluation.

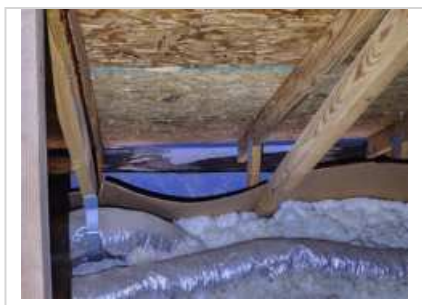
(2) Stains were noted along the fascia boards in areas through the attic. Water penetration into the attic can lead to problems if left unattended. Water stains in a dry attic may or may not indicate active leaks. Stains will remain after leaks have been repaired, making it almost impossible to determine whether or not a leak is active. Often leak activity will only be able to be determined by multiple inspections, over time, under varying atmospheric conditions. Because of this ask the seller to disclose the history of any stains and if repairs have been made to correct them and continue to monitor the attic conditions.

Consult with a qualified licensed contractor to evaluate the area(s) of concern and make any additional repairs as deemed necessary during their evaluation.

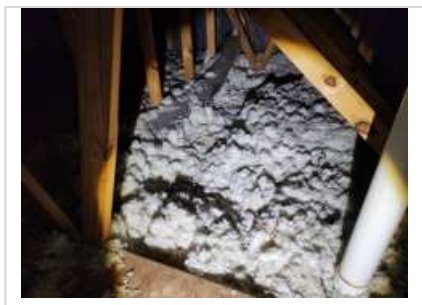
(3) Insulation is compacted in several areas throughout the attic and the true R-factor at this point may be substantially less than that originally installed.

Consult with a qualified licensed contractor to evaluate the area(s) of concern and make any additional repairs as deemed necessary during their evaluation.

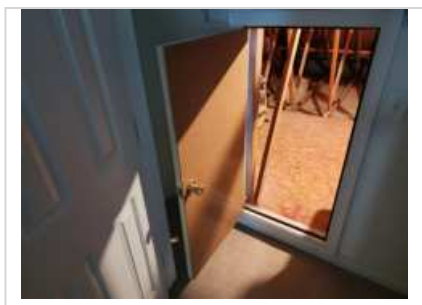
(4) The attic access door(s) are hollow-core door(s) and there is not any insulation installed on the back of them. Insulation is needed behind the attic access door(s) to prevent heating and air loss. As the attic access doors are hollow core doors and have a very low R-Value.

Consult with a qualified licensed contractor to evaluate the area(s) of concern and make any additional repairs as deemed necessary during their evaluation.

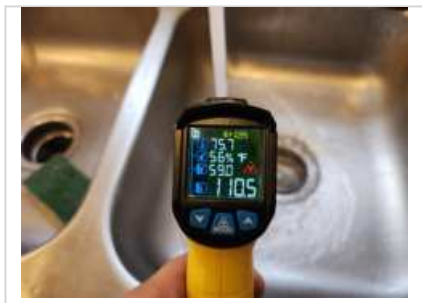
During the inspection, it was observed that the temperature was below the recommended level of 120 degrees. Setting your water heater temperature too low can lead to risks. When the temperature is below 120 degrees, it creates an environment where bacteria can thrive and stagnant water can accumulate inside the heater. To prevent this, it's advisable to maintain the water heater temperature above 120 degrees but below 125 to avoid scalding. To ensure optimal performance, adjust the temperature to 120 degrees. [Click here](#) to discover how to set your water heater to a safe and efficient temperature level.

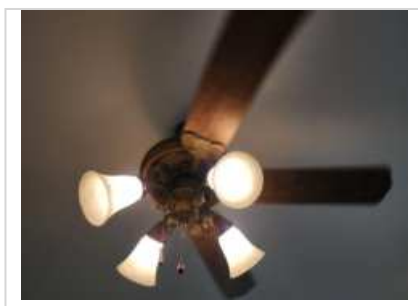
(2) The living room ceiling fan is missing multiple fan blades. Replacement is needed.

Consult with a qualified licensed contractor to evaluate the area(s) of concern and make any additional repairs as deemed necessary during their evaluation.

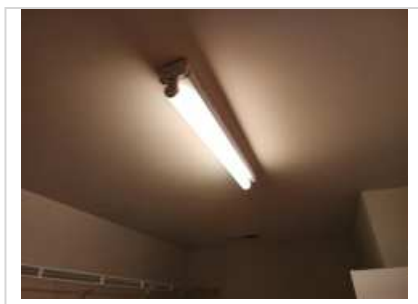
(3) The master closet light fixture is unusually dim. This may be an indication of a bad ballast. Repair or replacement is needed.

Consult with a qualified licensed contractor to evaluate the area(s) of concern and make any additional repairs as deemed necessary during their evaluation.

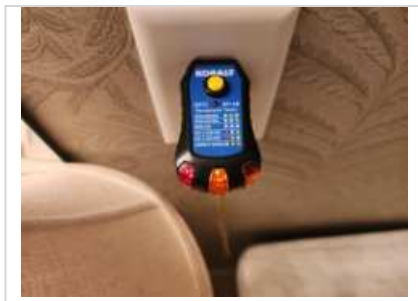
(4) The hot and neutral wires are reversed at certain outlets within the home, creating a condition known as reverse polarity. This issue occurs when the electrical system's hot and neutral wires are improperly connected to the outlet. While devices plugged into an outlet with reverse polarity may still function, the on/off switch will control the neutral wire instead of the hot wire. This significantly increases the risk of electric shock for anyone using the device. If one outlet is found to have reversed polarity, it's possible that other outlets in the home are

Consult with a qualified licensed contractor to evaluate the area(s) of concern and make any additional repairs as deemed necessary during their evaluation.

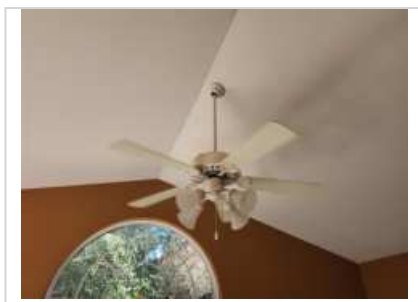
(5) There are ceiling fan(s) that are not balanced within the home and need to be properly balanced, adjusted, repaired, and/or replaced.

Consult with a qualified licensed contractor to evaluate the area(s) of concern and make any additional repairs as deemed necessary during their evaluation.

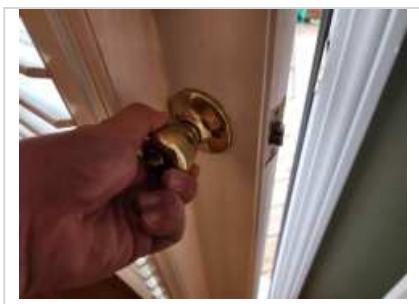
(2) The kitchen area rear exterior door handle sticks when operating. Corrections are needed.

Consult with a qualified licensed contractor to evaluate the area(s) of concern and make any additional repairs as deemed necessary during their evaluation.

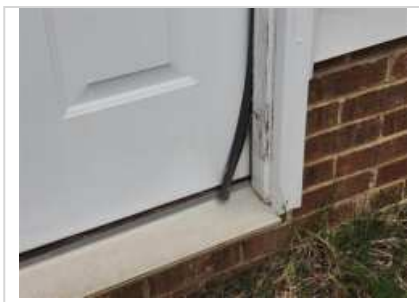
(3) The weather stripping on the following doors is either damaged or missing and needs replacement to prevent energy loss and maintain efficient heating and cooling.

Consult with a qualified licensed contractor to evaluate the area(s) of concern and make any additional repairs as deemed necessary during their evaluation.

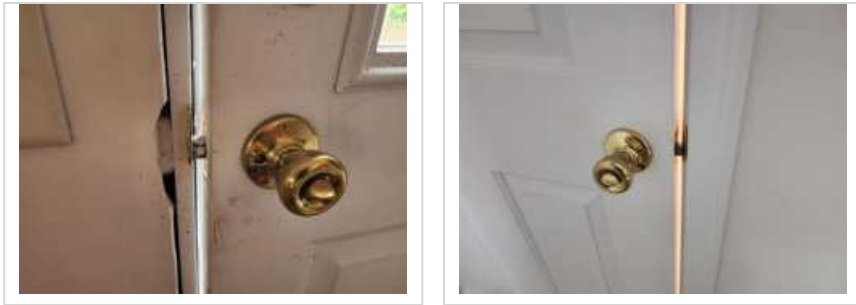
(4) The cylinder/strike plate does not catch or latch properly and needs corrections and/or adjustments to latch and/or close properly at the following door(s):

Consult with a qualified licensed contractor to evaluate the area(s) of concern and make any additional repairs as deemed necessary during their evaluation.

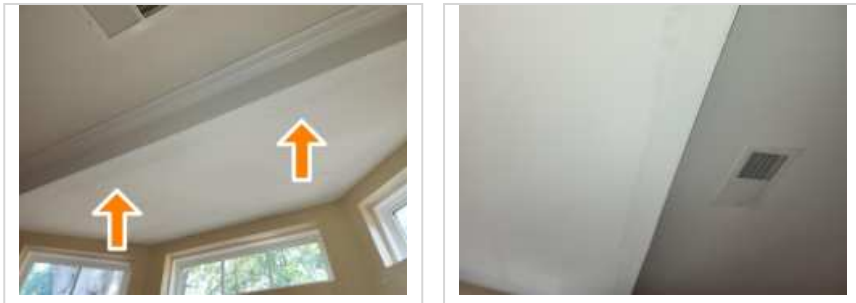
(5) Stains noted on the ceiling at the formal living room. Unable to determine if an active leak exists at the time of inspection as the stains were dry at the time of inspection. Ask the seller the history of the stains and if repairs have been made to correct any leaks that may have caused the stain.

Consult with a qualified licensed contractor to evaluate the area(s) of concern and make any additional repairs as deemed necessary during their evaluation.

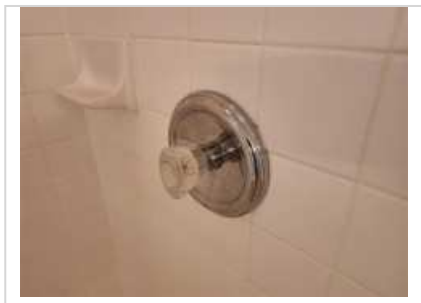
(2) The shower faucet handle is loose in the wall and need to be secured properly to prevent movement and possible leakage.

Consult with a qualified licensed contractor to evaluate the area(s) of concern and make any additional repairs as deemed necessary during their evaluation.

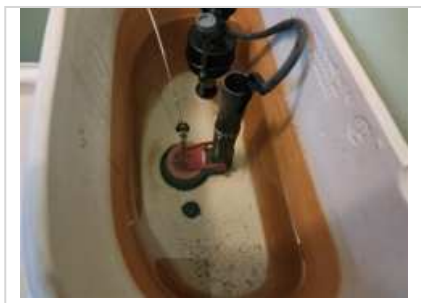
(3) The flush valve or flapper is not sealing properly, causing the toilet to run. Repair or replacement is needed.

Consult with a qualified licensed contractor to evaluate the area(s) of concern and make any additional repairs as deemed necessary during their evaluation.

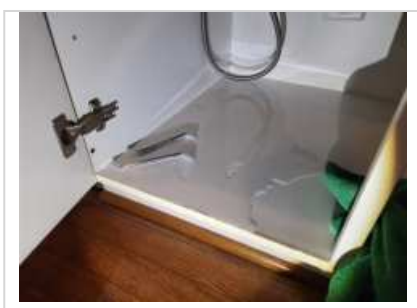
(2) The dishwasher was noted to be leaking at the time of inspection and needs repair or replacement.

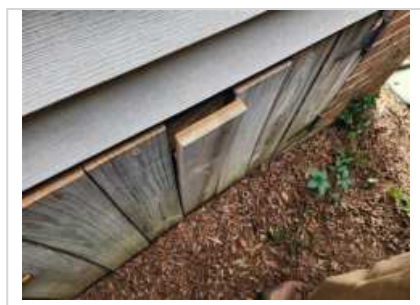
(2) The crawl space door is damaged and needs repair or replacement. Corrections are needed to prevent possible water and rodent intrusion.
