INSPECTION REPORT

INSPECTION DATE 8/3/2026

Home Inspection Carolina

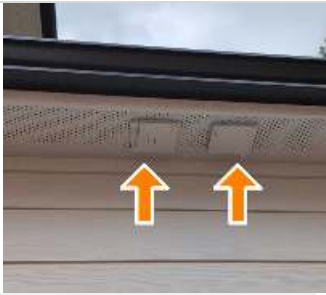
**2.0 Item 1 (Picture)**

(1) The vent terminations for the bathrooms were found to be taped over at the right side of the home on the soffit, typically taped as part of the painting process. Corrections are needed to allow the vents to function properly and to prevent possible damage from lack of air flow at the fans. Consult with your builder to gain a comprehensive understanding of the necessary repairs. Have them further evaluate and make the necessary corrective actions.

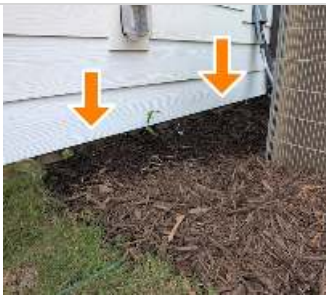
**2.0 Item 2 (Picture)**

(2) The siding at the right side of the home does not have the appropriate clearance from the ground. It is recommended that most claddings maintain a minimum clearance of 6 inches between the grade and the siding. This clearance is important in preventing water intrusion and deterring insects from causing damage. Consult with your builder to gain a comprehensive understanding of the necessary repairs. Have them further evaluate and make the necessary corrective actions.

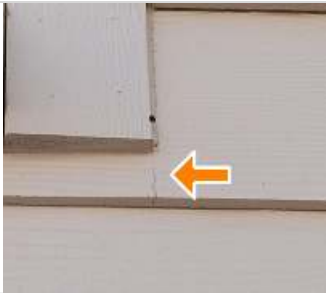
**2.0 Item 3 (Picture)**

1. There are noticeable cracked pieces of siding observed on the right side of the home. These cracks have the potential to allow water penetration, which could lead to damage. Corrections, repairs, and replacements are needed to ensure the property's structural integrity and prevent any further complications.
2. There was at least one hole in the siding at the right side of the home. Patch or repair as necessary to prevent possible water penetration and/or pest intrusion into the wall system which could result in concealed damage.
3. The paint was noted to be damaged or incomplete in at least a few areas along the left side and rear of the home. Make corrections as necessary to prevent possible accelerated deterioration of the siding material which could result in water penetration into the wall system.

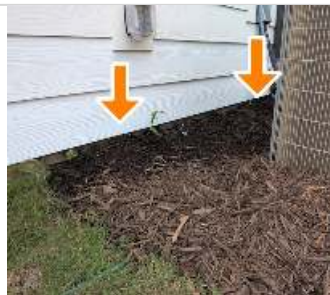
**2.3 Item 1 (Picture)**  
Example of limitation

Unable to fully view the foundation along the right side due to inadequate clearance between the siding and grade level. The conditions in these areas were unknown at the time of inspection.

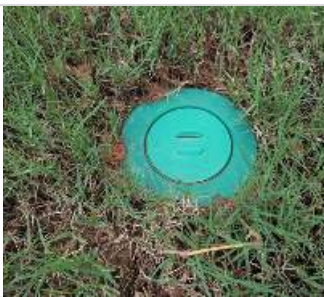
##### 3.1 Item 1 (Picture)

There are termite bait stations around the exterior foundation of the home. This home may be under a termite bond. It is recommended to verify with the builder if the termite bond is covered by an HOA or if it is the homeowner responsibility to maintain.

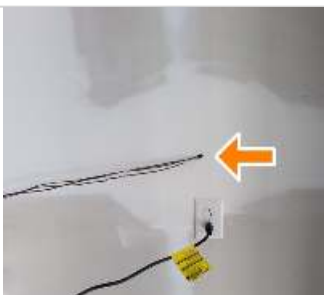
#### 4.0 Item 1 (Picture)

(1) **Holes and/or gaps were noted in the walls and/or ceiling within the garage.** All holes and gaps, including around the water lines and any other wall or ceiling penetrations need to be properly sealed to maintain the proper fire rating between the home and garage and prevent possible carbon monoxide entry into the home. Consult with your builder to gain a comprehensive understanding of the necessary repairs. Have them further evaluate and make the necessary corrective actions.

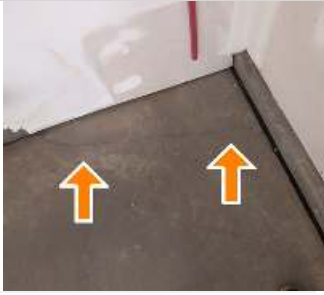
**4.0 Item 2 (Picture)**

(2) **There are cracks noted in the garage floor that need to be sealed and/or repaired properly to prevent water penetration and/or continual cracking.** Continue to monitor and make and additional repairs as needed. Consult with your builder to gain a comprehensive understanding of the necessary repairs. Have them further evaluate and make the necessary corrective actions.

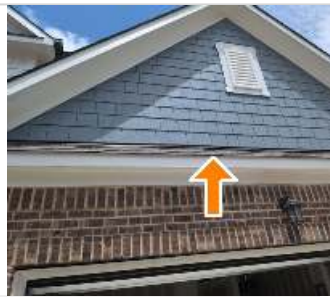
#### 5.2 Item 1 (Picture)

**The flashing was found to be loose and/or improperly installed in areas on the home.** Proper corrections and/or repairs are needed to prevent possible water penetration and/or water damage. Consult with your builder to gain a comprehensive understanding of the necessary repairs. Have them further evaluate and make the necessary corrective actions.

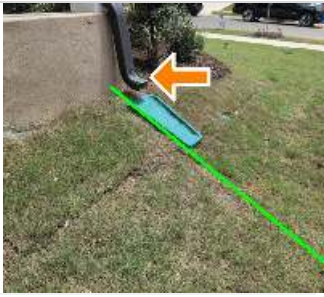
**5.4 Item 2 (Picture)**

(3) A downspout was noted to terminate at an area with steep grade change. This could result in soil erosion over time in some situations. It is recommended to continue to monitor for erosion and, if necessary, make corrections to appropriately slow or divert the water to a lower sloped area to prevent further erosion which could result in structural concerns.

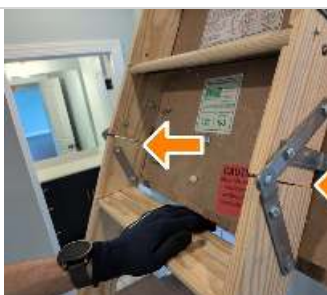
**6.0 Item 2 (Picture)**

1. **The ladder to the attic is loose, weak, damaged, and/or improperly attached** and needs repair and or replacement to ensure safety.
2. The ladder handrail was found to be very loose at the time of inspection and was finger-tightened for use during the inspection but should be properly tightened to the rated specification (if provided by the manufacturer) to ensure safety while navigating the ladder.
3. The attic ladder was found to be stiff or difficult to operate and needs adjustment, repair, or replacement to function as intended.

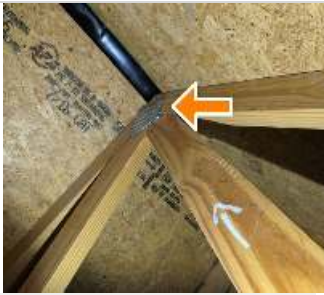
**6.0 Item 5 (Picture)**

(3) Truss gusset plates were found to be loose, damaged, and/or missing in the following areas of the attic: center (second floor, main attic) and front (above garage). Corrections are needed to prevent possible movement and/or damage. *Note: All repairs or modifications to trusses should be made under the direction of a licensed structural engineer or the truss manufacturer.* Consult with your builder to gain a comprehensive understanding of the necessary repairs. Have them further evaluate and make the necessary corrective actions.

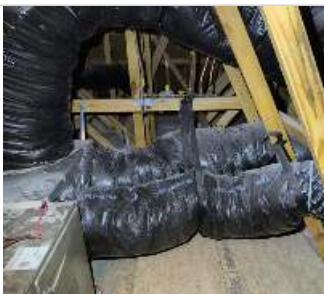
**6.1 Item 1 (Picture)**

Due to framing, ductwork, plumbing, and/or no flooring, the inspection of the attic above the second floor and walk-in attic above the first floor towards the rear was limited to the scuttle hole or floored area only by flashlight. The structure condition could not be fully viewed and the conditions are unknown. Ask the seller for full disclosure as to any repairs or defects that may have occurred in the past and if corrections have been made to correct them.

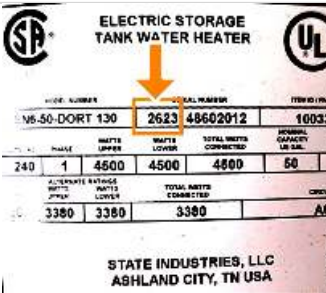
7.3 Item 1 (Picture)

(1) The lifespan of a typical water heater is noted to be 10-15 years for an electric water heater and 15-18 years for a gas water heater. The lifespan can depend on several things: the condition of the water; if the water heater is maintained properly; the location of the water heater (crawl space, interior closet, garage, etc.); and several other factors. Due to additional factors, it is impossible to determine the lifespan of the water heater(s) currently installed and/or the additional years left for the water heater. Based on the inspector's knowledge of the brand, the water heater appeared to have been manufactured in 2026. It is recommended to verify this information prior to closing.

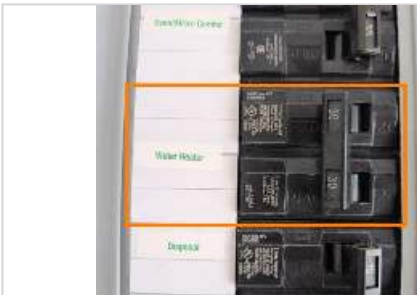
7.4 Item 1 (Picture)

(1) Unable to test the water temperature, function of the water heater, or hot / cold orientation at fixtures throughout the home due to the breaker for the water heater being off at the time of inspection. It is recommended to verify proper function and orientation prior to closing when the water heater has been turned on. Though often the breaker is turned off on vacant / new homes to save energy, this could also indicate incomplete installation or a known defect. Therefore, the breaker was not turned back on at the time of inspection.

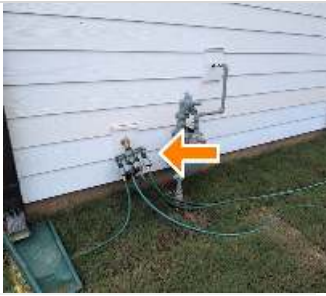
**7.4 Item 2 (Picture)**

(3) Unable to test one or more of the exterior faucet(s) due to the irrigation system connected at the time of inspection. Removal of the irrigation system could result in malfunction. It is recommended to verify proper operation of the faucet(s) prior to closing when the irrigation system has been removed.

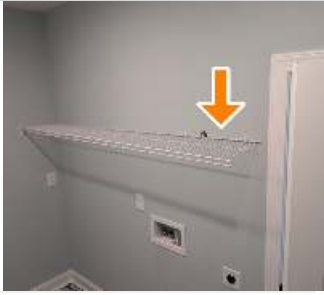
8.0 Item 2 (Picture)

(2) The wire shelf in the laundry room was not properly braced / supported at one end and needs correction to prevent a possible safety hazard and/or property damage if the shelf collapses. Consult with your builder to gain a comprehensive understanding of the necessary repairs. Have them further evaluate and make the necessary corrective actions.

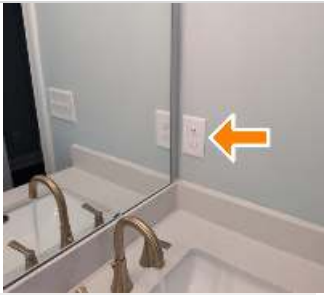
9.0 Item 4 (Picture)

(4) At least one electrical receptacle was found to be loosen in the wall at the primary bathroom. Corrections are needed to prevent possible loose connections which may result in sparking, loss of function, and/or a fire hazard. Consult with your builder to gain a comprehensive understanding of the necessary repairs. Have them further evaluate and make the necessary corrective actions.

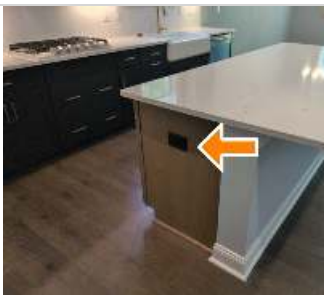
9.0 Item 5 (Picture)

1. Electrical outlets were noted to be installed on the sides of the kitchen island / bar. Though this was normal until recently, changes have been made to installation practices as it was found that this creates a potential safety hazard such as if cords are draped across the walking path or if clothes snag on the plugs sticking out. Make corrections as necessary to ensure safety. ***Typical for the age of the home.***
2. **The following outlets are not protected by GFCI:** kitchen dedicated appliance receptacles†. Ground fault interrupters work by sensing a loss of current in the circuit. When a GFCI senses such a problem, the electrical current to the outlet is shut down almost immediately. Corrections are needed for safety. ***Typical for the age of the home.***

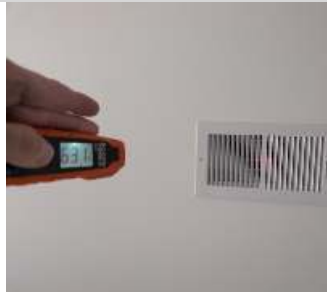
**11.0 Item 2 (Picture)**  
Sample supply temp. -  
Inadequate differential

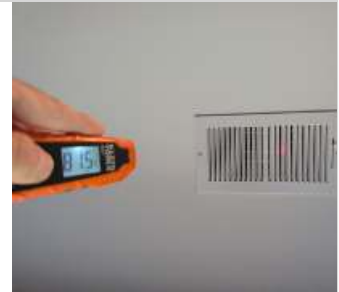
**11.0 Item 3 (Picture)**  
Sample supply temp. - Warm  
air in cooling mode

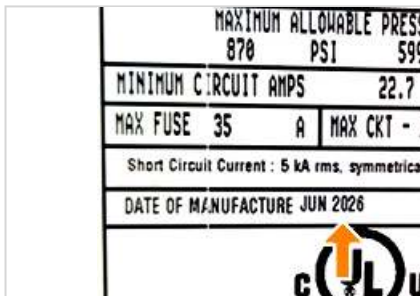
11.2 Item 1 (Picture)

(2) According to the label on the unit, the exterior AC compressor was manufactured in 2026.

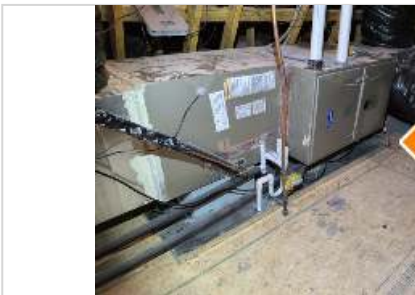
12.1 Item 1 (Picture)

This homes catch pans at the HVAC units has a "float switch" installed. These are designed to automatically shut the unit off if water ever fills the overflow pan. If the unit continues to turn off periodically this may indicate water in the overflow pan and repairs are needed.

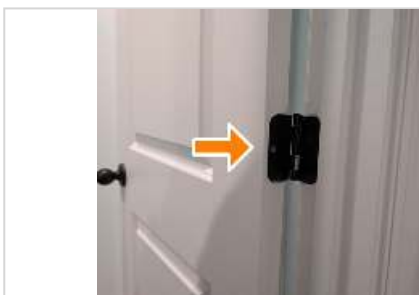
1. One or more fasteners were found to be missing or stripped at the door hinges in the following locations: Downstairs hall closet, half bathroom. Corrections are needed to ensure the door is properly secured to prevent possible damage and/or difficulty operating the door(s).
2. The door trim / frame was noted to be cracked or damaged in the following locations: Primary bathroom closet. Repair or replace as necessary to ensure the door is properly secured to prevent possible movement, damage, and/or difficulty operating the door.

**13.0 Item 1 (Picture)**  
Example - Item 1

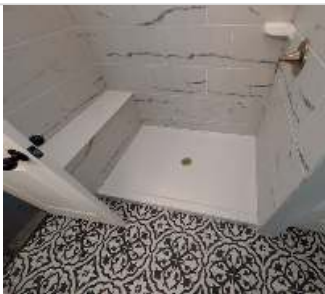
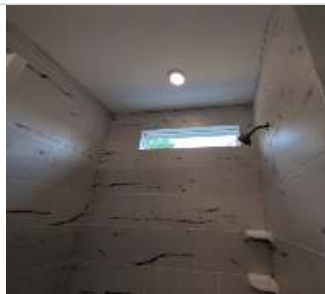
(1) Grout / caulk was missing in multiple areas throughout the shower enclosure and adjacent areas. This likely indicates incomplete installation. Follow up with your builder to ensure all necessary areas of grout / sealant are finished prior to closing to prevent moisture damage and related concerns. *Note: Due to this, the shower / tub fixtures were not tested during the inspection as testing could result in leaking / damage. It is recommended to verify proper operation of the fixtures and drains prior to closing when installation is completed.*

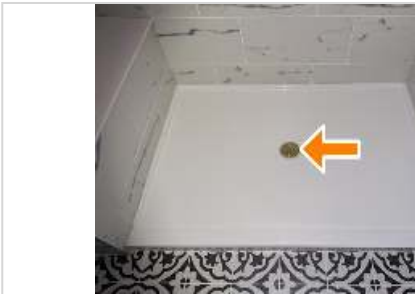
14.0 Item 4 (Picture)

(3) Debris is noted within the shower drain. Corrections are needed to prevent possible clogging. Consult with your builder to gain a comprehensive understanding of the necessary repairs. Have them further evaluate and make the necessary corrective actions.

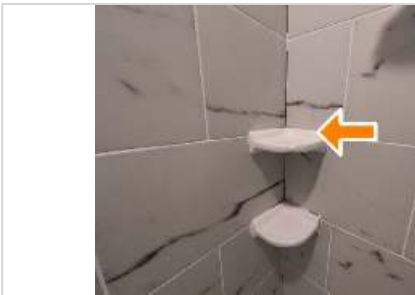
**14.2 Item 1 (Picture)**

(2) One of the shower corner shelves appeared to be flat or otherwise may not be appropriately pitched to drain. The shower was unable to be tested to confirm this due to limitation. It is recommended to verify if correction is necessary to prevent standing water on the shelf. Consult with your builder to gain a comprehensive understanding of the necessary repairs. Have them further evaluate and make the necessary corrective actions.

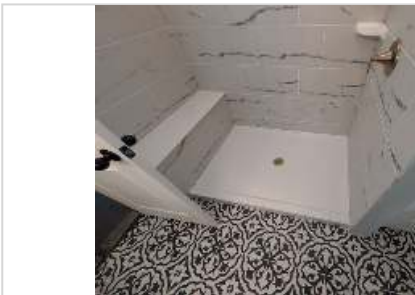
The shower / tub fixtures at the primary bathroom and upstairs hall bathroom were not tested during the inspection as testing could result in leaking / damage due to incomplete grout / sealant. It is recommended to verify proper operation of the fixtures and drains prior to closing when installation is completed.

**14.3 Item 1 (Picture)**  
Example area

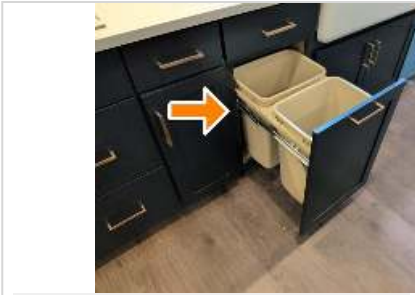
15.0 Item 1 (Picture)

One or more of the kitchen cabinet drawers did not slide or track properly. Adjustment, repair, or replacement is needed to ensure proper operation and prevent possible damage. Consult with your builder to gain a comprehensive understanding of the necessary repairs. Have them further evaluate and make the necessary corrective actions.

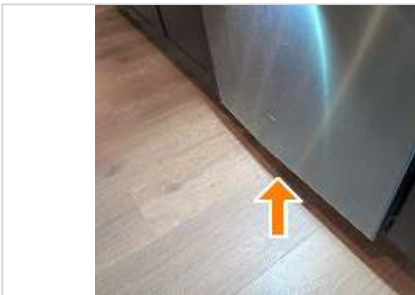
The front panel of the dishwasher was found to be loose and warped / bent. Repair or replace as needed to prevent possible further damage. Consult with your builder to gain a comprehensive understanding of the necessary repairs. Have them further evaluate and make the necessary corrective actions.

15.1 Item 1 (Picture)  
Bowed outward / loose

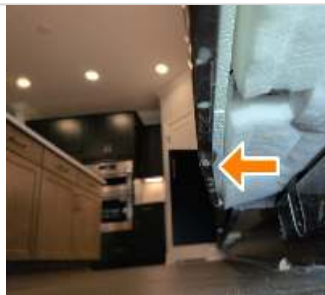
15.1 Item 2 (Picture)  
Bent / creased at lip

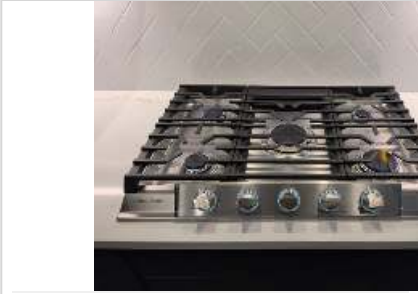
**15.2 Item 1 (Picture)**

(3) The cooktop was tested by operating the burners during the inspection. However, the efficiency of the burners could not be determined at that time.

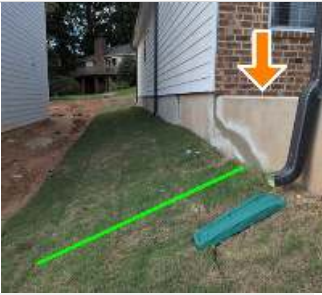
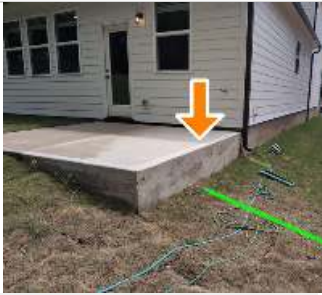
1. Potential fall hazards were noted at the front porch and rear raised patios. Both areas were not equipped with guardrails and, though not immediately at the height limit to require railing, these areas had steep or moderate change in pitch at the soil below which increases risk if a person stumbles or falls from the porch / patio. Make corrections as necessary to ensure safety. Consult with your builder to gain a comprehensive understanding of the necessary repairs. Have them further evaluate and make the necessary corrective actions.

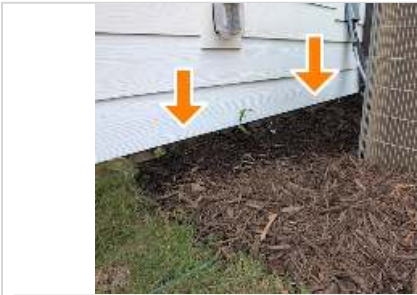
**Item 3 - Item 1 (Picture)**

3. (2) The siding at the right side of the home does not have the appropriate clearance from the ground. It is recommended that most claddings maintain a minimum clearance of 6 inches between the grade and the siding. This clearance is important in preventing water intrusion and deterring insects from causing damage. Consult with your builder to gain a comprehensive understanding of the necessary repairs. Have them further evaluate and make the necessary corrective actions.

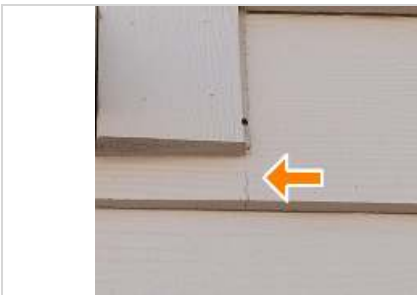
3. The paint was noted to be damaged or incomplete in at least a few areas along the left side and rear of the home. Make corrections as necessary to prevent possible accelerated deterioration of the siding material which could result in water penetration into the wall system.

**Item 4 - Item 1 (Picture)**  
Example - Item 1

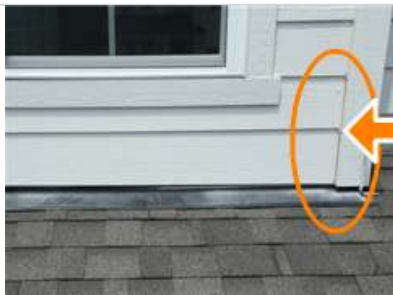
**Item 5 - Item 1 (Picture)**

5. Sealant deficiencies, such as missing or poorly sealed areas, were observed on the exterior siding and trim in various sections around the home, including window and door frames. Corrections are required to prevent potential water seepage or insect infestation. Consult with your builder to gain a comprehensive understanding of the necessary repairs. Have them further evaluate and make the necessary corrective actions.

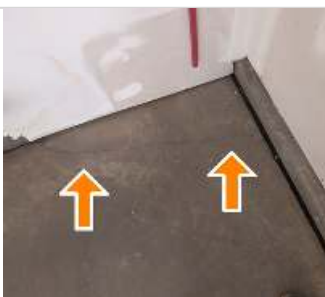
**Item 7 - Item 1 (Picture)**

7. (2) **There are cracks noted in the garage floor that need to be sealed and/or repaired properly to prevent water penetration and/or continual cracking.** Continue to monitor and make additional repairs as needed. Consult with your builder to gain a comprehensive understanding of the necessary repairs. Have them further evaluate and make the necessary corrective actions.

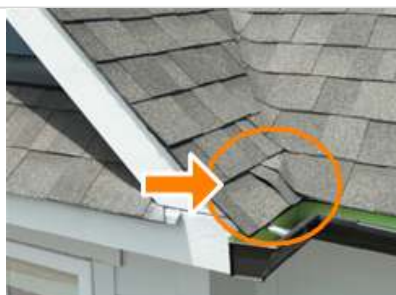
1. **There are nail pops or otherwise lifted shingles noted at the front and rear of the roof.** Corrections are needed to prevent possible damage and/or water penetration.

**Item 8 - Item 1 (Picture)**  
Example - Item 1

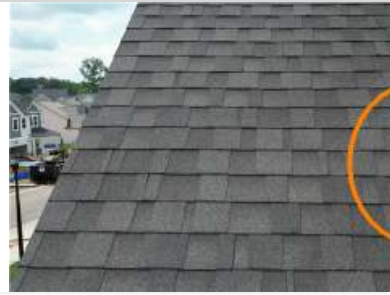
3. Areas of concentrated granular loss were noted throughout the roof system. This is typically an indication of mechanical damage such as foot traffic and/or objects falling on the roof, though could be an indication of a manufacturer's defect. *Note: Examples include damage typical of ladders set on the roof at the front and worn granules at the rear.* Corrections are needed to prevent possible accelerated deterioration and/or water penetration.

**Item 8 - Item 11 (Picture)**  
Example - Item 3 - Possible  
ladder damage

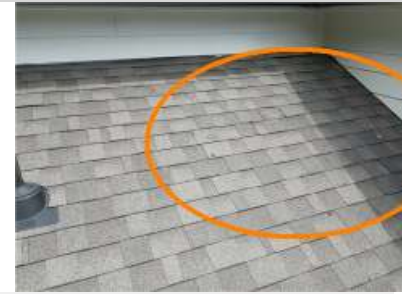
**Item 8 - Item 12 (Picture)**  
Example - Item 3 - Evidence of  
foot traffic

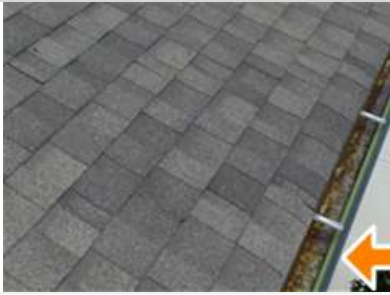
1. **There is standing water in the gutter located at the front and rear of the home.** The gutter is either clogged and/or not sloped properly. Proper corrections and/or repairs are needed to direct water away from the home and foundation.
2. The gutter appeared to be improperly pitched at the right front of the home. Further evaluation is needed to ensure the gutter is appropriately installed to drain. Improper pitch can allow for standing water and potential overflowing / leaking.

9. The following items(s) need further evaluation to determine if corrections are necessary. Please consult with your builder to evaluate the following areas of concern and make any additional repairs as deemed necessary during their evaluation:
  1. **There is standing water in the gutter located at the front and rear of the home.** The gutter is either clogged and/or not sloped properly. Proper corrections and/or repairs are needed to direct water away from the home and foundation.
  2. The gutter appeared to be improperly pitched at the right front of the home. Further evaluation is needed to ensure the gutter is appropriately installed to drain. Improper pitch can allow for standing water and potential overflowing / leaking.

**Item 9 - Item 1 (Picture)**  
Example - Item 1

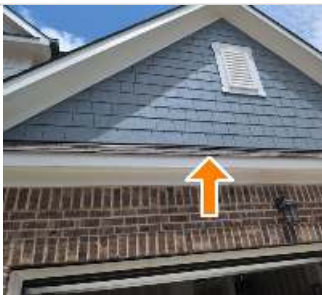
- 10. The flashing was found to be loose and/or improperly installed in areas on the home.** Proper corrections and/or repairs are needed to prevent possible water penetration and/or water damage. Consult with your builder to gain a comprehensive understanding of the necessary repairs. Have them further evaluate and make the necessary corrective actions.

**Item 10 - Item 1 (Picture)**  
Example area

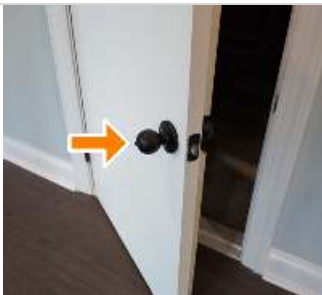
**Item 12 - Item 1 (Picture)**

12. (1) The walk-in attic door was found to have the lock(s) installed on the wrong side. This could allow a person to become locked inside the attic. Corrections are needed to prevent a possible safety hazard. Consult with your builder to gain a comprehensive understanding of the necessary repairs. Have them further evaluate and make the necessary corrective actions.

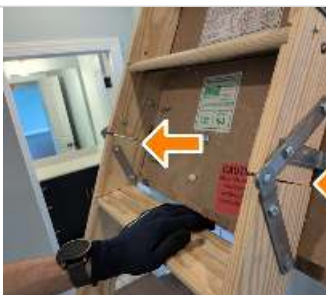
**Item 13 - Item 1 (Picture)**

3. The attic ladder was found to be stiff or difficult to operate and needs adjustment, repair, or replacement to function as intended.

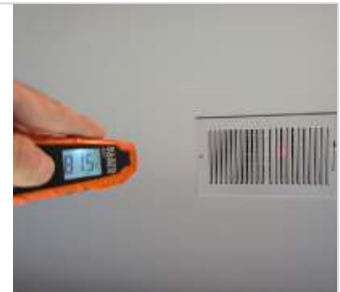
**Item 26 - Item 3 (Picture)**  
Sample supply temp. - Warm  
air in cooling mode

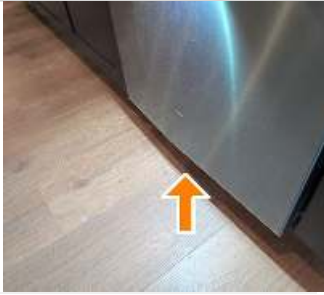
**Item 35 - Item 1 (Picture)**

Bowed outward / loose
