PRE-DRYWALL INSPECTION REPORT

INSPECTION DATE 9/28/2026 BUYER'S AGENT

Home Inspection Carolina

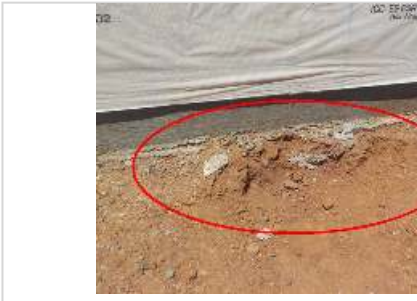
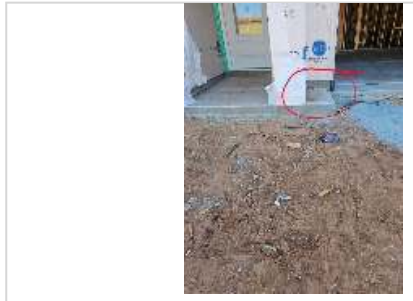
#### 1.0 Sheathing Findings

Crack noted at the left side of the foundation, evaluation and repair is needed to prevent further damage  
Irregular slab installation at the front of the home, correction is needed for proper function.

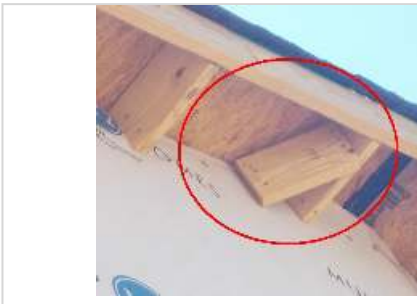
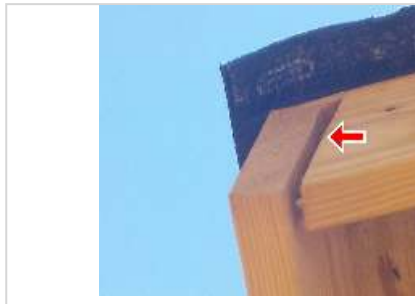
## 2.0 Roofing Findings

Spacing and irregular installation noted at the fascia

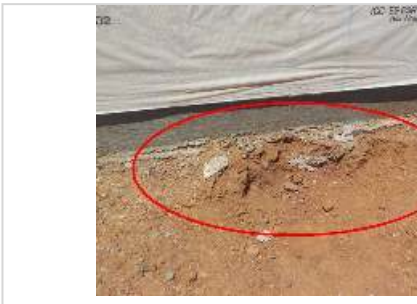
## 3.0 Structural Findings

A crack was noted in the foundation at the at the time of inspection. Cracks in foundations should be evaluated to determine whether they are cosmetic or structural in nature. Have a qualified licensed contractor or structural engineer evaluate the crack before construction continues.

A crack was noted in the foundation at the

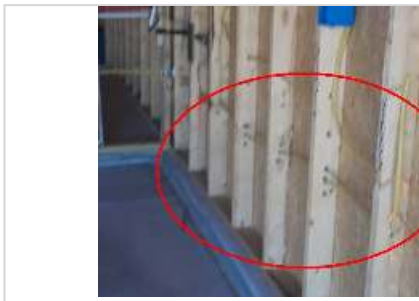
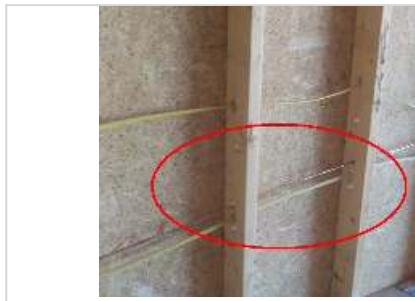
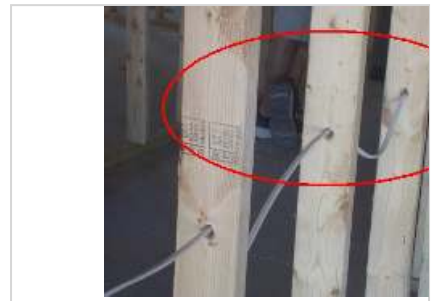
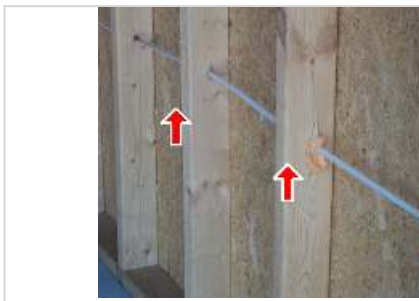
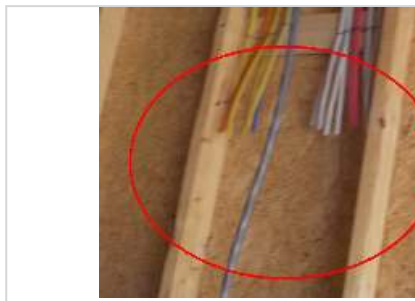
## 5.0 Electrical Findings

The electrical wiring protective plates are missing at the following locations. The protective plates are needed to protect the wiring from becoming punctured or damaged when installing the sheetrock.

An electrical panel is missing. Electrical panel must be installed and firmly secured to support the weight of devices and cover plates. Have the builder secure the electrical box before drywall is applied.

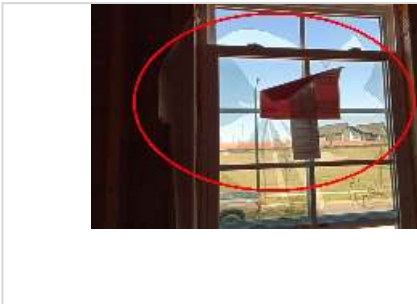
#### 8.0 Rough Opening Findings

Broken window noted, replace is needed to prevent further damage.

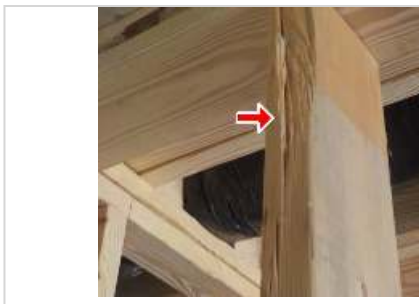
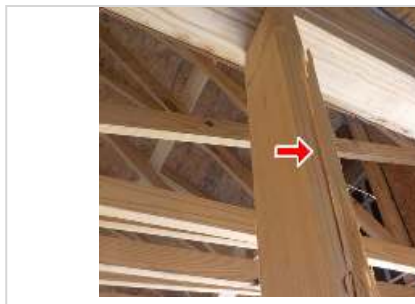
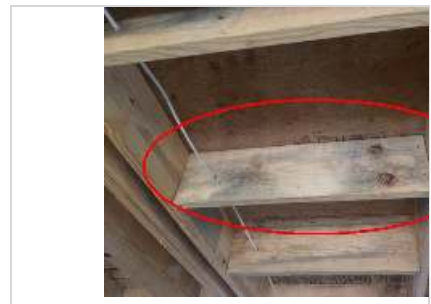
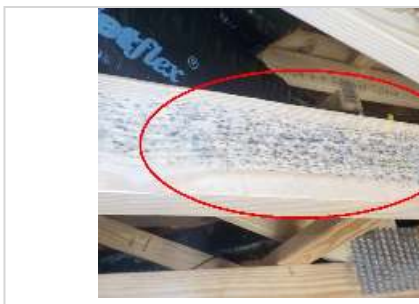
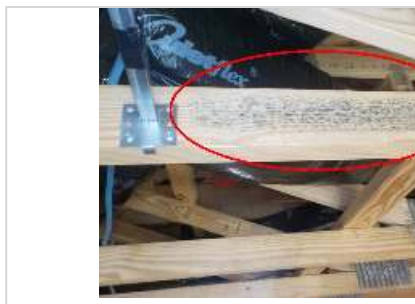
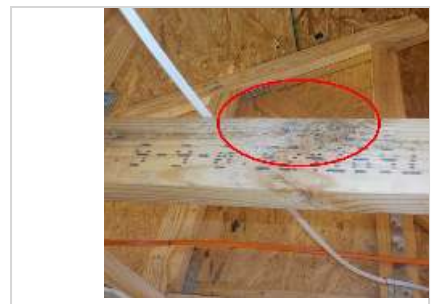
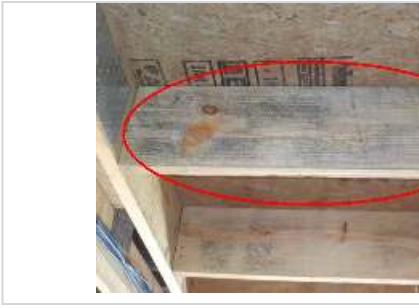
## 9.0 Attic Findings

There is a broken truss support that needs additional support at the multiple locations . Securing a 2x4 along the side of the truss support should give the additional support needed. This is typically referred to as sistering or scabbing. However, have the builder further evaluate to determine what repairs are required and make any additional repairs as needed or deemed necessary.

The roof rafters/trusses were found to have fungus or organic growth along them in the attic area. Have a licensed or certified fungus specialist further evaluate the entire crawl space and any components within the crawl space to determine the type of fungus and if removal is needed.

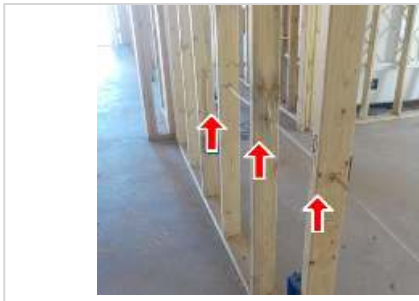
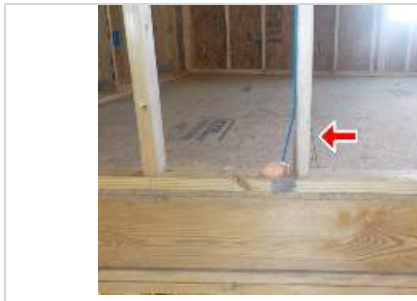
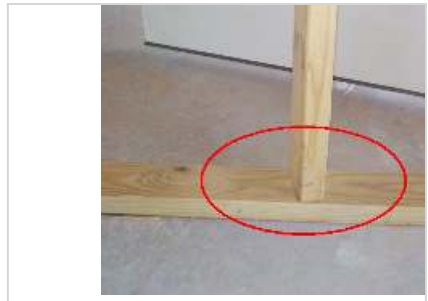
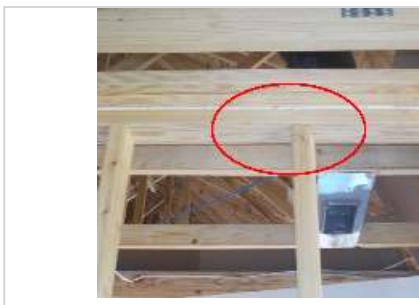
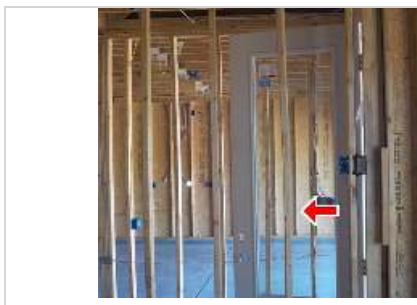
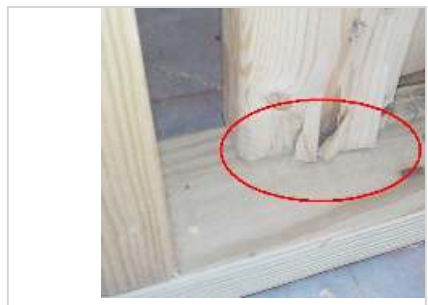
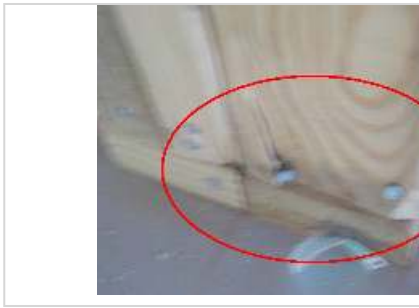
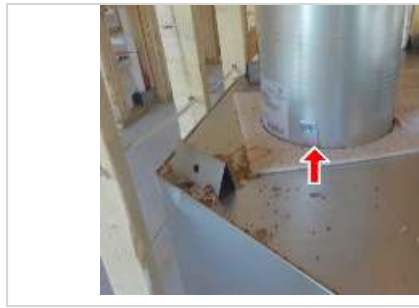
#### 10.0 Interior Findings

A)The electrical wiring protective plates are missing at the following locations. The protective plates are needed to protect the wiring from becoming punctured or damaged when installing the sheetrock.

B)There are twisted and or warped wall studs that need to be corrected and or replaced properly at the following locations. Note: All twisted studs were marked with blue tape.

C)There are several areas throughout the first floor joist framing where the I-joists were nailed into the side of the bottom flange causing damage to the joist.

D)There were spacing at the fireplace flue noted when the flue meet the firebox that need fire blocking and/or foam.

Have the builder further evaluate to determine what repairs are required and make any additional repairs as needed or deemed necessary.
