SEWER SCOPE INSPECTION REPORT

INSPECTION DATE 9/15/2026

# Sewer Scope Inspection Report

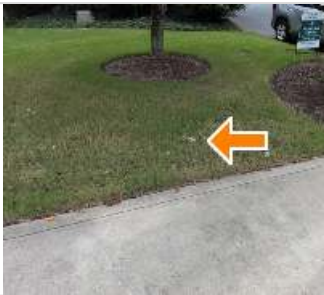
### 1.2 Item 1 (Picture)

The sewer line was accessed from a clean-out located in the front yard and the line was scoped towards the street connection or septic tank until either reaching the connection point or until otherwise limited. The conditions elsewhere in the sewer / septic system were unknown at the time of inspection.

Access point
