INSPECTION REPORT

**123 Sample Street**

Anytown, SC

INSPECTION DATE 8/19/2026

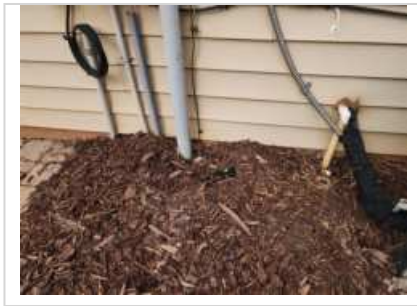
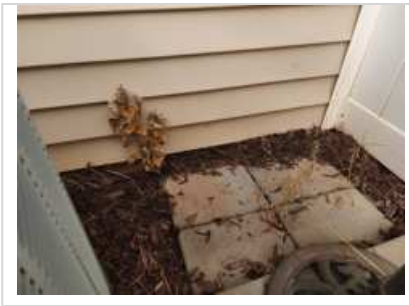
The siding at the Rear of the home does not have the appropriate clearance from the ground. It is recommended that most claddings maintain a minimum clearance of 6 inches between the grade and the siding. This clearance

is important in preventing water intrusion and deterring insects from causing damage.

Consult with a qualified licensed contractor to evaluate the area(s) of concern and make any additional repairs as deemed necessary during their evaluation.

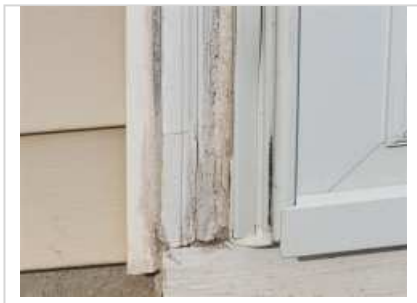
## 1.1 Trim Visual Findings

Wood rot and water damage was observed at the trim on the Rear side of the house. Additional assessment is required to ascertain the extent of repair or replacement required.

Consult with a qualified licensed contractor to evaluate the area(s) of concern and make any additional repairs as deemed necessary during their evaluation.

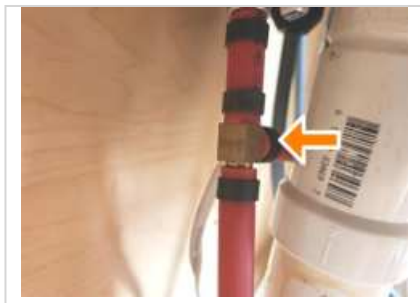
5.0 Plumbing Conditions/Visual Findings

The visible plumbing lines in this home are plastic PEX with brass metal fittings. Evidence of fitting deterioration was noted during the inspection in a few/several locations. The deterioration could be the result of a known problem referred to as “dezincification”. Dezincification occurs when brass fittings that are considered a high-zinc copper alloy are exposed to water and the zinc is leached from the fitting or component leaving the fitting in a weakened state. This process also leads to a build-up inside the fitting, restricting water flow and ultimately leaving the plumbing system prone to breakage and leaking. A licensed plumbing contractor should be

consulted for a complete evaluation of the plumbing system to determine the general condition of the plumbing distribution and supply lines, the significance of this concern, and make necessary repairs.

Consult with a qualified licensed contractor to fully understand the extent of the repairs needed and determine if corrective actions are required.

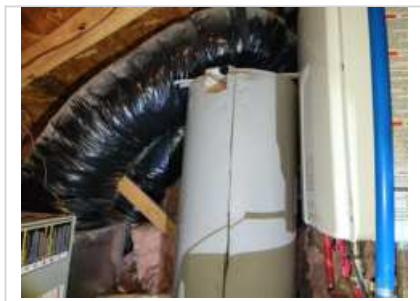
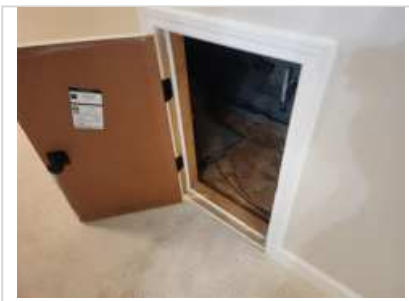
## 5.1 Water Heater Conditions/Visual Findings

📋 Further evaluation is needed.

Consult with a qualified licensed contractor to evaluate the area(s) of concern and make any additional repairs as deemed necessary during their evaluation.

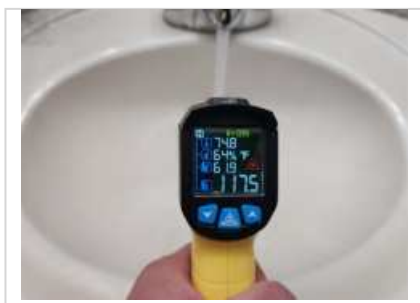
## 5.2 Water Temperature Information

117 degrees

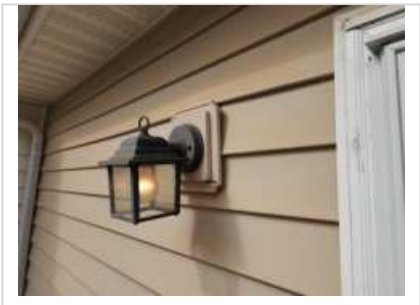
(1) The rear exterior light fixture is not properly secured to the wall behind the siding. Corrections are needed to prevent further movement and possible damage. Consult with a qualified licensed contractor to evaluate the area(s) of concern and make any additional repairs as deemed necessary during their evaluation.

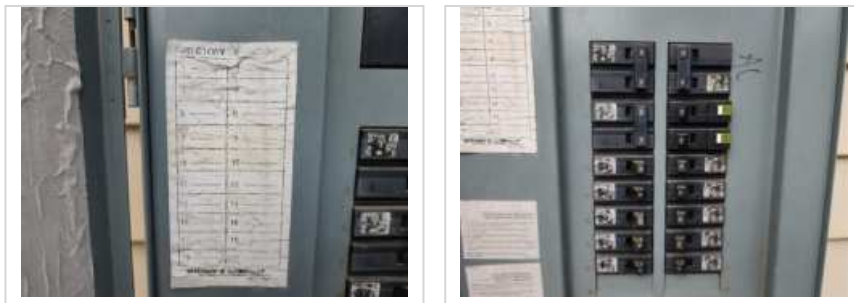
(2) The breakers are not marked as to what they control in the electrical panel. When the breakers are not marked it is difficult to determine which one needs to be turned of in an emergency.

Consult with a qualified licensed contractor to evaluate the area(s) of concern and make any additional repairs as deemed necessary during their evaluation.

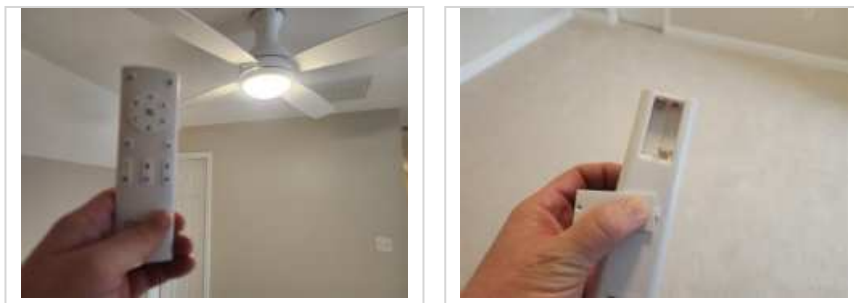
(3) The upstairs ceiling fan remote control is missing the batteries. It is recommended to have the seller installed batteries and verify functionality prior to closing.

Consult with a qualified licensed contractor to evaluate the area(s) of concern and make any additional repairs as deemed necessary during their evaluation.

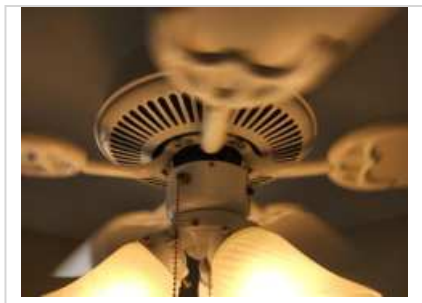
(4) There are ceiling fans that squeaked and/or made unusual noises when testing within the home at the time of inspection. This may be an indication that the fan or bearings are going bad and replacement may be needed in the near future.

Consult with a qualified licensed contractor to evaluate the area(s) of concern and make any additional repairs as deemed necessary during their evaluation.

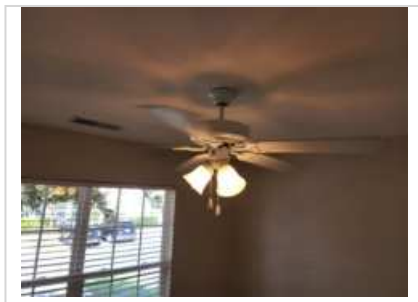
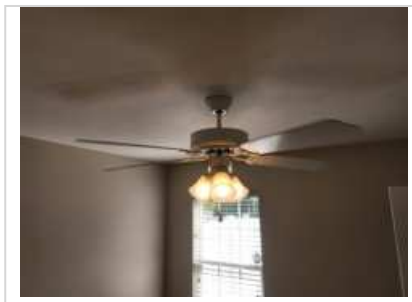
(5) There are ceiling fan(s) that are not balanced within the home and need to be properly balanced, adjusted, repaired, and/or replaced.

Consult with a qualified licensed contractor to evaluate the area(s) of concern and make any additional repairs as deemed necessary during their evaluation.

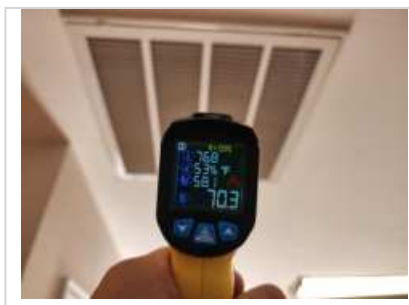
Main Supply Air Temperature- 58 degrees.

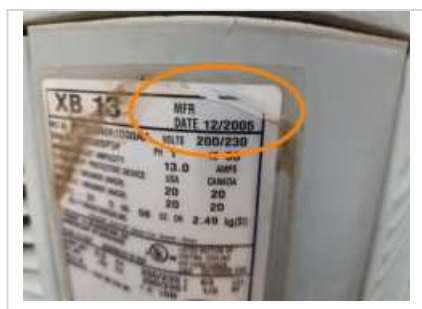
(2) The HVAC system was operational at the time of inspection; however, if your AC unit was manufactured before 2010, it may be wise to consider a replacement if repairs are necessary. On January 1, 2010, the Environmental Protection Agency (EPA) enforced a ban on the production and importation of R22 refrigerant, permitting its use only for servicing existing equipment. As of January 1, 2020, purchasing R22 has become illegal. Consequently, repairing older R22 systems will likely be quite costly, especially when it involves adding refrigerant. For more information please [click here](#).

Consult a qualified licensed contractor to assess the areas of concern and perform any additional repairs deemed necessary during their evaluation.

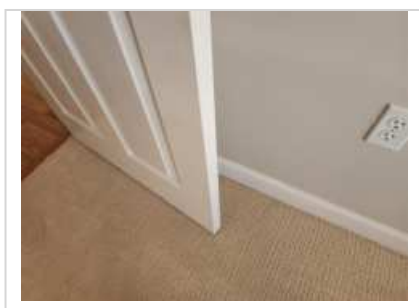
(4) There are door stops missing/damaged behind doors in areas throughout the home; replacement needed to prevent possible damage to the walls behind the doors.

Consult with a qualified licensed contractor to evaluate the area(s) of concern and make any additional repairs as deemed necessary during their evaluation.

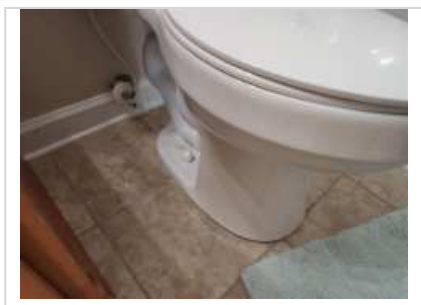
(2) The toilet is loose at the floor and needs to be secured properly to prevent movement and or possible leakage. The toilet may need to be pulled to determine if the wax seal has been damaged. Replace wax seal if needed.

Consult with a qualified licensed contractor to evaluate the area(s) of concern and make any additional repairs as deemed necessary during their evaluation.

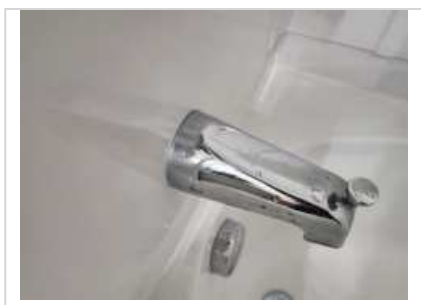
(3) Caulk is needed around the tub faucet where it meets the shower wall to prevent water penetration.

Consult with a qualified licensed contractor to evaluate the area(s) of concern and make any additional repairs as deemed necessary during their evaluation.

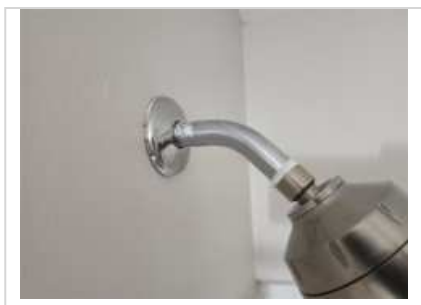
(4) The shower head arm is loose where it connects inside the wall. Water may be leaking at the connection inside the wall where it is not visible.

Consult with a qualified licensed contractor to evaluate the area(s) of concern and make any additional repairs as deemed necessary during their evaluation.

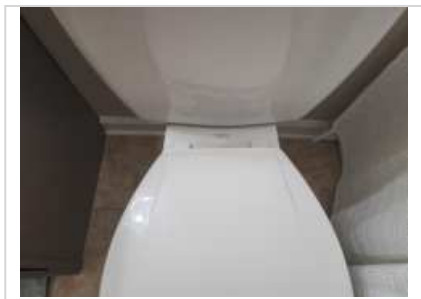
(2) The toilet seat was found to be loose at the time of inspection and needs to be secured properly to prevent continual movement.

Consult with a qualified licensed contractor to evaluate the area(s) of concern and make any additional repairs as deemed necessary during their evaluation.

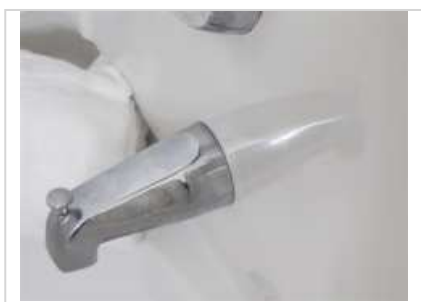
(3) Caulk is needed around the tub faucet where it meets the shower wall to prevent water penetration.

Consult with a qualified licensed contractor to evaluate the area(s) of concern and make any additional repairs as deemed necessary during their evaluation.

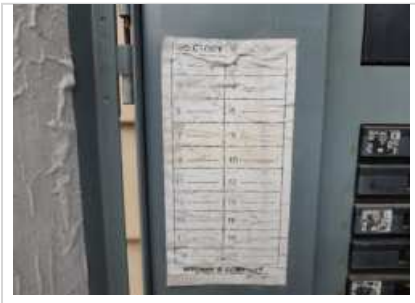
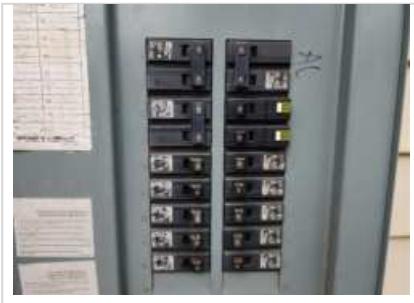
6. (2) The breakers are not marked as to what they control in the electrical panel. When the breakers are not marked it is difficult to determine which one needs to be turned of in an emergency.

Consult with a qualified licensed contractor to evaluate the area(s) of concern and make any additional repairs as deemed necessary during their evaluation.

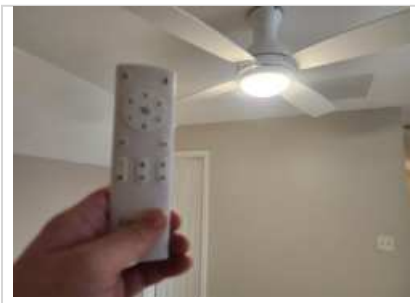
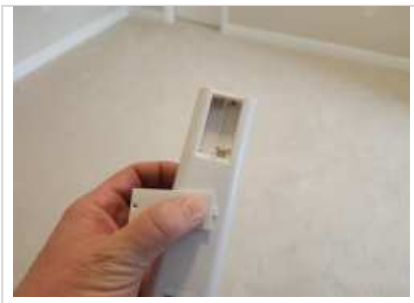
7. (3) The upstairs ceiling fan remote control is missing the batteries. It is recommended to have the seller installed batteries and verify functionality prior to closing.

Consult with a qualified licensed contractor to evaluate the area(s) of concern and make any additional repairs as deemed necessary during their evaluation.

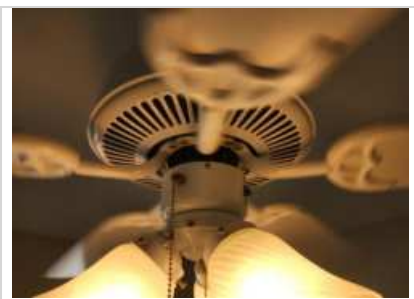
8. (4) There are ceiling fans that squeaked and/or made unusual noises when testing within the home at the time of inspection. This may be an indication that the fan or bearings are going bad and replacement may be needed in the near future.

Consult with a qualified licensed contractor to evaluate the area(s) of concern and make any additional repairs as deemed necessary during their evaluation.

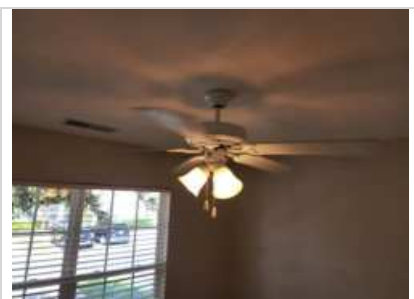
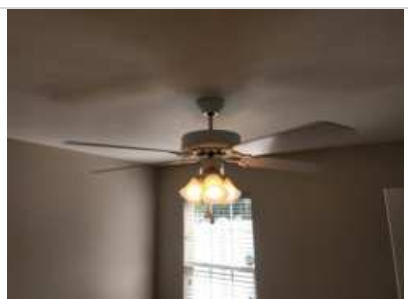
9. (5) There are ceiling fan(s) that are not balanced within the home and need to be properly balanced, adjusted, repaired, and/or replaced.

Consult with a qualified licensed contractor to evaluate the area(s) of concern and make any additional repairs as deemed necessary during their evaluation.

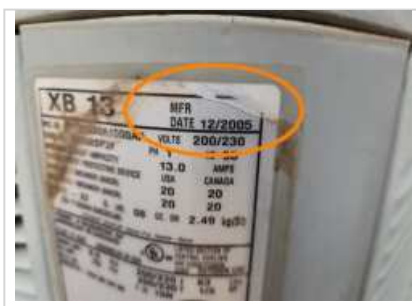
11. (2) The HVAC system was operational at the time of inspection; however, if your AC unit was manufactured before 2010, it may be wise to consider a replacement if repairs are necessary. On January 1, 2010, the Environmental Protection Agency (EPA) enforced a ban on the production and importation of R22 refrigerant, permitting its use only for servicing existing equipment. As of January 1, 2020, purchasing R22 has become illegal. Consequently, repairing older R22 systems will likely be quite costly, especially when it involves adding refrigerant. For more information please [click here](#).

Consult a qualified licensed contractor to assess the areas of concern and perform any additional repairs deemed necessary during their evaluation.

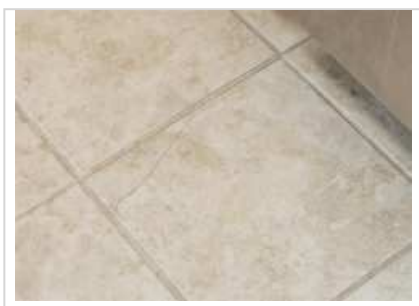
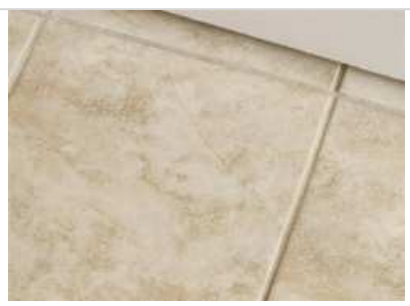
- 
13. (2) The floor tiles in the following areas have visible cracks that require repair or replacement to prevent further damage:

Consult with a qualified licensed contractor to evaluate the area(s) of concern and make any additional repairs as deemed necessary during their evaluation.

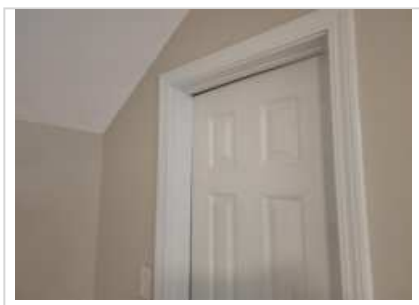
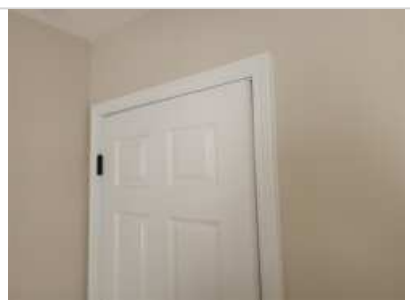
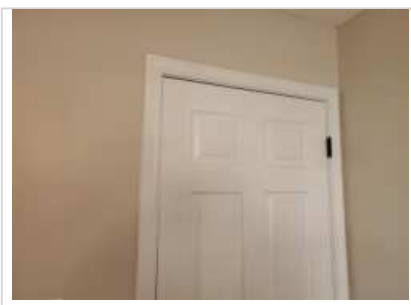
- 
14. (3) The following door(s) listed below rubbed at the frame/flooring and need adjustment and/or repair for the door(s) to open and close properly without rubbing:

Consult with a qualified licensed contractor to evaluate the area(s) of concern and make any additional repairs as deemed necessary during their evaluation.

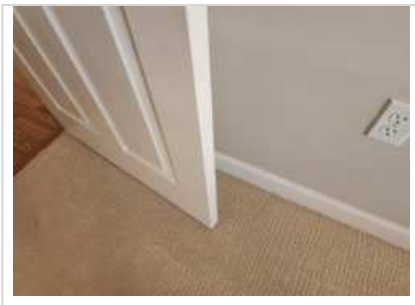
15. (4) There are door stops missing/damaged behind doors in areas throughout the home; replacement needed to prevent possible damage to the walls behind the doors.

Consult with a qualified licensed contractor to evaluate the area(s) of concern and make any additional repairs as deemed necessary during their evaluation.

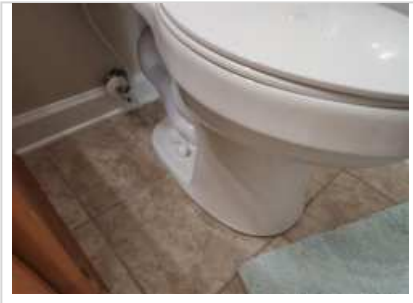
- 
18. (2) The toilet is loose at the floor and needs to be secured properly to prevent movement and or possible leakage. The toilet may need to be pulled to determine if the wax seal has been damaged. Replace wax seal if needed.

Consult with a qualified licensed contractor to evaluate the area(s) of concern and make any additional repairs as deemed necessary during their evaluation.

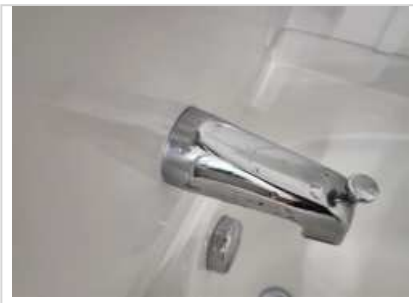
- 
19. (3) Caulk is needed around the tub faucet where it meets the shower wall to prevent water penetration.

Consult with a qualified licensed contractor to evaluate the area(s) of concern and make any additional repairs as deemed necessary during their evaluation.

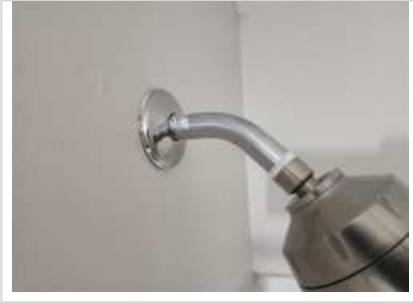
- 
20. (4) The shower head arm is loose where it connects inside the wall. Water may be leaking at the connection inside the wall where it is not visible.

Consult with a qualified licensed contractor to evaluate the area(s) of concern and make any additional repairs as deemed necessary during their evaluation.

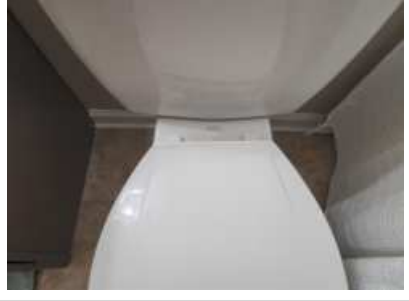
22. (2) The toilet seat was found to be loose at the time of inspection and needs to be secured properly to prevent continual movement.

Consult with a qualified licensed contractor to evaluate the area(s) of concern and make any additional repairs as deemed necessary during their evaluation.

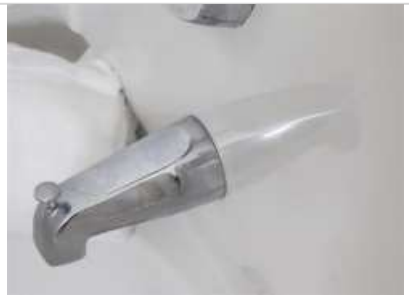
- 
23. (3) Caulk is needed around the tub faucet where it meets the shower wall to prevent water penetration.

Consult with a qualified licensed contractor to evaluate the area(s) of concern and make any additional repairs as deemed necessary during their evaluation.
