POOL INSPECTION REPORT

## 123 Sample Street

**INSPECTION DATE** 9/11/2026 **START TIME** 09:00:00 AM **REPORT ID** 123 Sample Street (Pool)

# Pool & Spa Inspection Report

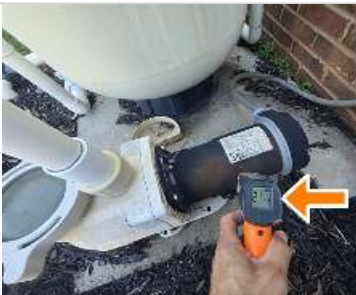
(2) **The pool pump motor was operating at an elevated temperature of approximately 211°F when measured at the motor housing.** This may indicate overheating and could contribute to premature motor failure. Consult with a qualified licensed contractor to evaluate the following areas of concern and make any additional repairs as deemed necessary during their evaluation.

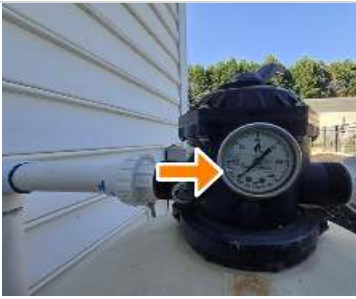
(3) **The pressure gauge on the sand filter was inoperable at the time of inspection.** An operational gauge is necessary to monitor filter pressure and help determine when filter cleaning/backwashing or other maintenance may be needed. Replacement is needed. Consult with a qualified licensed contractor to evaluate the following areas of concern and make any additional repairs as deemed necessary during their evaluation.

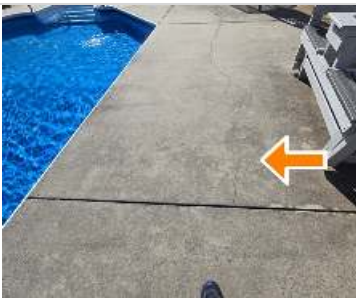
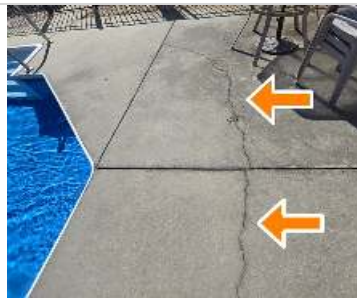
(4) **Cracks were noted in the concrete pool decking** that need to be properly sealed to prevent water penetration and further cracking. Consult with a qualified licensed contractor to evaluate the following areas of concern and make any additional repairs as deemed necessary during their evaluation.
