WELL & WATER INSPECTION REPORT

## 123 Sample Street

# Well Inspection Report

## 1. Well Inspection

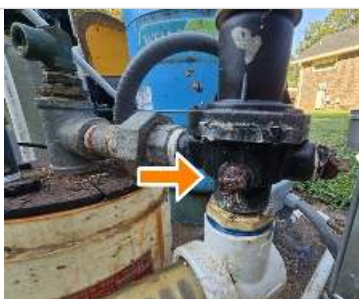
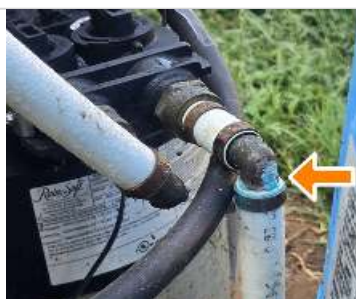
#### 1.1 Pump Findings

**Rust/corrosion was noted at plumbing fittings and/or fasteners at the well equipment.** No leaks were observed at the time of the inspection. Replacement may be needed in the near future. Continue to monitor and make any repairs deemed necessary.

**There is no anti-backflow preventer valve installed at the pump faucet.** Backflow preventer valves are required to prevent cross-contamination between water supply sources.

Due to the finding(s) identified, it's recommended to consult with a qualified licensed contractor to evaluate further and make any additional repairs deemed necessary.

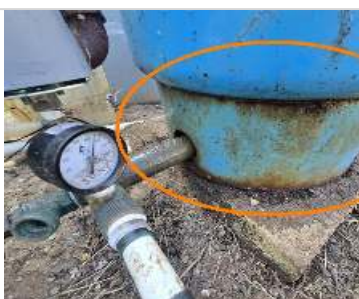
## 1.2 Bladder Tank Findings

**Rust/corrosion was noted around the the bottom of the bladder tank at the time of the inspection.** Continue to monitor and make any repairs deemed necessary.

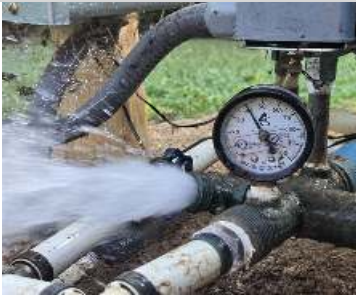
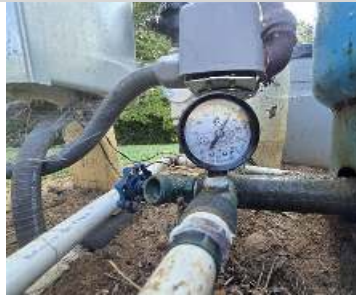
## 1.3 Water Pressure and PSI Information

The PSI was set between 40 - 60

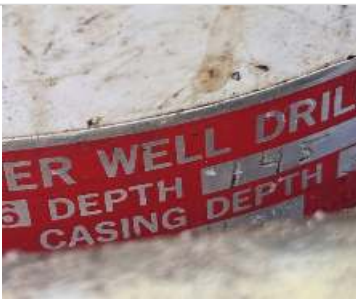
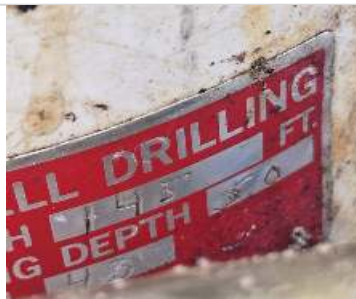
## 1.4 Well/Casing Depth

According to the attached data plate,  
The well depth was recorded to be 145 ft  
The casing depth was recorded to be 50 ft

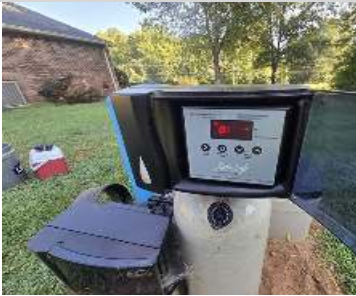
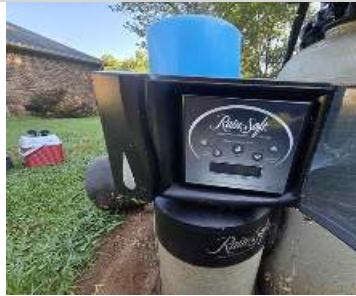
## 1.5 Additional Information

Two water-softening tanks were observed at the private well, each equipped with a separate control panel. One control panel was operable; the other was not operational at the time of the inspection. Water-softening and treatment equipment is outside the scope of this inspection and was not evaluated for proper operation, performance, or effectiveness. Recommend evaluation of the water-treatment system by a qualified water-treatment professional to determine whether both units are intended to be operational and whether service or repair is needed.
