INSPECTION REPORT

**123 Sample Street**

Anytown, NC

INSPECTION DATE 9/16/2026

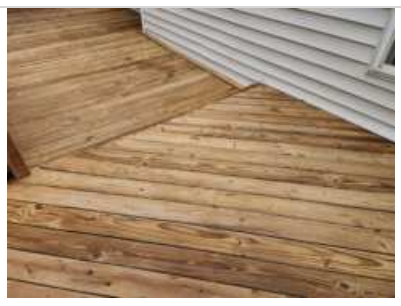
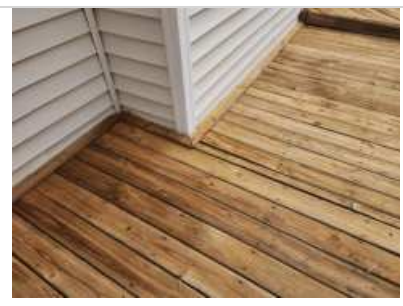
(3) Cracking, splitting and/or general deterioration was noted throughout the deck surface, railing and stairs. Further damage may occur.

Consult with a qualified licensed contractor to evaluate the area(s) of concern and make any additional repairs as deemed necessary during their evaluation.

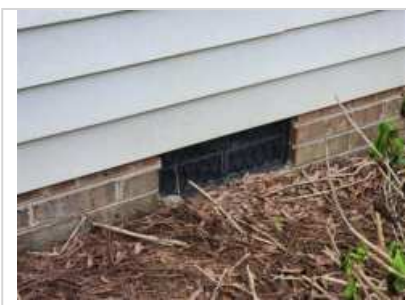
The crawl space vents were at or below grade and need to have a vent well(s) added. When vents are below grade, rain and runoff water are likely to enter the crawl space, which can attract wood destroying organisms or lead to fungal issues such as rot or organic growth. If vents are far enough below grade, the dirt can block the openings so air will not circulate and the vents will not ventilate. When foundation vent wells are installed, the grade should be dug a minimal of 2" below the foundation vent itself. Another issue is that often people block the vents in an unconditioned crawl space. This can lead to high moisture levels and it is recommended that the foundation vents be left open year round.

Consult with a qualified licensed contractor to evaluate the area(s) of concern and make any additional repairs as deemed necessary during their evaluation.

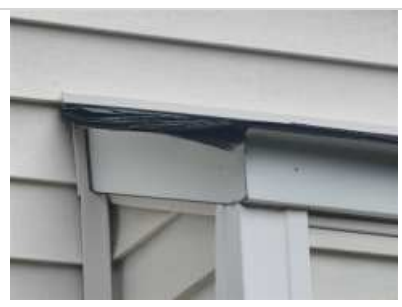
Loose drip edge flashing and or shingles were noted at the fireplace bump out roof. Repair is needed. Consult with a qualified licensed contractor to evaluate the area(s) of concern and make any additional repairs as deemed necessary during their evaluation.

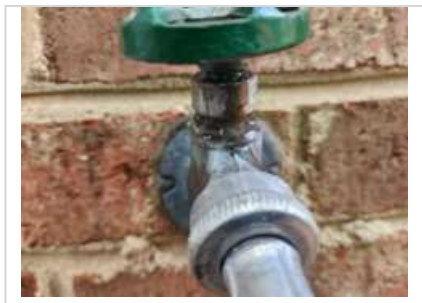
(1) There was a leak noted at the exterior hose faucet(s) that needs repair and/or replacement to prevent continual leaking located at Front of the home.

Consult with a qualified licensed contractor to evaluate the area(s) of concern and make any additional repairs as deemed necessary during their evaluation.

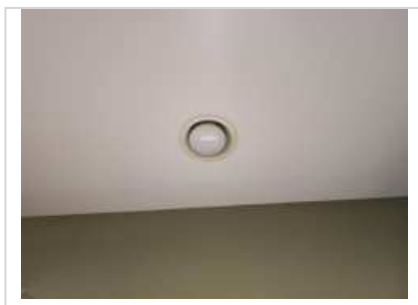
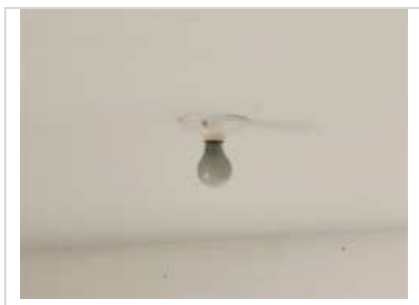
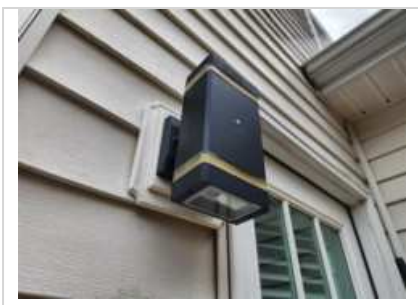
(1) There are lights noted within the home that had missing bulb(s) and/or a bulb that did not function when tested. Due to the height or disassembly required the bulb could not be replaced and tested at the time of inspection.

Consult with a qualified licensed contractor to evaluate the area(s) of concern and make any additional repairs as deemed necessary during their evaluation.

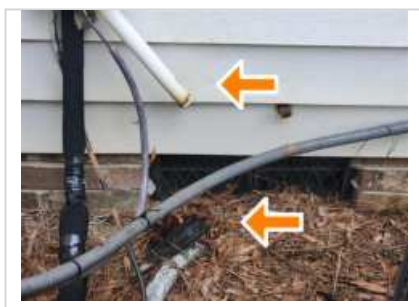
The condensate drain line for the HVAC systems terminates at the right side of the home at a crawl space vent and the foundation wall. The drain line needs to be directed away from the foundation of the home to prevent water penetration into the crawl space and saturated soils at the foundation.

Consult a qualified licensed contractor to assess the areas of concern and perform any additional repairs deemed necessary during their evaluation.

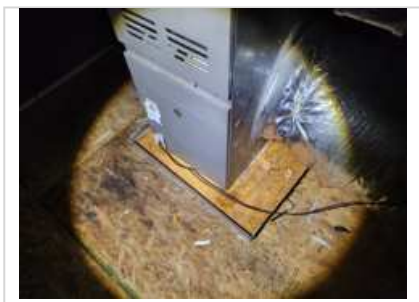
The overflow pan was found to be rusted under the HVAC unit in the attic. This is evidence that the unit may have previously leaked at one point causing water to stand in the overflow pan. Because of this, it is recommended that the sellers disclose any servicing that has been made to the unit and if any repairs have been required to correct any previous problems. There may be additional defects that were concealed and/or otherwise unseen at the time of the original inspection.

Consult with a qualified licensed contractor to evaluate the area(s) of concern and make any additional repairs as deemed necessary during their evaluation.

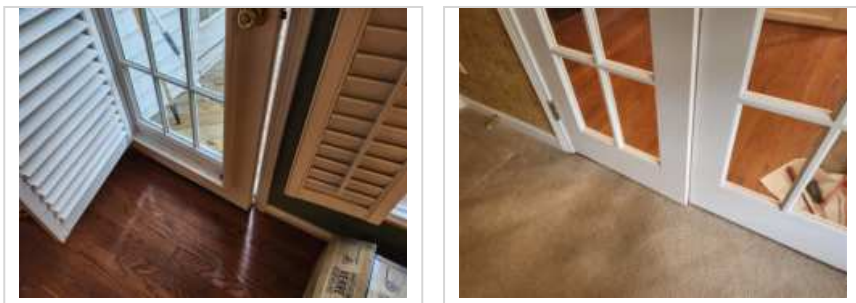
Rear exterior door and study French door

Consult with a qualified licensed contractor to evaluate the area(s) of concern and make any additional repairs as deemed necessary during their evaluation.

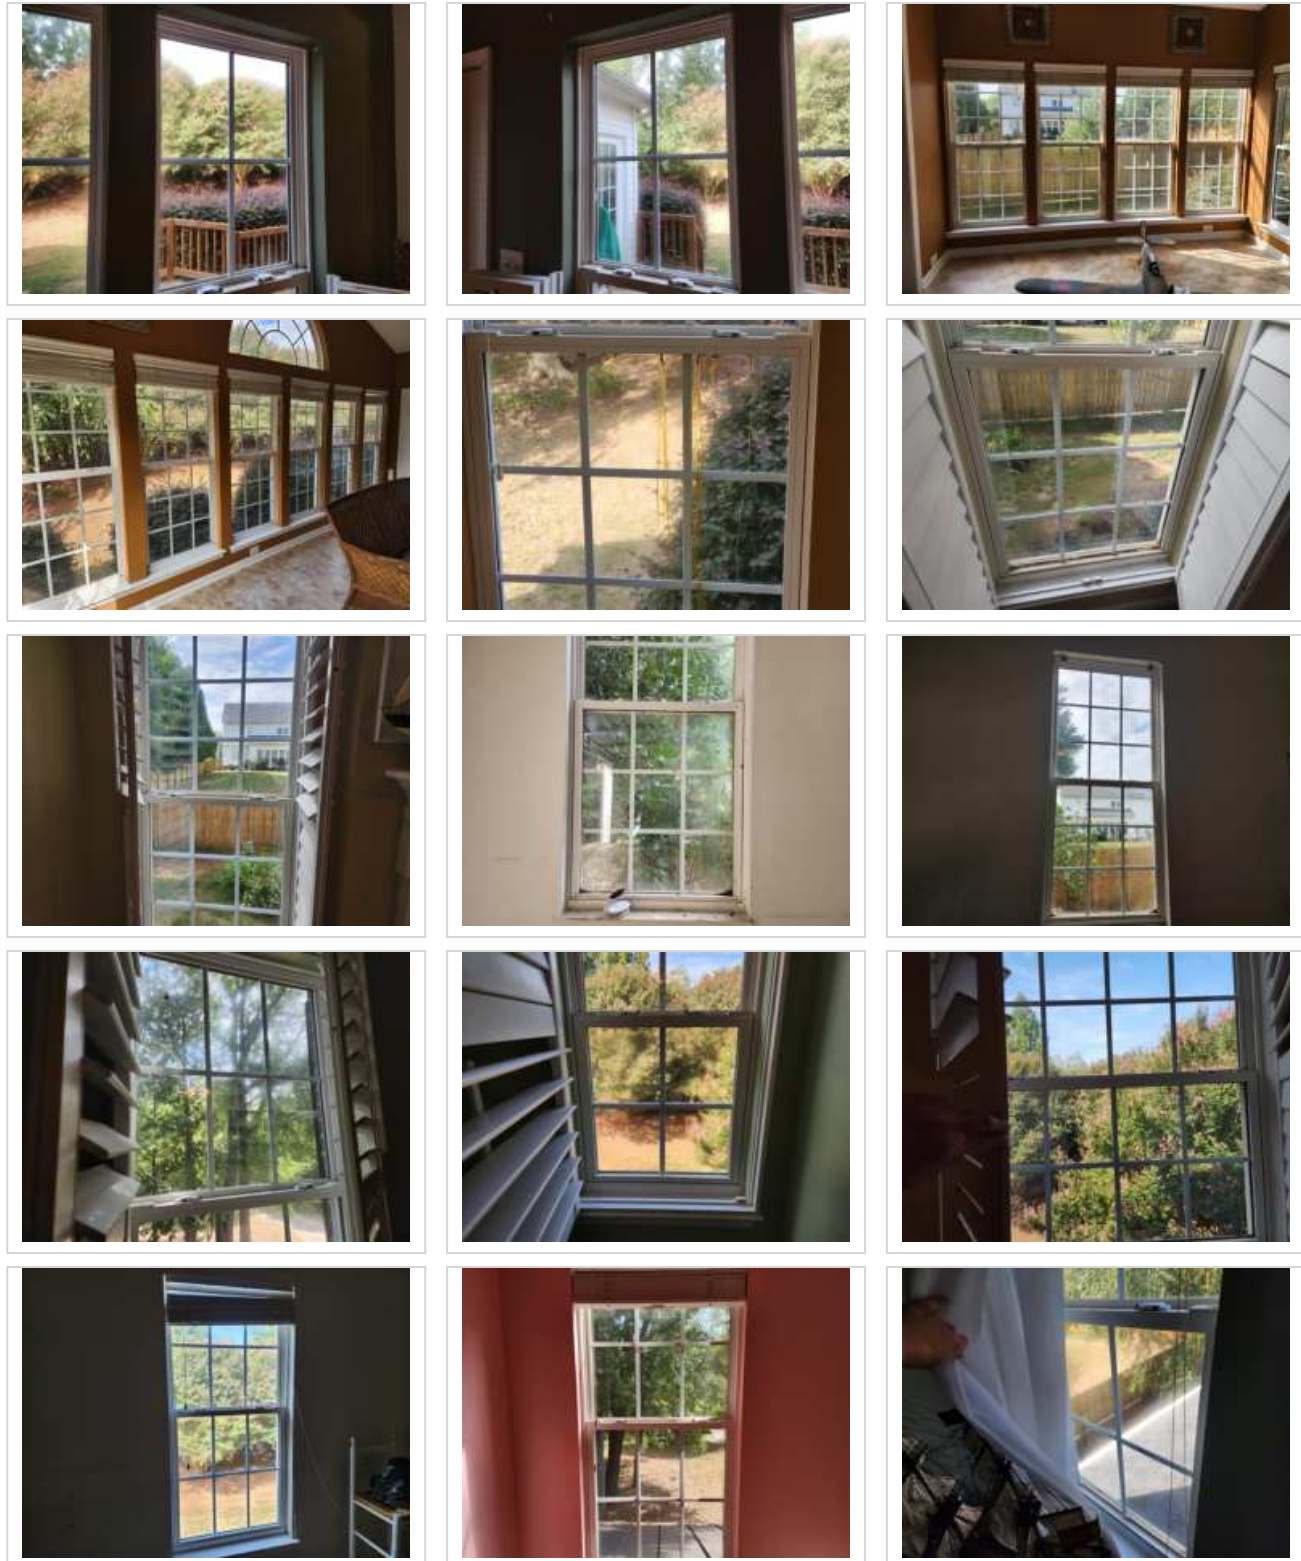
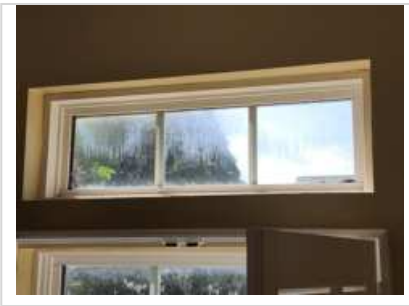
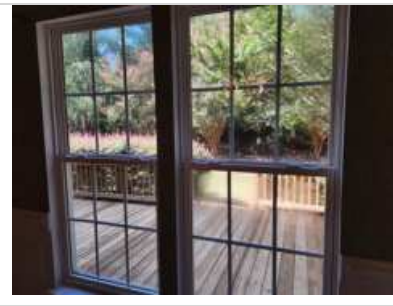
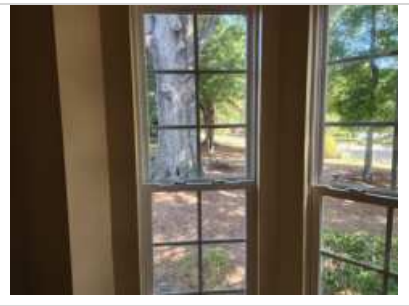
(1) Multiple window(s) and/or sashes were found to have a bad or broken thermal seal. When a bad or broken thermal seal is found, it is possible there may be more that cannot be found at the time of inspection. Because of this it is recommended that all windows be evaluated to prevent heating and air loss.

Consult with a qualified licensed contractor to evaluate the area(s) of concern and make any additional repairs as deemed necessary during their evaluation.

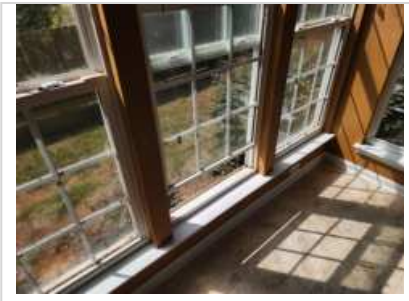
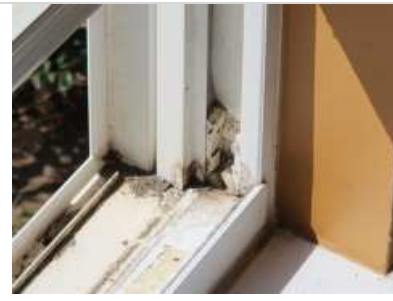
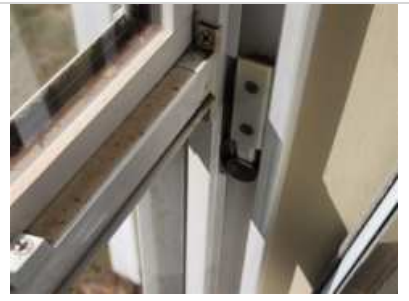
(2) The following window(s) have a bad reverse tension spring(s) or weights. This prevents the window from staying up when opening. If the spring or rope is bad, the window will slide back down when operating. Corrections and/or repairs are needed so the windows will stay up or function properly:  
Sunroom left wall middle right window and living room left window.

Consult with a qualified licensed contractor to evaluate the area(s) of concern and make any additional repairs as deemed necessary during their evaluation.

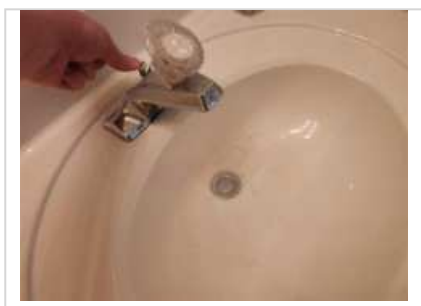
(1) The left sink stopper did not function properly at the time of inspection. When pulling the lever the stopper would not respond or open.

Consult with a qualified licensed contractor to evaluate the area(s) of concern and make any additional repairs as deemed necessary during their evaluation.

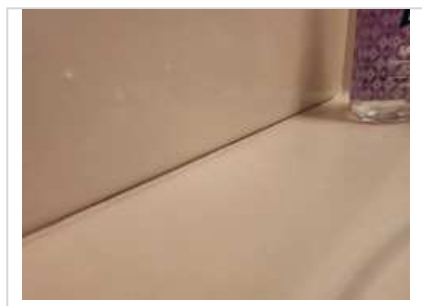
Caulk is needed to fill the gaps where the sink countertop and backsplash meet to prevent water penetration.

Consult with a qualified licensed contractor to evaluate the area(s) of concern and make any additional repairs as deemed necessary during their evaluation.

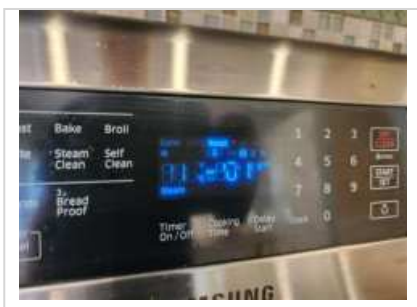
(1) The oven control panel display is not functioning properly and needs repair or replacement. Consult with a qualified licensed contractor to evaluate the area(s) of concern and make any additional repairs as deemed necessary during their evaluation.

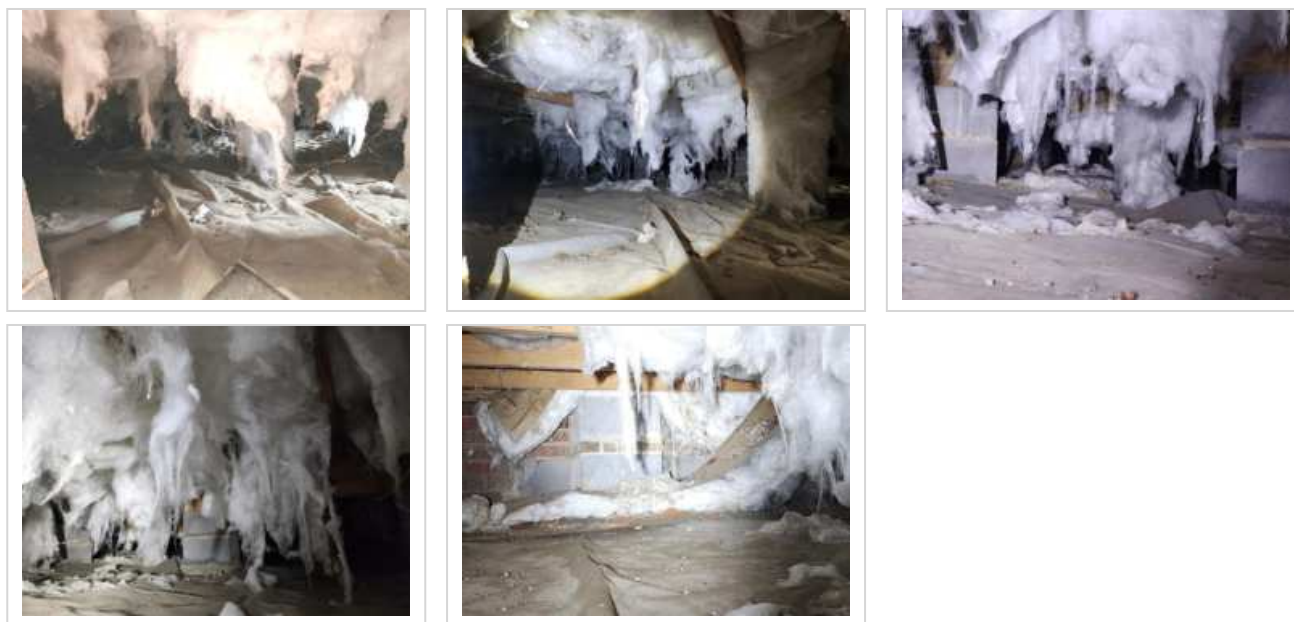
Insulation has fallen, drooping or stringy throughout the entire crawl space. This unusually indicates that there is or has had a moisture problem. Recommend leaving the crawl space vent open year round to allow adequate air flow in the crawl space.

Consult with a qualified licensed contractor to evaluate the area(s) of concern and make any additional repairs as deemed necessary during their evaluation.

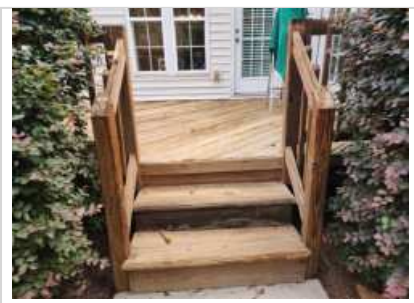
1. (1) There are loose railing(s) that need to be secured properly to prevent continual movement and/or a possible hazard at the Rear deck

Consult with a qualified licensed contractor to evaluate the area(s) of concern and make any additional repairs as deemed necessary during their evaluation.

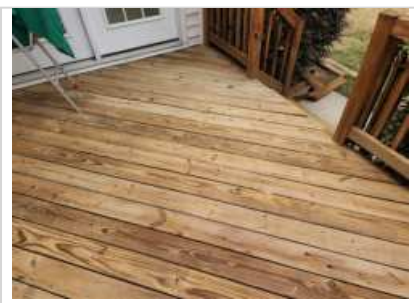
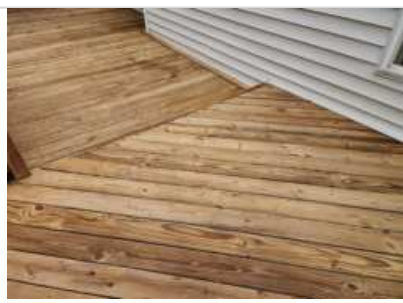
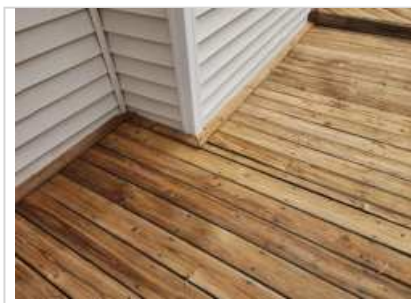
2. (2) Loose deck boards were noted at the rear deck. The boards need to be properly secured to prevent further movement and possible damage at multiple locations.

Consult with a qualified licensed contractor to evaluate the area(s) of concern and make any additional repairs as deemed necessary during their evaluation.

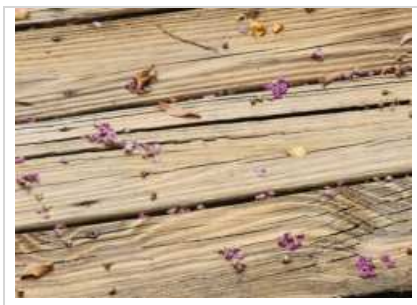
3. (3) Cracking, splitting and/or general deterioration was noted throughout the deck surface, railing and stairs. Further damage may occur.

Consult with a qualified licensed contractor to evaluate the area(s) of concern and make any additional repairs as deemed necessary during their evaluation.

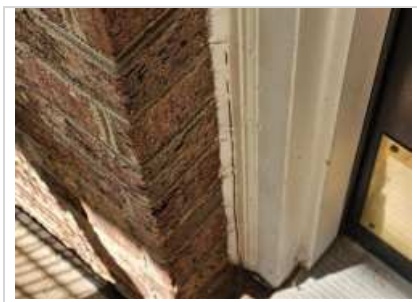
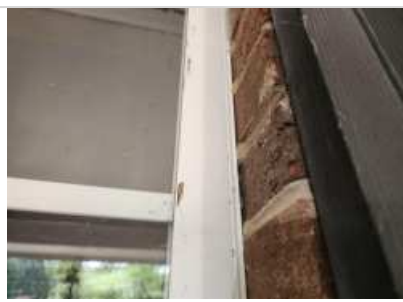
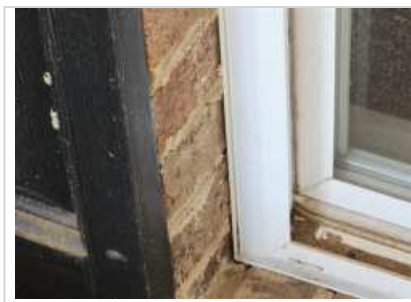
4. Spacing or gapping was observed at the trim where it intersects with various materials at multiple locations around the home. It is important to address this issue by adequately sealing the trim to effectively safeguard against potential water penetration and associated damages within the home environment.

Consult with a qualified licensed contractor to evaluate the area(s) of concern and make any additional repairs as deemed necessary during their evaluation.

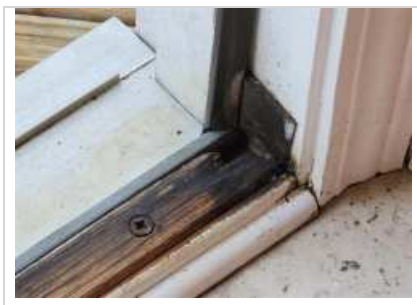
5. Wood rot has been observed at the trim where it intersects the threshold of the sunroom rear exterior door. A more thorough assessment is required to ascertain the extent of repair or replacement necessary.

Consult with a qualified licensed contractor to evaluate the area(s) of concern and make any additional repairs as deemed necessary during their evaluation.

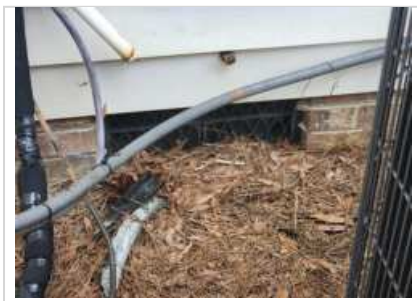
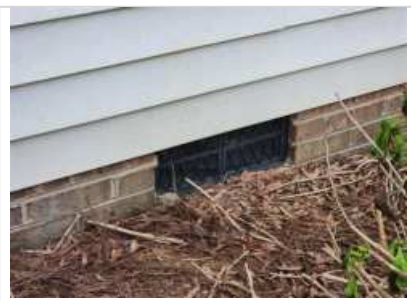
6. The crawl space vents were at or below grade and need to have a vent well(s) added. When vents are below grade, rain and runoff water are likely to enter the crawl space, which can attract wood destroying organisms or lead to fungal issues such as rot or organic growth. If vents are far enough below grade, the dirt can block the openings so air will not circulate and the vents will not ventilate. When foundation vent wells are installed, the grade should be dug a minimal of 2" below the foundation vent itself. Another issue is that often people block the vents in an unconditioned crawl space. This can lead to high moisture levels and it is recommended that the foundation vents be left open year round.

Consult with a qualified licensed contractor to evaluate the area(s) of concern and make any additional repairs as deemed necessary during their evaluation.

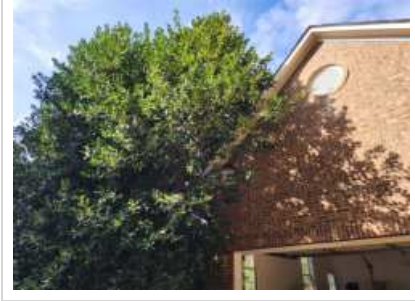
7. Trees are touching or overhanging the roof at the Left side of the home. Continual maintenance is needed to prevent further or possible damage.

Consult with a qualified licensed contractor to evaluate the area(s) of concern and make any additional repairs as deemed necessary during their evaluation.

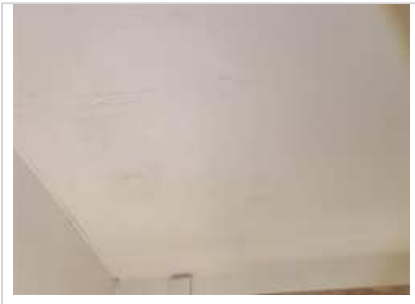
8. Stains were noted on the ceiling in the garage. Unable to determine if an active leak exists at the time of inspection. Ask the seller the history of the stains and if repairs have been made to correct any leaks that may have caused the stain. If the sellers aren't aware of the stain or the home is vacant, then the stain should be treated as active. Water penetration into the ceiling can lead to problems if left unattended.

Consult with a qualified licensed contractor to evaluate the area(s) of concern and make any additional repairs as deemed necessary during their evaluation.

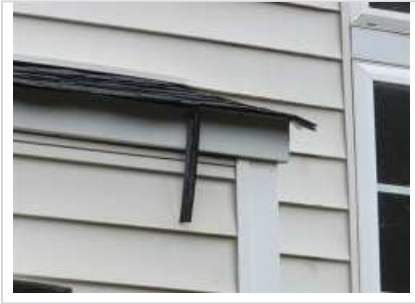
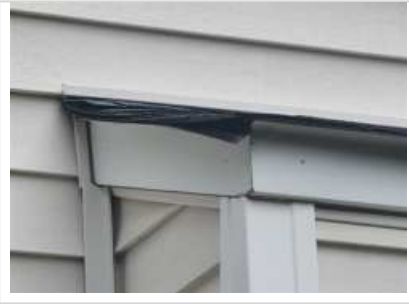
9. Loose drip edge flashing and or shingles were noted at the fireplace bump out roof. Repair is needed.

Consult with a qualified licensed contractor to evaluate the area(s) of concern and make any additional repairs as deemed necessary during their evaluation.

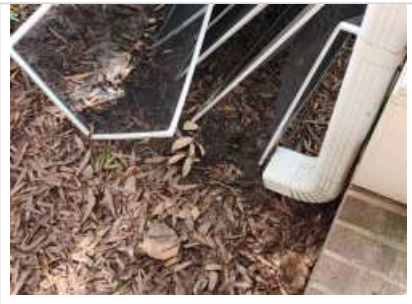
10. (1) A splash block is needed to properly direct water away from the foundation of the home under multiple gutter down spouts around the home.

Consult with a qualified licensed contractor to evaluate the area(s) of concern and make any additional repairs as deemed necessary during their evaluation.

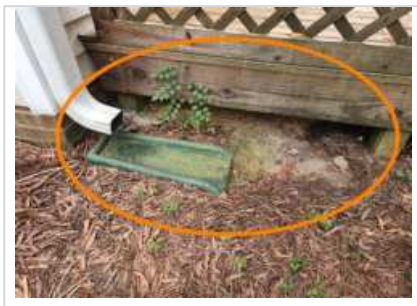
11. (2) The gutter at the rear right corner of the home needs to be redirected away from the foundation of the home and prevent water from pooling under the rear deck.

Consult with a qualified licensed contractor to evaluate the area(s) of concern and make any additional repairs as deemed necessary during their evaluation.

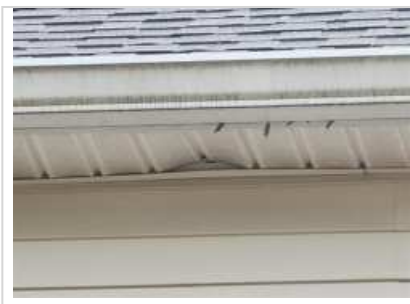
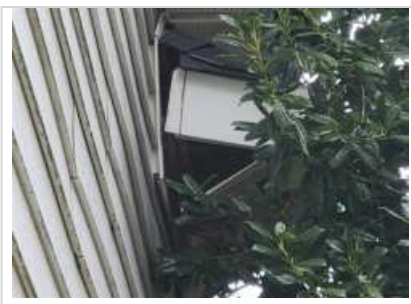
- 
12. There are loose piece(s) of fascia and/or soffit that need to be re-installed and/or secured properly to prevent water penetration and/or possible damage at the Rear and left side of the home.

Consult with a qualified licensed contractor to evaluate the area(s) of concern and make any additional repairs as deemed necessary during their evaluation.

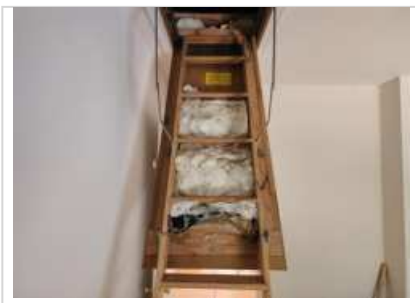
- 
13. (1) There is damaged insulation installed on the back of the attic stairs. This can result in a large source of heating and air loss, installation of new insulation and weather stripping is needed to prevent heating and air loss.

Consult with a qualified licensed contractor to evaluate the area(s) of concern and make any additional repairs as deemed necessary during their evaluation.

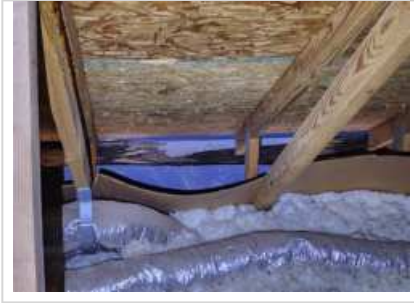
- 
14. (2) Stains were noted along the fascia boards in areas through the attic. Water penetration into the attic can lead to problems if left unattended. Water stains in a dry attic may or may not indicate active leaks. Stains will remain after leaks have been repaired, making it almost impossible to determine whether or not a leak is active. Often leak activity will only be able to be determined by multiple inspections, over time, under varying atmospheric conditions. Because of this ask the seller to disclose the history of any stains and if repairs have been made to correct them and continue to monitor the attic conditions.

Consult with a qualified licensed contractor to evaluate the area(s) of concern and make any additional repairs as deemed necessary during their evaluation.

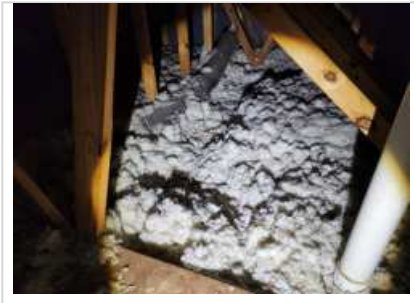
- 
15. (3) Insulation is compacted in several areas throughout the attic and the true R-factor at this point may be substantially less than that originally installed.

Consult with a qualified licensed contractor to evaluate the area(s) of concern and make any additional repairs as deemed necessary during their evaluation.

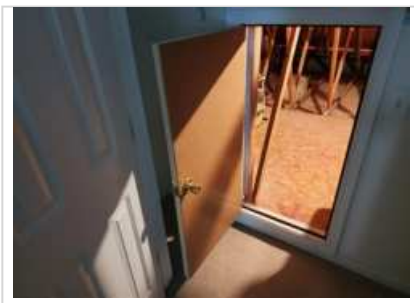
- 
16. (4) The attic access door(s) are hollow-core door(s) and there is not any insulation installed on the back of them. Insulation is needed behind the attic access door(s) to prevent heating and air loss. As the attic access doors are hollow core doors and have a very low R-Value.

Consult with a qualified licensed contractor to evaluate the area(s) of concern and make any additional repairs as deemed necessary during their evaluation.

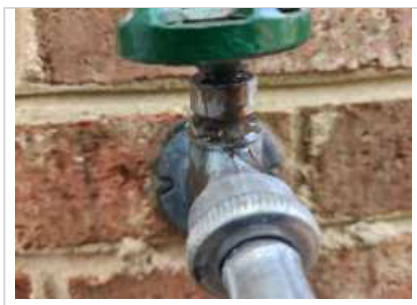
17. (1) There was a leak noted at the exterior hose faucet(s) that needs repair and/or replacement to prevent continual leaking located at Front of the home.

Consult with a qualified licensed contractor to evaluate the area(s) of concern and make any additional repairs as deemed necessary during their evaluation.

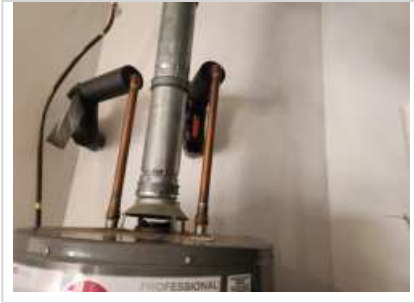
19. The water heater did not have an expansion tank installed at the time of the inspection. Expansion tanks are used to prevent possible leaks from the hot water heater. When the hot water heater turns on, the water within the piping system begins to expand. Without the expansion tank, the expanding water can create too much pressure on the heater and potentially fail or leak. With the expansion tank, the expanding water enters the expansion tank preventing possible damage.

Consult with a qualified licensed contractor to evaluate the area(s) of concern and make any additional repairs as deemed necessary during their evaluation.

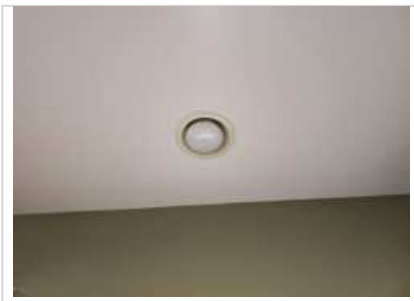
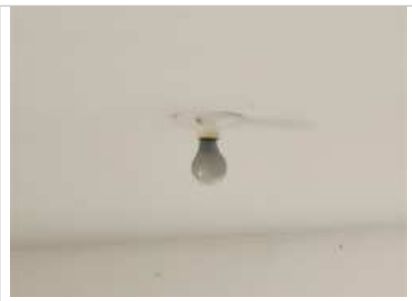
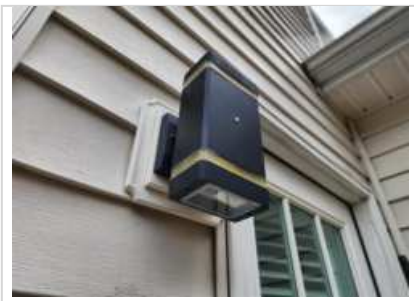
20. (1) There are lights noted within the home that had missing bulb(s) and/or a bulb that did not function when tested. Due to the height or disassembly required the bulb could not be replaced and tested at the time of inspection.

Consult with a qualified licensed contractor to evaluate the area(s) of concern and make any additional repairs as deemed necessary during their evaluation.

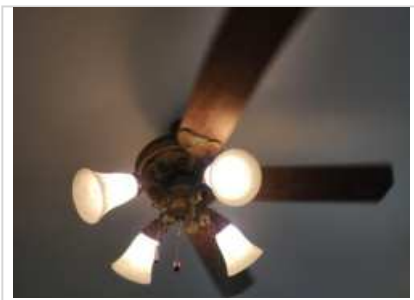
21. (2) The living room ceiling fan is missing multiple fan blades. Replacement is needed.

Consult with a qualified licensed contractor to evaluate the area(s) of concern and make any additional repairs as deemed necessary during their evaluation.

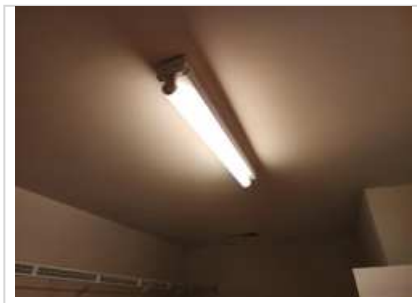
- 
22. (3) The master closet light fixture is unusually dim. This may be an indication of a bad ballast. Repair or replacement is needed.

Consult with a qualified licensed contractor to evaluate the area(s) of concern and make any additional repairs as deemed necessary during their evaluation.

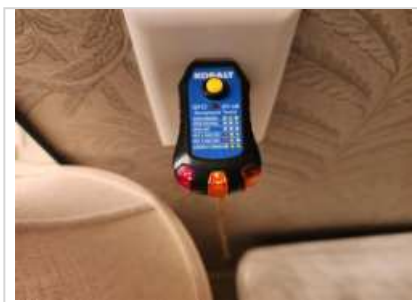
- 
23. (4) The hot and neutral wires are reversed at certain outlets within the home, creating a condition known as reverse polarity. This issue occurs when the electrical system's hot and neutral wires are improperly connected to the outlet. While devices plugged into an outlet with reverse polarity may still function, the on/off switch will control the neutral wire instead of the hot wire. This significantly increases the risk of electric shock for anyone using the device. If one outlet is found to have reversed polarity, it's possible that other outlets in the home are similarly affected. A thorough evaluation of all outlets is recommended, as some may have been inaccessible or obstructed during the initial inspection. Below is a list of outlets that were identified at the time of the inspection:

Upstairs hall bathroom outlet to the right of the sinks.

Consult with a qualified licensed contractor to evaluate the area(s) of concern and make any additional repairs as deemed necessary during their evaluation.

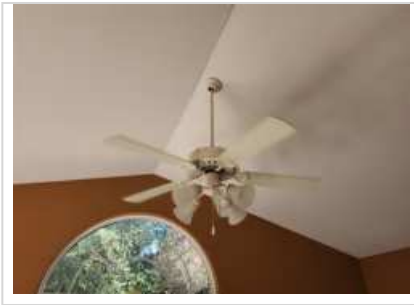
- 
24. (5) There are ceiling fan(s) that are not balanced within the home and need to be properly balanced, adjusted, repaired, and/or replaced.

Consult with a qualified licensed contractor to evaluate the area(s) of concern and make any additional repairs as deemed necessary during their evaluation.

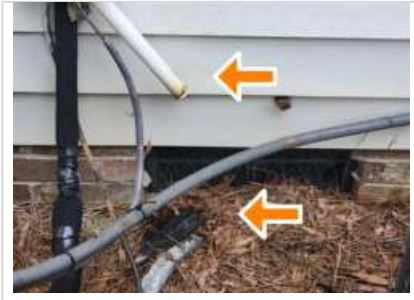
25. The condensate drain line for the HVAC systems terminates at the right side of the home at a crawl space vent and the foundation wall. The drain line needs to be directed away from the foundation of the home to prevent water penetration into the crawl space and saturated soils at the foundation.
- Consult a qualified licensed contractor to assess the areas of concern and perform any additional repairs deemed necessary during their evaluation.

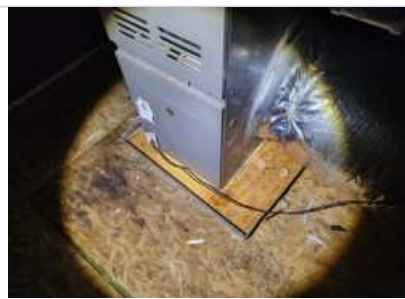
26. The overflow pan was found to be rusted under the HVAC unit in the attic. This is evidence that the unit may have previously leaked at one point causing water to stand in the overflow pan. Because of this, it is recommended that the sellers disclose any servicing that has been made to the unit and if any repairs have been required to correct any previous problems. There may be additional defects that were concealed and/or otherwise unseen at the time of the original inspection.

Consult with a qualified licensed contractor to evaluate the area(s) of concern and make any additional repairs as deemed necessary during their evaluation.

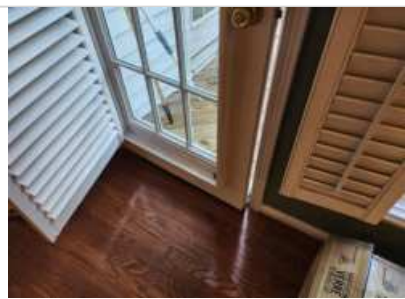
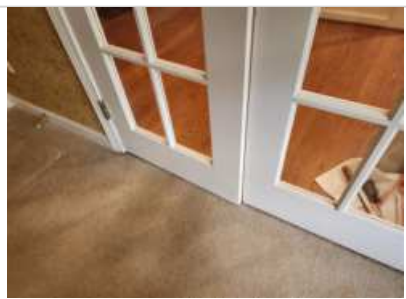
27. (1) The following door(s) listed below rubbed at the frame/flooring and need adjustment and/or repair for the door(s) to open and close properly without rubbing:  
Rear exterior door and study French door

Consult with a qualified licensed contractor to evaluate the area(s) of concern and make any additional repairs as deemed necessary during their evaluation.

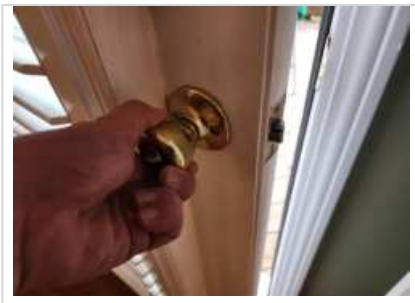
28. (2) The kitchen area rear exterior door handle sticks when operating. Corrections are needed.  
Consult with a qualified licensed contractor to evaluate the area(s) of concern and make any additional repairs as deemed necessary during their evaluation.

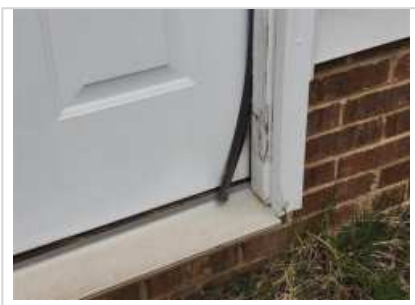
29. (3) The weather stripping on the following doors is either damaged or missing and needs replacement to prevent energy loss and maintain efficient heating and cooling.

Garage side exterior door

Consult with a qualified licensed contractor to evaluate the area(s) of concern and make any additional repairs as deemed necessary during their evaluation.

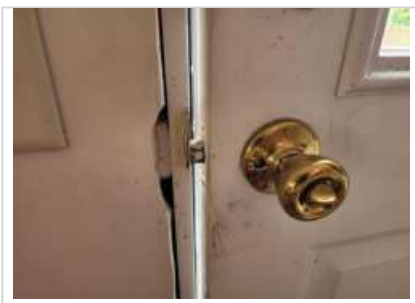
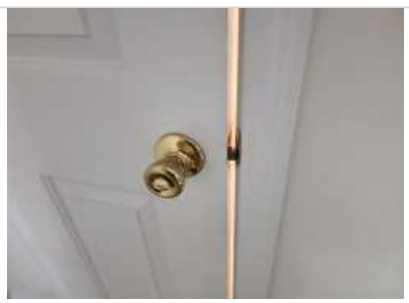
30. (4) The cylinder/strike plate does not catch or latch properly and needs corrections and/or adjustments to latch and/or close properly at the following door(s):

Garage side exterior door and rear middle bedroom entry door.

Consult with a qualified licensed contractor to evaluate the area(s) of concern and make any additional repairs as deemed necessary during their evaluation.

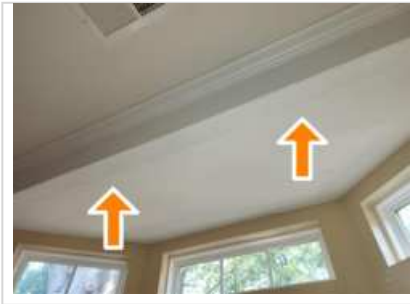
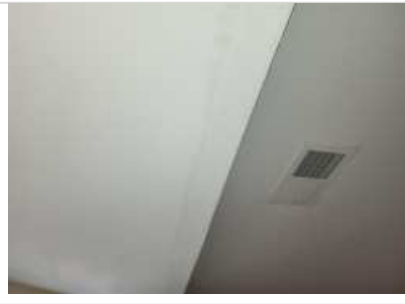
31. (5) Stains noted on the ceiling at the formal living room. Unable to determine if an active leak exists at the time of inspection as the stains were dry at the time of inspection. Ask the seller the history of the stains and if repairs have been made to

correct any leaks that may have caused the stain.

Consult with a qualified licensed contractor to evaluate the area(s) of concern and make any additional repairs as deemed necessary during their evaluation.

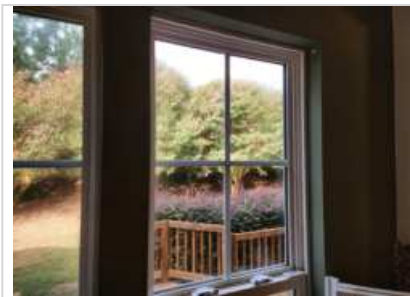
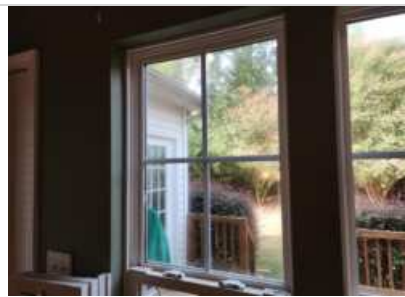
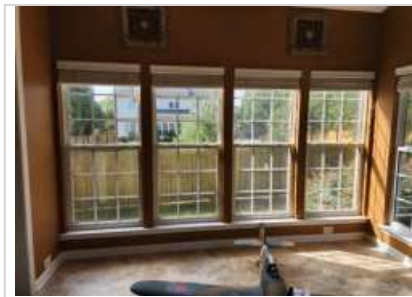
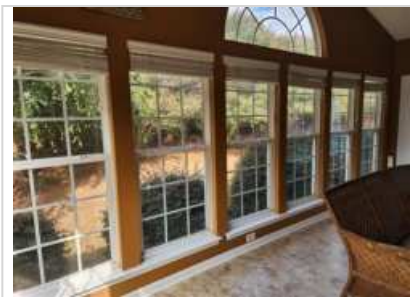
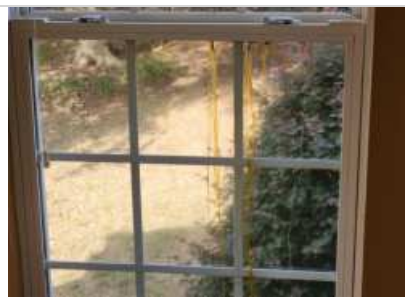
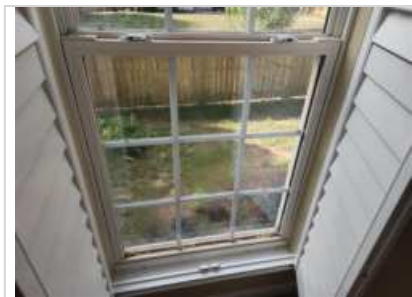
32. (1) Multiple window(s) and/or sashes were found to have a bad or broken thermal seal. When a bad or broken thermal seal is found, it is possible there may be more that cannot be found at the time of inspection. Because of this it is recommended that all windows be evaluated to prevent heating and air loss.

Consult with a qualified licensed contractor to evaluate the area(s) of concern and make any additional repairs as deemed necessary during their evaluation.

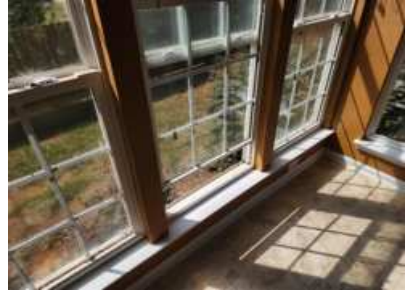
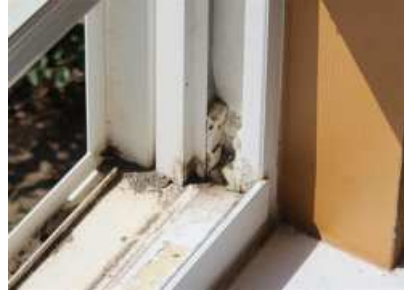
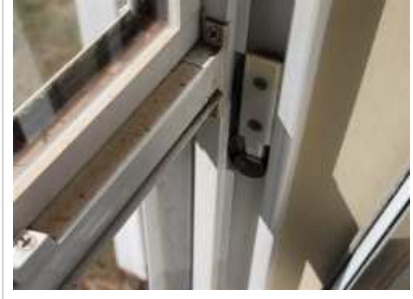
33. (2) The following window(s) have a bad reverse tension spring(s) or weights. This prevents the window from staying up when opening. If the spring or rope is bad, the window will slide back down when operating. Corrections and/or repairs are needed so the windows will stay up or function properly:

Sunroom left wall middle right window and living room left window.

Consult with a qualified licensed contractor to evaluate the area(s) of concern and make any additional repairs as deemed necessary during their evaluation.

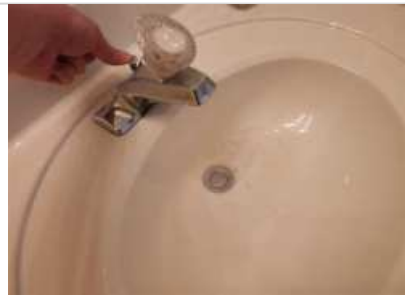
34. (1) The left sink stopper did not function properly at the time of inspection. When pulling the lever the stopper would not respond or open.
- Consult with a qualified licensed contractor to evaluate the area(s) of concern and make any additional repairs as deemed necessary during their evaluation.

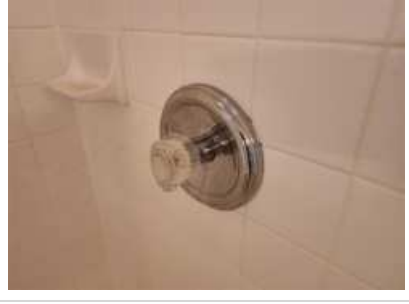
35. (2) The shower faucet handle is loose in the wall and need to be secured properly to prevent movement and possible leakage.

Consult with a qualified licensed contractor to evaluate the area(s) of concern and make any additional repairs as deemed necessary during their evaluation.

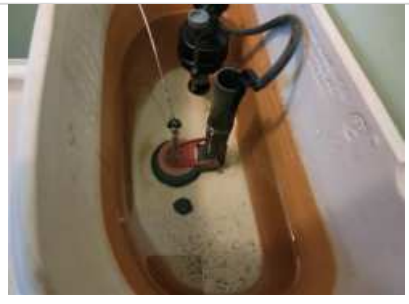
- 
36. (3) The flush valve or flapper is not sealing properly, causing the toilet to run. Repair or replacement is needed.

Consult with a qualified licensed contractor to evaluate the area(s) of concern and make any additional repairs as deemed necessary during their evaluation.

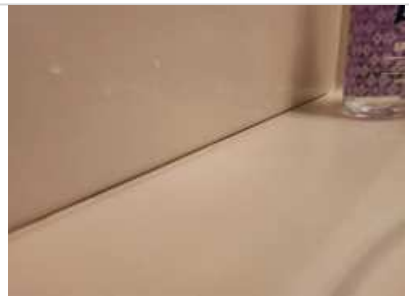
- 
37. Caulk is needed to fill the gaps where the sink countertop and backsplash meet to prevent water penetration.

Consult with a qualified licensed contractor to evaluate the area(s) of concern and make any additional repairs as deemed necessary during their evaluation.

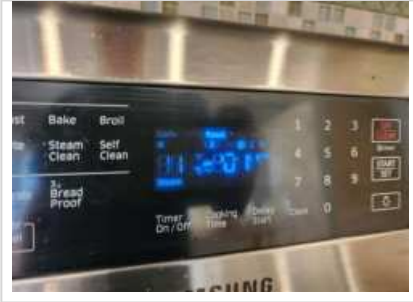
38. (1) The oven control panel display is not functioning properly and needs repair or replacement. Consult with a qualified licensed contractor to evaluate the area(s) of concern and make any additional repairs as deemed necessary during their evaluation.

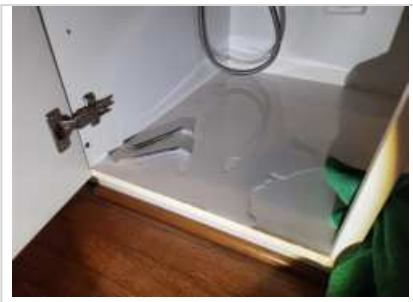
39. (2) The dishwasher was noted to be leaking at the time of inspection and needs repair or replacement.

Have a qualified Licensed contractor further evaluate and make any additional repairs as needed or deemed necessary.

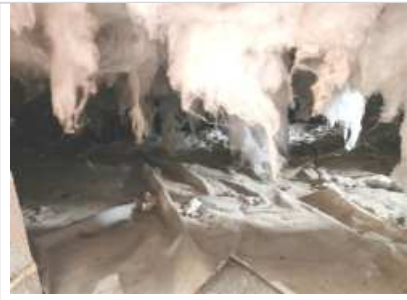
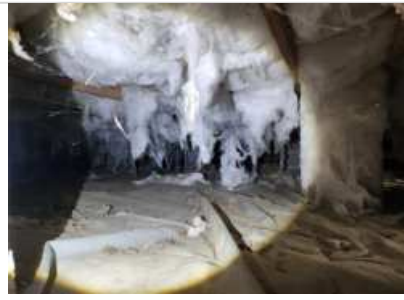
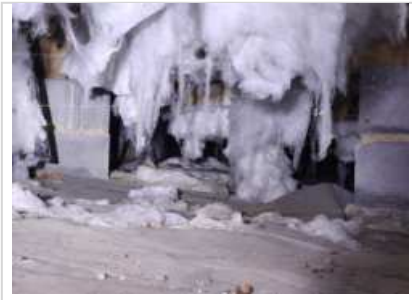
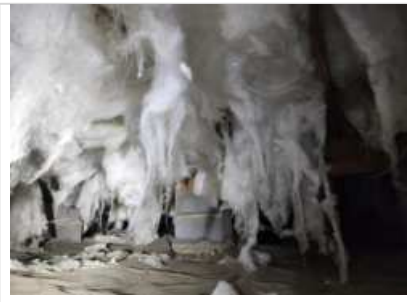
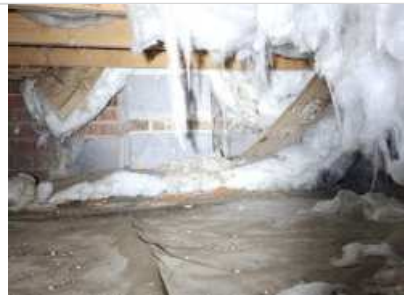
40. (1) Insulation was noted to be falling, fallen and/or is drooping within the crawl space area. The insulation needs to be re-installed and/or supported properly. Note: Where it has touched the ground and become damaged needs to be replaced.

moisture problem. Recommend leaving the crawl space vent open year round to allow adequate air flow in the crawl space.

Consult with a qualified licensed contractor to evaluate the area(s) of concern and make any additional repairs as deemed necessary during their evaluation.

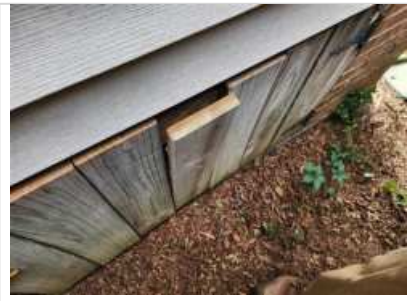
- 
41. (2) The crawl space door is damaged and needs repair or replacement. Corrections are needed to prevent possible water and rodent intrusion.

Consult with a qualified licensed contractor to evaluate the area(s) of concern and make any additional repairs as deemed necessary during their evaluation.
