INSPECTION REPORT

INSPECTION DATE 8/3/2026

Home Inspection Carolina

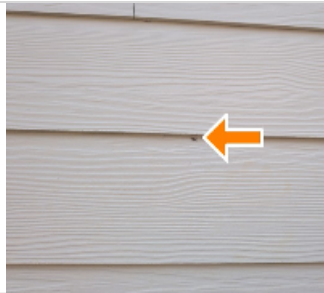
**2.0 Item 3 (Picture)**

1. There are noticeable cracked pieces of siding observed on the right side of the home. These cracks have the potential to allow water penetration, which could lead to damage. Corrections, repairs, and replacements are needed to ensure the property's structural integrity and prevent any further complications.
2. There was at least one hole in the siding at the right side of the home. Patch or repair as necessary to prevent possible water penetration and/or pest intrusion into the wall system which could result in concealed damage.
3. The paint was noted to be damaged or incomplete in at least a few areas along the left side and rear of the home. Make corrections as necessary to prevent possible accelerated deterioration of the siding material which could result in water penetration into the wall system.

Example - Item 1

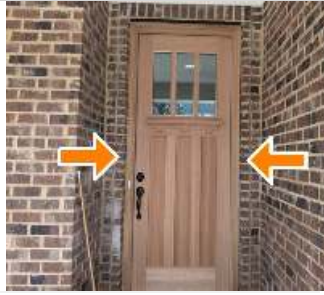
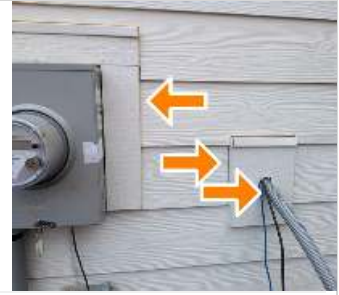
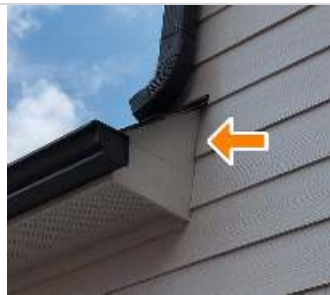
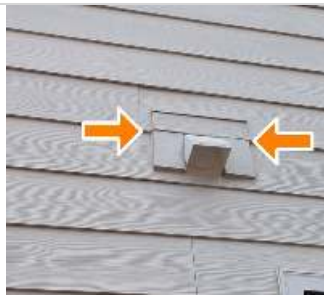
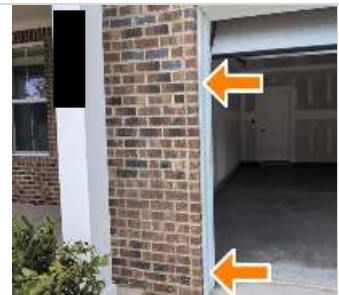
Sealant deficiencies, such as missing or poorly sealed areas, were observed on the exterior siding and trim in various sections around the home, including window and door frames. Corrections are required to prevent potential water seepage or insect infestation. Consult with your builder to gain a comprehensive understanding of the necessary repairs. Have them further evaluate and make the necessary corrective actions.

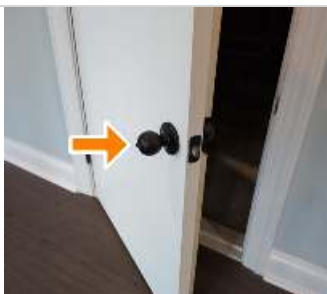
**6.0 Item 1 (Picture)**

(1) The walk-in attic door was found to have the lock(s) installed on the wrong side. This could allow a person to become locked inside the attic. Corrections are needed to prevent a possible safety hazard. Consult with your

builder to gain a comprehensive understanding of the necessary repairs. Have them further evaluate and make the necessary corrective actions.

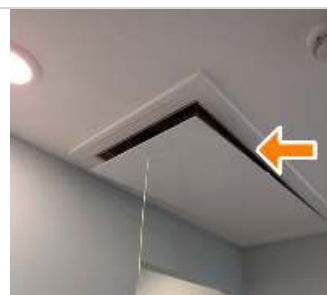
**6.0 Item 4 (Picture)**

Example - Item 3 - Ladder stiff at top and bottom of range

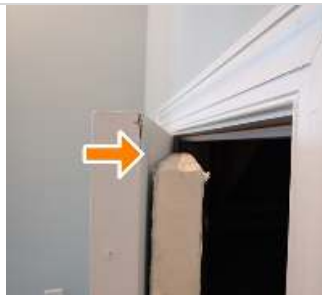
**6.0 Item 8 (Picture)**

Example - Item 2 - Foam cut short

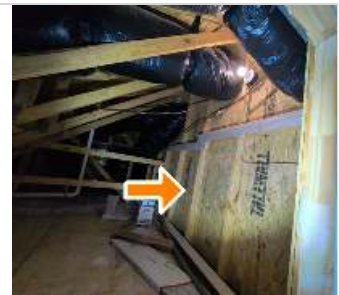
**6.0 Item 9 (Picture)**

Example - Item 3

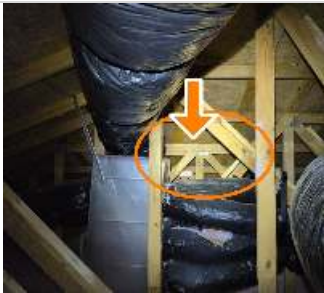
**6.0 Item 10 (Picture)**

(5) Repairs or modifications were noted to the truss system in the rear area of the walk-in attic above the first floor. The inspector was unable to locate a structural engineers letter attached to the repairs. When a truss is cut/ damage and/or otherwise modified, the modifications should be performed under the direction of a licensed

Example area

engineer that specializes in residential dwellings. Ask the builder to provide a structural engineers letter approving the repairs or modifications made to the truss system. If the sellers cannot provide this then further evaluation of the repairs or modifications by a licensed structural engineer is needed. Consult with your builder to gain a comprehensive understanding of the necessary repairs. Have them further evaluate and make the necessary corrective actions.

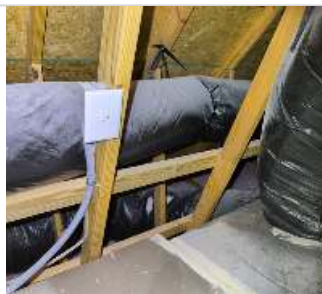
**6.1 Item 2 (Picture)**

Example of limitation

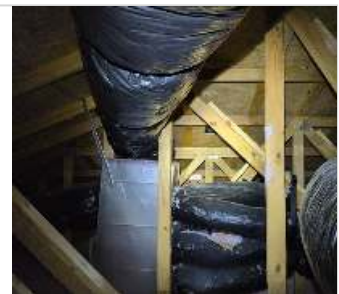
**6.1 Item 3 (Picture)**

Example of limitation

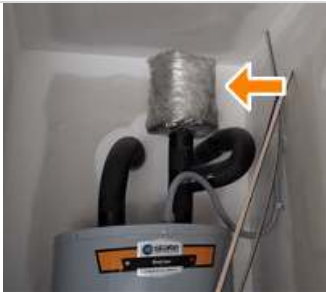
7.1 Item 1 (Picture)

The expansion tank is installed in a horizontal/vertical position which may apply excessive stress on the fittings when the tank is full. Due to the weight of this tank when it is full of water, the tank should be additionally supported. With insufficient support the tank could become loose and leak. Consult with your builder to gain a

comprehensive understanding of the necessary repairs. Have them further evaluate and make the necessary corrective actions.

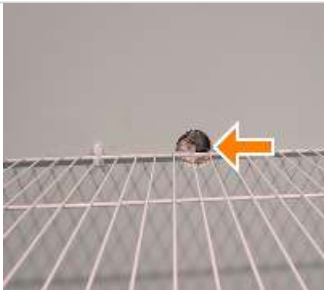
8.0 Item 1 (Picture)

(1) A hole was noted in the wall behind the wire shelving suggesting that a shelving anchor had been improperly installed in this area. Through the hole, the dryer vent was visible with at least some damage implying the screw contacted the dryer vent. Further evaluation is needed to determine if the dryer vent was compromised (if there is actually a hole or just a dent) which could allow the moist, lint-laden air to escape into the wall cavity. Repair or replace as necessary to prevent moisture concerns and/or a possible fire hazard. Consult with your builder to gain a comprehensive understanding of the necessary repairs. Have them further evaluate and make the necessary corrective actions.

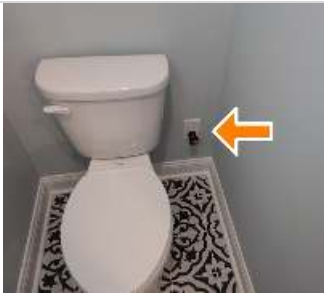
**9.0 Item 1 (Picture)**

(1) **The following outlets are not protected by GFCI:** Primary bathroom toilet room (at least one). Ground fault interrupters work by sensing a loss of current in the circuit. When a GFCI senses such a problem, the electrical current to the outlet is shut down almost immediately. Corrections are needed for safety. Consult with your builder to gain a comprehensive understanding of the necessary repairs. Have them further evaluate and make the necessary corrective actions.

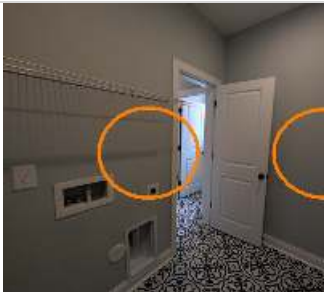
**9.0 Item 2 (Picture)**

(2) There was not a switch to control the light fixtures in the laundry room when entering from one or more sides. Corrections are needed to prevent a possible trip hazard due to navigating the room in the dark to reach the switch. Consult with your builder to gain a comprehensive understanding of the necessary repairs. Have them further evaluate and make the necessary corrective actions.

No switch at bathroom  
entryway

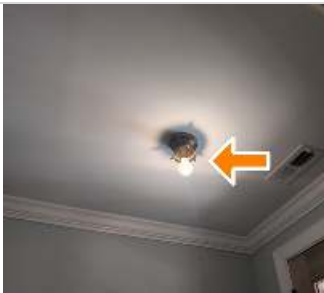
**9.0 Item 3 (Picture)**

(3) The light fixture cover was missing at the foyer and needs replacement to properly protect the bulb from damage which could result in safety hazards. Consult with your builder to gain a comprehensive understanding of the necessary repairs. Have them further evaluate and make the necessary corrective actions.

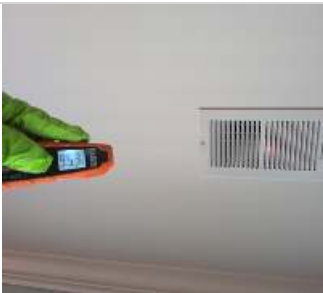
**11.0 Item 4 (Picture)**  
Sample supply temp. - Hot air  
in cooling mode

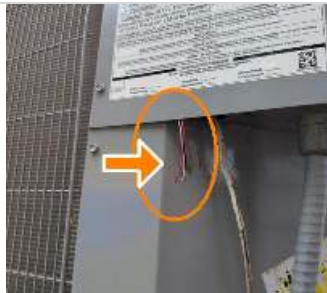
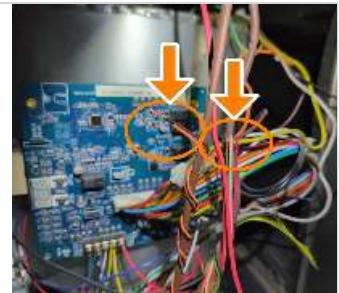
2. Exposed wires were noted at the exterior of the condenser unit and within the blower compartment in the attic. These wires appeared typical of thermostat wiring, possibly indicating unnecessary extra cables or improper installation. If the cables are unnecessary they should be properly capped and secured to prevent possible shorting out at live electrical components. If the cables are necessary, they should be properly installed for the system to function as intended.

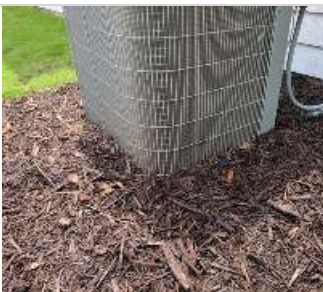
**11.0 Item 7 (Picture)**  
Example - Item 3, 4

3. During the inspection, it was noted that the outdoor coils and fins were dirty and required cleaning at the Primary unit. When these components are obstructed by dirt, they hinder airflow into or through the compressor, which can diminish the unit's efficiency and potentially lead to damage.
4. Mulch is present around the base of the HVAC unit(s), and it must be cleared away to ensure proper airflow through the compressor. This will help prevent premature rusting at the bottom of the unit and the fins at the Primary unit.

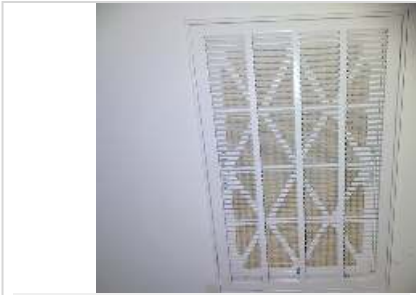
11.1 Item 1 (Picture)

**The air filter(s) is/are dirty and need replaced to prevent possible damaged and/or unnecessary strain on the unit(s).** This can greatly reduce the life expectancy of the unit(s) and when the air filter(s) are found to be extremely dirty it is recommended that the unit be services and/or cleaned to ensure efficiently and that they

are operating and functioning properly. Air filter(s) are recommended to be changed and/or cleaned depending on the type every 30 to 45 days to optimize the best performance of the unit(s). *Note: The air filters were found to be clogged to the point that air was whistling past the edges of the filters, likely putting strain on the system which could eventually result in damage or malfunction.*

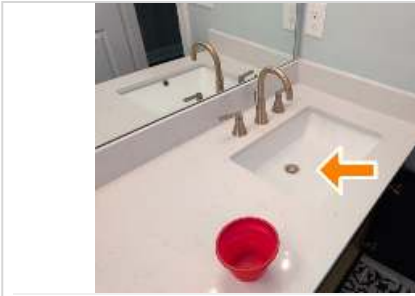
14.0 Item 3 (Picture)

(2) **The drain stopper did not function properly** or respond to the lever when testing at the time of inspection and needs repair or corrections. Corrections are needed for the sink to hold water properly. *Note: The inspector was unable to get the stopper opened again after it seemed to close normally.* Consult with your builder to gain

a comprehensive understanding of the necessary repairs. Have them further evaluate and make the necessary corrective actions.

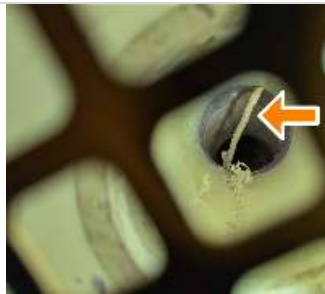
14.0 Item 5 (Picture)

(3) Debris is noted within the shower drain. Corrections are needed to prevent possible clogging. Consult with your builder to gain a comprehensive understanding of the necessary repairs. Have them further evaluate and make the necessary corrective actions.

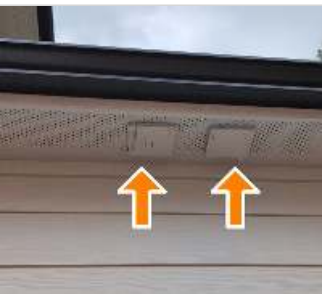
Item 2 - Item 1 (Picture)

2. (1) The vent terminations for the bathrooms were found to be taped over at the right side of the home on the soffit, typically taped as part of the painting process. Corrections are needed to allow the vents to function properly and to prevent possible damage from lack of air flow at the fans. Consult with your builder to gain a comprehensive understanding of the necessary repairs. Have them further evaluate and make the necessary corrective actions.

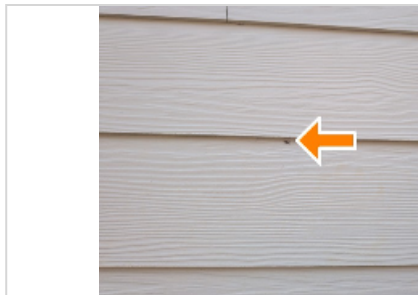
**Item 4 - Item 2 (Picture)**  
Example - Item 2 - Near AC

2. There was at least one hole in the siding at the right side of the home. Patch or repair as necessary to prevent possible water penetration and/or pest intrusion into the wall system which could result in concealed damage.

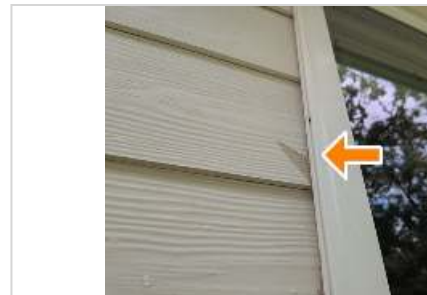
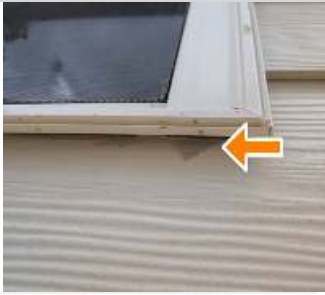
3. The paint was noted to be damaged or incomplete in at least a few areas along the left side and rear of the home. Make corrections as necessary to prevent possible accelerated deterioration of the siding material which could result in water penetration into the wall system.

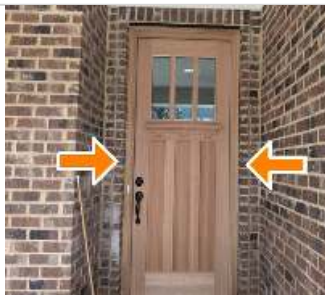
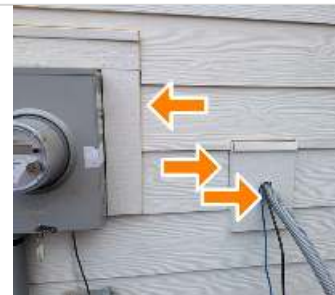
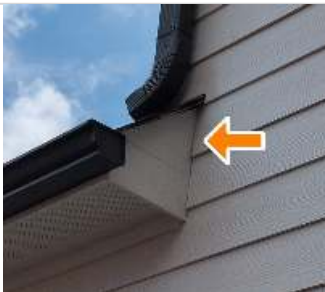
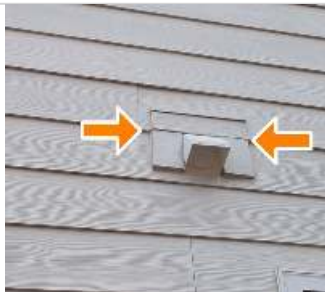
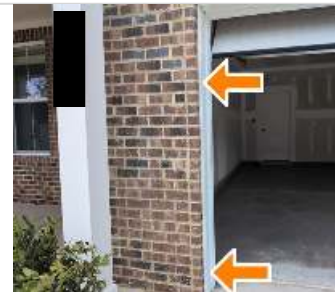
5. Sealant deficiencies, such as missing or poorly sealed areas, were observed on the exterior siding and trim in various sections around the home, including window and door frames. Corrections are required to prevent potential water seepage or insect infestation. Consult with your builder to gain a comprehensive understanding of the necessary repairs. Have them further evaluate and make the necessary corrective actions.

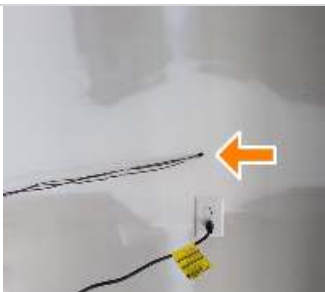
**Item 6 - Item 1 (Picture)**

6. (1) **Holes and/or gaps were noted in the walls and/or ceiling within the garage.** All holes and gaps, including around the water lines and any other wall or ceiling penetrations need to be properly sealed to maintain the proper fire rating between the home and garage and prevent possible carbon monoxide entry into the home. Consult with your builder to gain a comprehensive understanding of the necessary repairs. Have them further evaluate and make the necessary corrective actions.

Example area - Ceiling at door opener wires

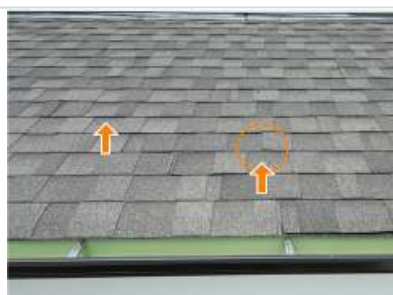
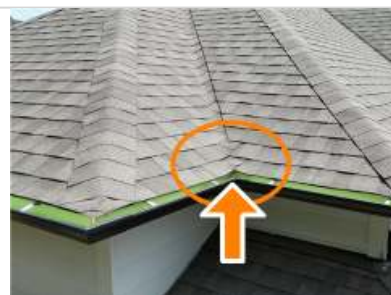
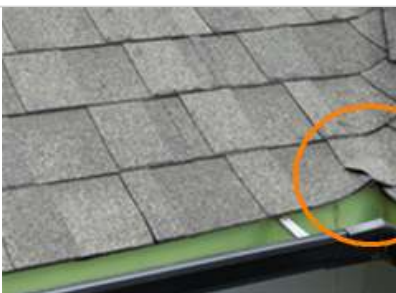
1. **There are nail pops or otherwise lifted shingles noted at the front and rear of the roof.** Corrections are needed to prevent possible damage and/or water penetration.

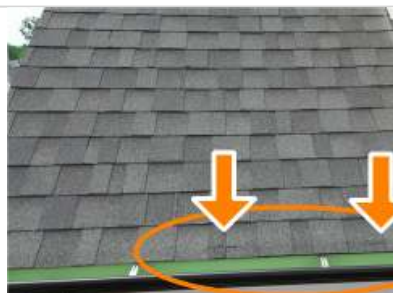
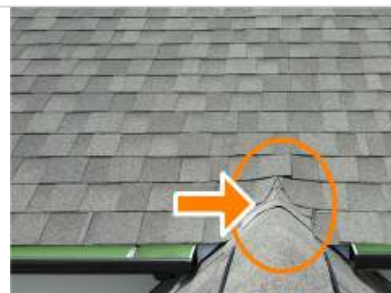
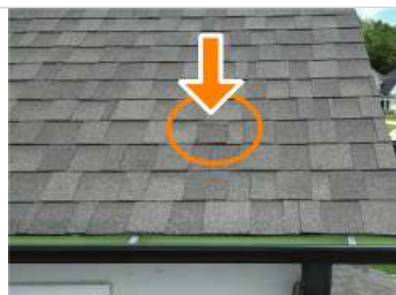
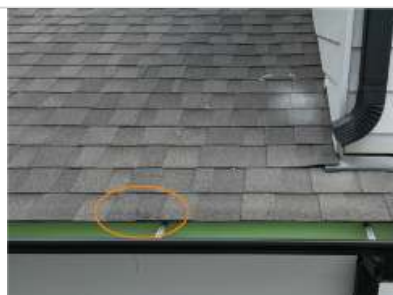
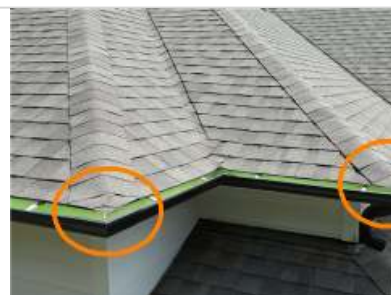
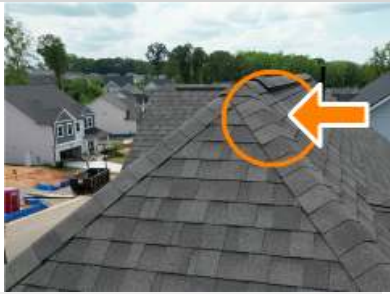
2. **There were cracked / torn / damaged shingles noted on or throughout the roof that need repair and/or replacement to prevent possible water penetration and/or damage.**

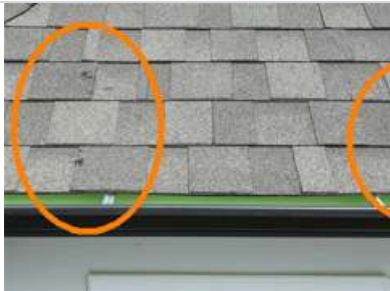
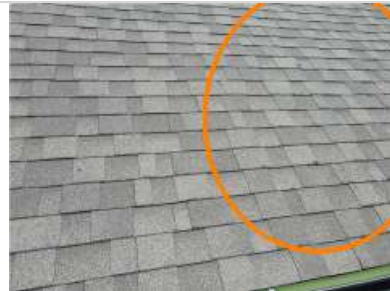
3. Areas of concentrated granular loss were noted throughout the roof system. This is typically an indication of mechanical damage such as foot traffic and/or objects falling on the roof, though could be an indication of a manufacturer's defect. *Note: Examples include damage typical of ladders set on the roof at the front and worn granules at the rear.* Corrections are needed to prevent possible accelerated deterioration and/or water penetration.

**Item 8 - Item 13 (Picture)**  
Example - Item 3 - Left side

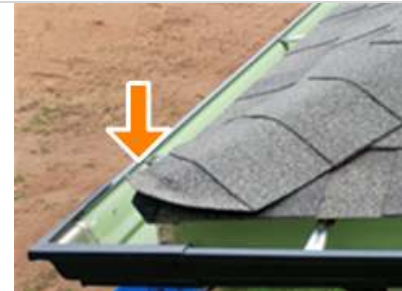
**Item 8 - Item 15 (Picture)**  
Example - Item 4

4. At least one shingle was found to be lifted at the rear right corner of the roof. Corrections are needed to prevent damage and to ensure water sheds off of the roof appropriately.

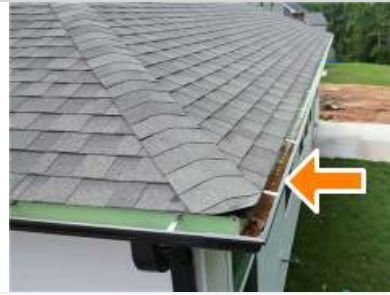
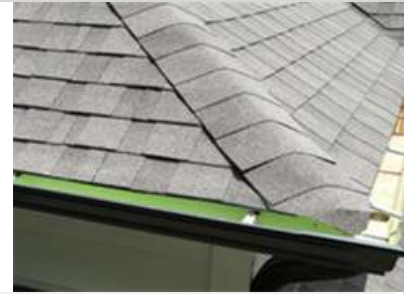
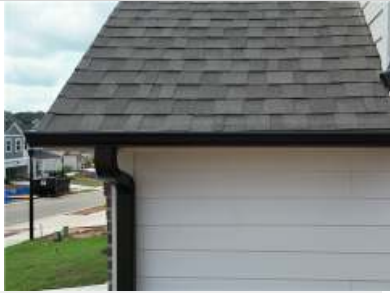
9. The following items(s) need further evaluation to determine if corrections are necessary. Please consult with your builder to evaluate the following areas of concern and make any additional repairs as deemed necessary during their evaluation:
  1. **There is standing water in the gutter located at the front and rear of the home.** The gutter is either clogged and/or not sloped properly. Proper corrections and/or repairs are needed to direct water away from the home and foundation.
  2. The gutter appeared to be improperly pitched at the right front of the home. Further evaluation is needed to ensure the gutter is appropriately installed to drain. Improper pitch can allow for standing water and potential overflowing / leaking.

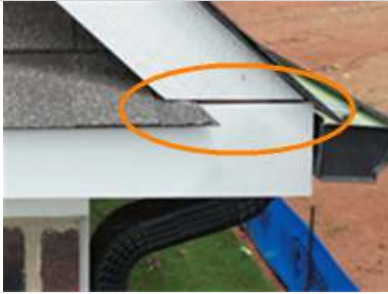
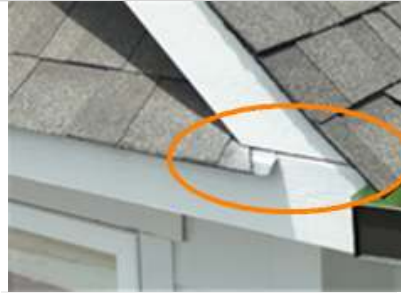
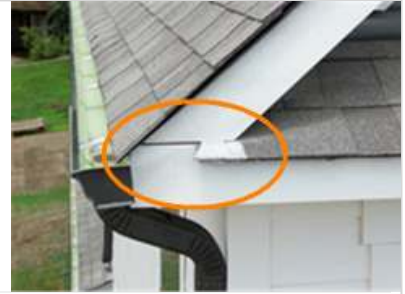
- 11. Sealant deficiencies, such as missing or poorly sealed areas, were observed on the exterior trim in various sections around the roof.** Corrections are required to prevent potential water seepage or insect infestation. Consult with your builder to gain a

comprehensive understanding of the necessary repairs. Have them further evaluate and make the necessary corrective actions.

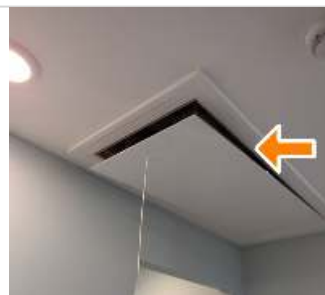
**Item 13 - Item 3 (Picture)**

3. The attic ladder was found to be stiff or difficult to operate and needs adjustment, repair, or replacement to function as intended.

Example - Item 3 - Ladder stiff at top and bottom of range

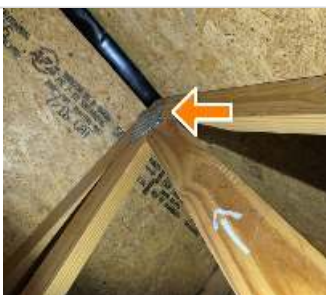
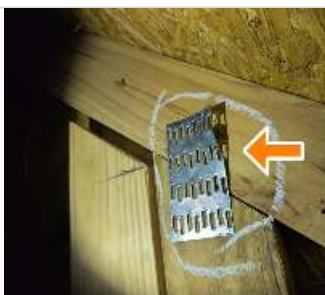
14. (3) Truss gusset plates were found to be loose, damaged, and/or missing in the following areas of the attic: center (second floor, main attic) and front (above garage). Corrections are needed to prevent possible movement and/or damage. *Note: All repairs or modifications to trusses should be made under the direction of a licensed structural engineer or the truss manufacturer.* Consult with your builder to gain a comprehensive understanding of the necessary repairs. Have them further evaluate and make the necessary corrective actions.

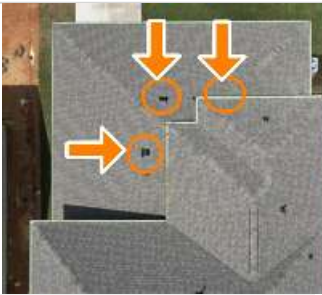
**Item 15 - Item 1 (Picture)**

Example - Item 1 - Only 3 passive vents on rear lower roof

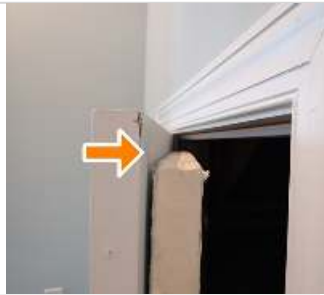
**Item 15 - Item 2 (Picture)**

Example - Item 2 - Foam cut short

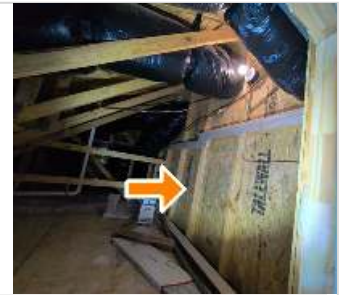
**Item 15 - Item 3 (Picture)**

3. The inspector was unable to verify if proper insulation was present at the stairwell wall between the attic and interior of the home. There appeared to be a wall cavity between what was visible in the attic and the interior space which could have insulation, but this should be verified to ensure heating and cooling losses are minimized.

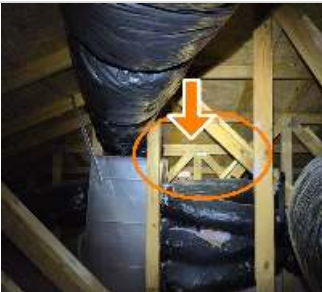
**Item 16 - Item 1 (Picture)**

16. (5) Repairs or modifications were noted to the truss system in the rear area of the walk-in attic above the first floor. The inspector was unable to locate a structural engineers letter attached to the repairs. When a truss is cut/damage and/or otherwise modified, the modifications should be performed under the direction of a licensed engineer that specializes in residential dwellings. Ask the builder to provide a structural engineers letter approving the repairs or modifications made to the truss system. If the sellers cannot provide this then further evaluation of the repairs or modifications by a licensed structural engineer is needed. Consult with your builder to gain a comprehensive understanding of the necessary repairs. Have them further evaluate and make the necessary corrective actions.

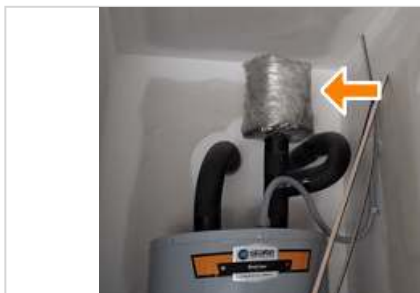
Item 17 - Item 1 (Picture)

17. The expansion tank is installed in a horizontal/vertical position which may apply excessive stress on the fittings when the tank is full. Due to the weight of this tank when it is full of water, the tank should be additionally supported. With insufficient support the tank could become loose and leak. Consult with your builder to gain a comprehensive understanding of the necessary repairs. Have them further evaluate and make the necessary corrective actions.

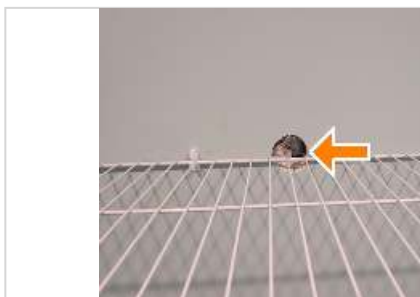
Item 18 - Item 1 (Picture)

18. (1) A hole was noted in the wall behind the wire shelving suggesting that a shelving anchor had been improperly installed in this area. Through the hole, the dryer vent was visible with at least some damage implying the screw contacted the dryer vent. Further evaluation is needed to determine if the dryer vent was compromised (if there is actually a hole or just a dent) which could allow the moist, lint-laden air to escape into the wall cavity. Repair or replace as necessary to prevent moisture concerns and/or a possible fire hazard. Consult with your builder to gain a comprehensive understanding of the necessary repairs. Have them further evaluate and make the necessary corrective actions.

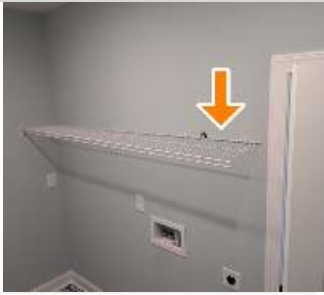
Item 19 - Item 1 (Picture)

19. (2) The wire shelf in the laundry room was not properly braced / supported at one end and needs correction to prevent a possible safety hazard and/or property damage if the shelf collapses. Consult with your builder to gain a comprehensive understanding of the necessary repairs. Have them further evaluate and make the necessary corrective actions.

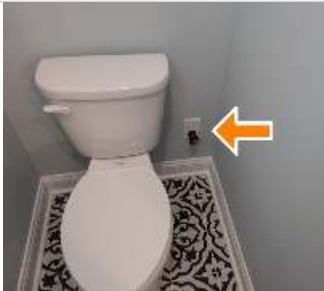
Item 20 - Item 1 (Picture)

20. (1) **The following outlets are not protected by GFCI:** Primary bathroom toilet room (at least one). Ground fault interrupters work by sensing a loss of current in the circuit. When a GFCI senses such a problem, the electrical current to the outlet is shut down almost immediately. Corrections are needed for safety. Consult with your builder to gain a comprehensive understanding of the necessary repairs. Have them further evaluate and make the necessary corrective actions.

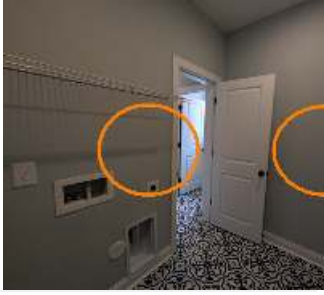
**Item 21 - Item 1 (Picture)**

21. (2) There was not a switch to control the light fixtures in the laundry room when entering from one or more sides. Corrections are needed to prevent a possible trip hazard due to navigating the room in the dark to reach the switch. Consult with your builder to gain a comprehensive understanding of the necessary repairs. Have them further evaluate and make the necessary corrective actions.

No switch at bathroom entryway

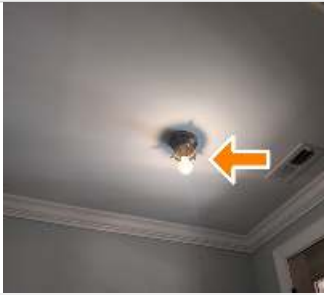
**Item 22 - Item 1 (Picture)**

22. (3) The light fixture cover was missing at the foyer and needs replacement to properly protect the bulb from damage which could result in safety hazards. Consult with your builder to gain a comprehensive understanding of the necessary repairs. Have them further evaluate and make the necessary corrective actions.

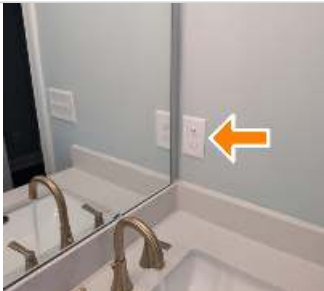
**Item 23 - Item 1 (Picture)**

23. (4) At least one electrical receptacle was found to be loosen in the wall at the primary bathroom. Corrections are needed to prevent possible loose connections which may result in sparking, loss of function, and/or a fire hazard. Consult with your builder to gain a comprehensive understanding of the necessary repairs. Have them further evaluate and make the necessary corrective actions.

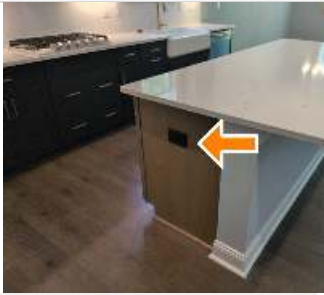
1. Electrical outlets were noted to be installed on the sides of the kitchen island / bar. Though this was normal until recently, changes have been made to installation practices as it was found that this creates a potential safety hazard such as if cords are draped across the walking path or if clothes snag on the plugs sticking out. Make corrections as necessary to ensure safety. **Typical for the age of the home.**
2. **The following outlets are not protected by GFCI:** kitchen dedicated appliance receptacles†. Ground fault interrupters work by sensing a loss of current in the circuit. When a GFCI senses such a problem, the electrical current to the outlet is shut down almost immediately. Corrections are needed for safety. **Typical for the age of the home.**

Item 24 - Item 1 (Picture)  
Example - Item 1

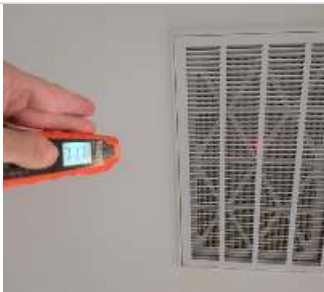
1. Improper function of the HVAC system was noted in multiple capacities during the inspection. Upon arriving to the inspection, the first floor thermostat was found set to 65 degrees in cooling mode but the interior temperature was still 75 degrees. Supply registers throughout the first floor never produced air cooler than the return air throughout the inspection, and at some points produced air significantly hotter (as high as 107 degrees). Supply registers throughout the second floor did produce cooler air but did not achieve the typical differentials expected and, similar to the previous sentence, at some points produced very warm air (temperatures in the 80s) after the system had turned off from opening the blower compartment hatch where a safety switch is installed. Additionally, the second floor supply registers produced warmer air when the first floor thermostat was turned to fan-only. The evidence noted during the inspection suggests possible faults with the multi-zone damper system, thermostat, and/or the HVAC system itself. Further evaluation is needed to determine the full extent of the concern and make corrections as necessary for proper operation of the HVAC system.

**Item 26 - Item 1 (Picture)**  
Sample return temp.

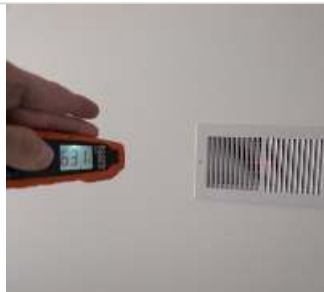
**Item 26 - Item 2 (Picture)**  
Sample supply temp. -  
Inadequate differential

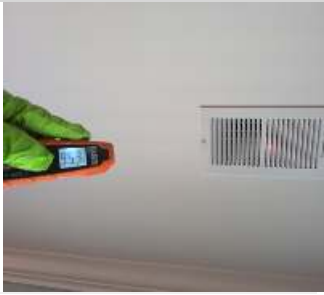
**Item 26 - Item 4 (Picture)**

Sample supply temp. - Hot air  
in cooling mode

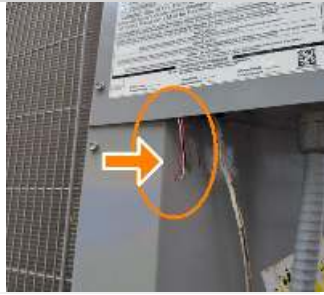
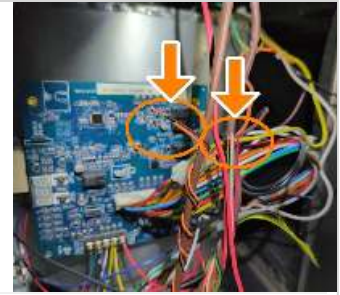
2. Exposed wires were noted at the exterior of the condenser unit and within the blower compartment in the attic. These wires appeared typical of thermostat wiring, possibly indicating unnecessary extra cables or improper installation. If the cables are unnecessary they should be properly capped and secured to prevent possible shorting out at live electrical components. If the cables are necessary, they should be properly installed for the system to function as intended.

Example - Item 2

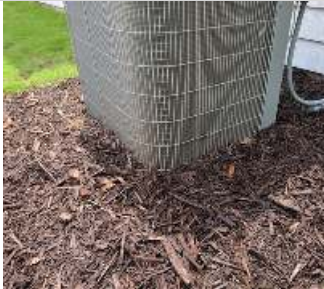
**Item 26 - Item 7 (Picture)**

3. During the inspection, it was noted that the outdoor coils and fins were dirty and required cleaning at the Primary unit. When these components are obstructed by dirt, they hinder airflow into or through the compressor, which can diminish the unit's efficiency and potentially lead to damage.

4. Mulch is present around the base of the HVAC unit(s), and it must be cleared away to ensure proper airflow through the compressor. This will help prevent premature rusting at the bottom of the unit and the fins at the Primary unit.

Example - Item 3, 4

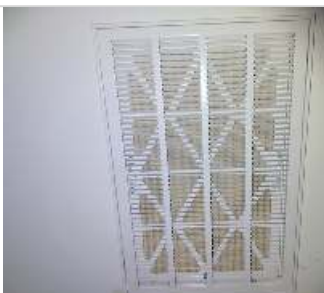
**Item 27 - Item 1 (Picture)**

**27. The air filter(s) is/are dirty and need replaced to prevent possible damaged and/or unnecessary strain on the unit(s).**

This can greatly reduce the life expectancy of the unit(s) and when the air filter(s) are found to be extremely dirty it is recommended that the unit be services and/or cleaned to ensure efficiently and that they are operating and functioning properly. Air filter(s) are recommended to be changed and/or cleaned depending on the type every 30 to 45 days to optimize the best performance of the unit(s). *Note: The air filters were found to be clogged to the point that air was whistling past the edges of the filters, likely putting strain on the system which could eventually result in damage or malfunction.*

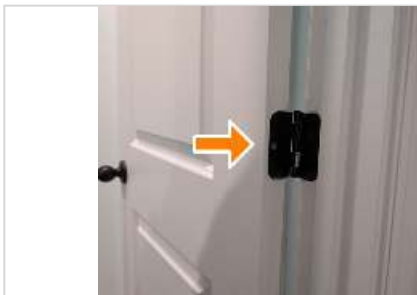
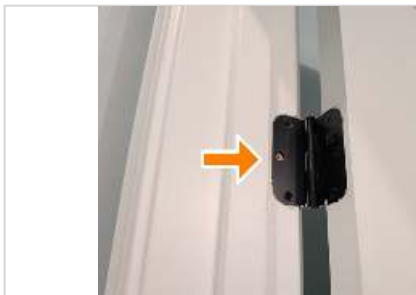
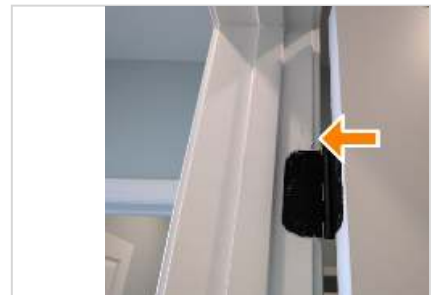
28. The following items(s) need further evaluation to determine if corrections are necessary. Please consult with your builder to evaluate the following areas of concern and make any additional repairs as deemed necessary during their evaluation:
1. One or more fasteners were found to be missing or stripped at the door hinges in the following locations:  
Downstairs hall closet, half bathroom. Corrections are needed to ensure the door is properly secured to prevent possible damage and/or difficulty operating the door(s).
  2. The door trim / frame was noted to be cracked or damaged in the following locations: Primary bathroom closet.  
Repair or replace as necessary to ensure the door is properly secured to prevent possible movement, damage, and/or difficulty operating the door.

Item 28 - Item 1 (Picture)  
Example - Item 1

Item 28 - Item 2 (Picture)  
Example - Item 1

Item 28 - Item 3 (Picture)  
Example - Item 2

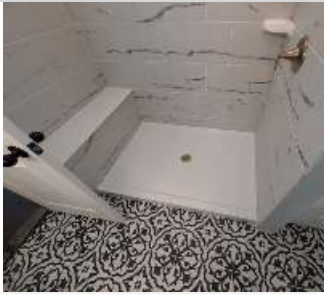
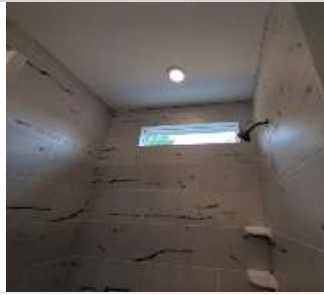
#### Primary Bathroom Visual Findings

29. (1) Grout / caulk was missing in multiple areas throughout the shower enclosure and adjacent areas. This likely indicates incomplete installation. Follow up with your builder to ensure all necessary areas of grout / sealant are finished prior to closing to prevent moisture damage and related concerns. *Note: Due to this, the shower / tub fixtures were not tested during the inspection as testing could result in leaking / damage. It is recommended to verify proper operation of the fixtures and drains prior to closing when installation is completed.*

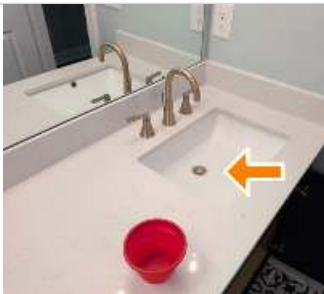
Item 30 - Item 1 (Picture)

30. (2) **The drain stopper did not function properly** or respond to the lever when testing at the time of inspection and needs repair or corrections. Corrections are needed for the sink to hold water properly. *Note: The inspector was unable to get the stopper opened again after it seemed to close normally.* Consult with your builder to gain a comprehensive understanding of the necessary repairs. Have them further evaluate and make the necessary corrective actions.

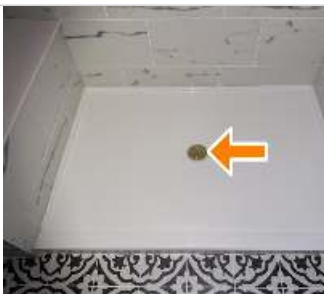
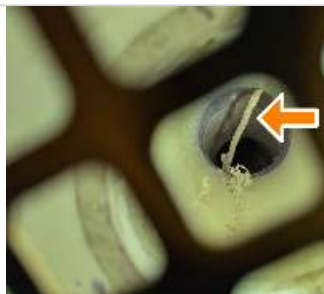
31. (3) Debris is noted within the shower drain. Corrections are needed to prevent possible clogging. Consult with your builder to gain a comprehensive understanding of the necessary repairs. Have them further evaluate and make the necessary corrective actions.

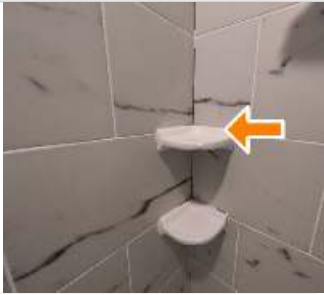
Item 33 - Item 1 (Picture)

33. (2) One of the shower corner shelves appeared to be flat or otherwise may not be appropriately pitched to drain. The shower was unable to be tested to confirm this due to limitation. It is recommended to verify if correction is necessary to prevent standing water on the shelf. Consult with your builder to gain a comprehensive understanding of the necessary repairs. Have them further evaluate and make the necessary corrective actions.

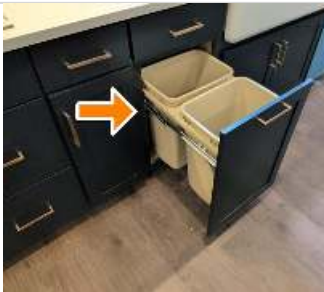
Item 34 - Item 1 (Picture)

34. One or more of the kitchen cabinet drawers did not slide or track properly. Adjustment, repair, or replacement is needed to ensure proper operation and prevent possible damage. Consult with your builder to gain a comprehensive understanding of the necessary repairs. Have them further evaluate and make the necessary corrective actions.

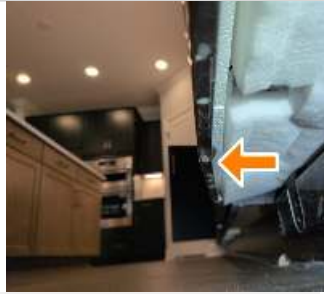
**Item 35 - Item 2 (Picture)**

- 
35. The front panel of the dishwasher was found to be loose and warped / bent. Repair or replace as needed to prevent possible further damage. Consult with your builder to gain a comprehensive understanding of the necessary repairs. Have them further evaluate and make the necessary corrective actions.

Bent / creased at lip
