INSPECTION REPORT

**123 Sample Street**

Anytown, SC

INSPECTION DATE 8/19/2026

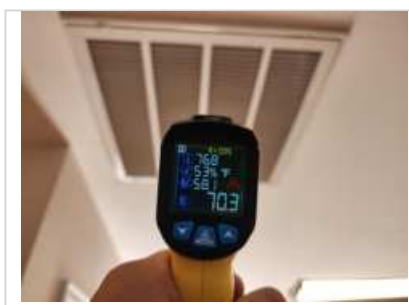
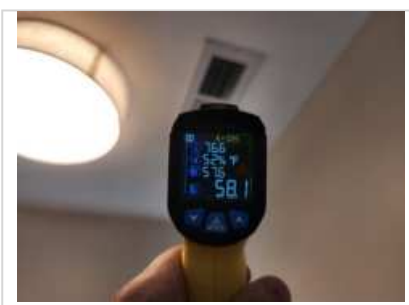
(1) The Primary unit is failing to achieve a sufficient air temperature drop, which could suggest a range of issues, including but not limited to low Freon levels, a dirty air filter, or clogged coils. When tested, the temperature differentials should ideally fall between 14 and 24 degrees; however, the current differentials measured only 12 degrees.

Consult a qualified licensed contractor to assess the areas of concern and perform any additional repairs deemed necessary during their evaluation.

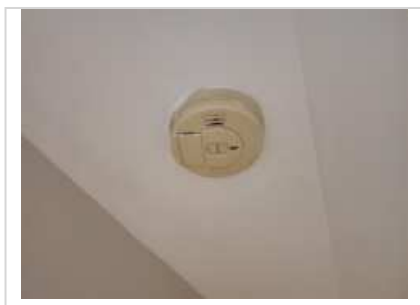
optimal functionality and safety.

Consult with a qualified licensed contractor to evaluate the area(s) of concern and make any additional repairs as deemed necessary during their evaluation.

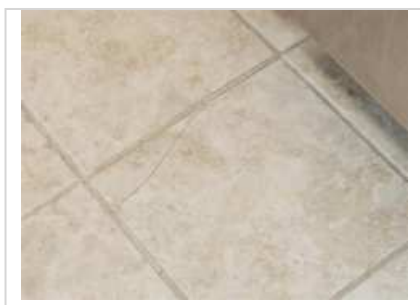
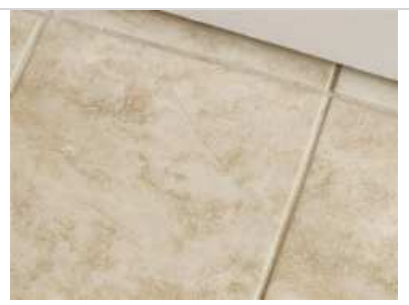
(2) The floor tiles in the following areas have visible cracks that require repair or replacement to prevent further damage:

Kitchen

Consult with a qualified licensed contractor to evaluate the area(s) of concern and make any additional repairs as deemed necessary during their evaluation.

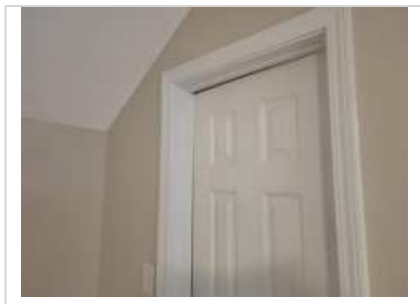
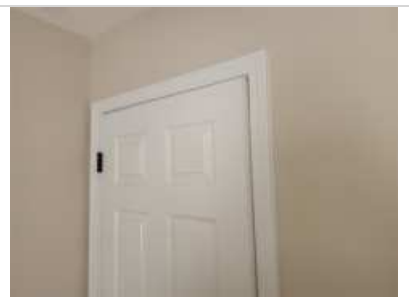
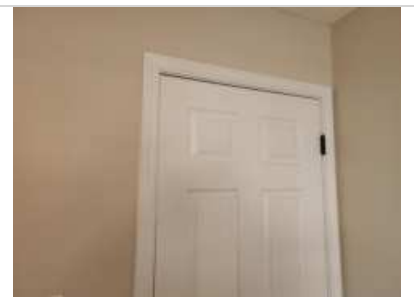
(3) The following door(s) listed below rubbed at the frame/flooring and need adjustment and/or repair for the door(s) to open and close properly without rubbing:

Upstairs bedroom closet door, front bedroom entry door, downstairs hall bathroom door, and rear bedroom entry door.

Consult with a qualified licensed contractor to evaluate the area(s) of concern and make any additional repairs as deemed necessary during their evaluation.

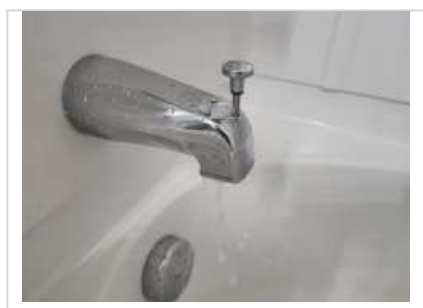
(1) The shower diverter is not functioning properly and needs repair/replacement. The diverter still allows water to flow out at the tub faucet when switching to the showerhead. Corrections and repairs are needed.

Consult with a qualified licensed contractor to evaluate the area(s) of concern and make any additional repairs as deemed necessary during their evaluation.

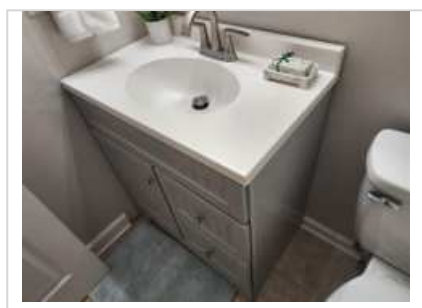
(1) The sink cabinet was loose at the floor or wall at the time of inspection and needs to be secured properly.

Consult with a qualified licensed contractor to evaluate the area(s) of concern and make any additional repairs as deemed necessary during their evaluation.

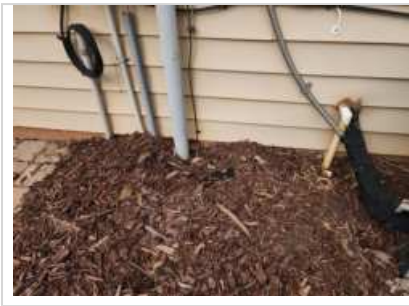
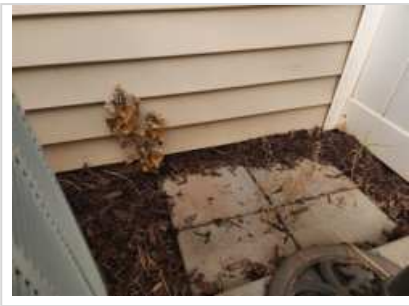
1. The siding at the Rear of the home does not have the appropriate clearance from the ground. It is recommended that most claddings maintain a minimum clearance of 6 inches between the grade and the siding. This clearance is important in preventing water intrusion and deterring insects from causing damage.

Consult with a qualified licensed contractor to evaluate the area(s) of concern and make any additional repairs as deemed necessary during their evaluation.

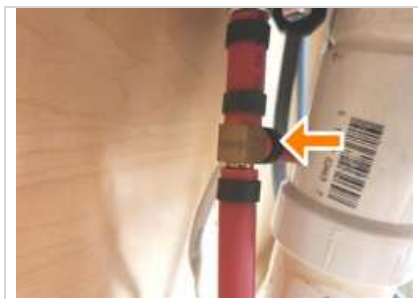
3. The visible plumbing lines in this home are plastic PEX with brass metal fittings. Evidence of fitting deterioration was noted during the inspection in a few/several locations. The deterioration could be the result of a known problem referred to as “dezincification”. Dezincification occurs when brass fittings that are considered a high-zinc copper alloy are exposed to water and the zinc is leached from the fitting or component leaving the fitting in a weakened state. This process also leads to a build-up inside the fitting, restricting water flow and ultimately leaving the plumbing system prone to breakage and leaking. A licensed plumbing contractor should be consulted for a complete evaluation of the plumbing system to determine the general condition of the plumbing distribution and supply lines, the significance of this concern, and make necessary repairs.

Consult with a qualified licensed contractor to fully understand the extent of the repairs needed and determine if corrective actions are required.

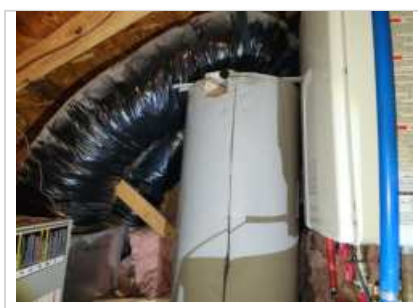
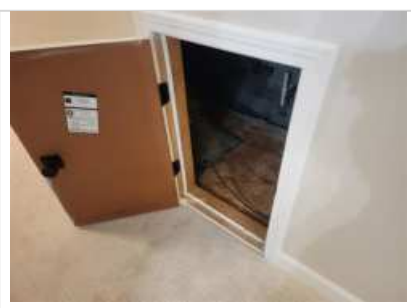
4. The abandoned water heater in the Attic needs to be removed by a contractor as disassembly may be required to fit the tank through the attic access door.

Consult with a qualified licensed contractor to evaluate the area(s) of concern and make any additional repairs as deemed necessary during their evaluation.

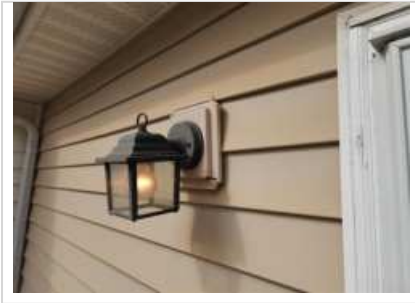
5. (1) The rear exterior light fixture is not properly secured to the wall behind the siding. Corrections are needed to prevent further movement and possible damage.

Consult with a qualified licensed contractor to evaluate the area(s) of concern and make any additional repairs as deemed necessary during their evaluation.

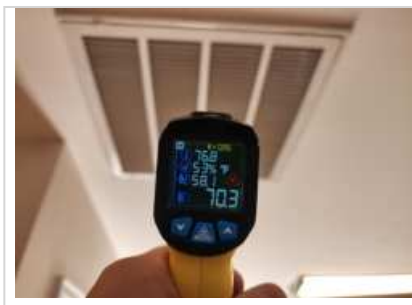
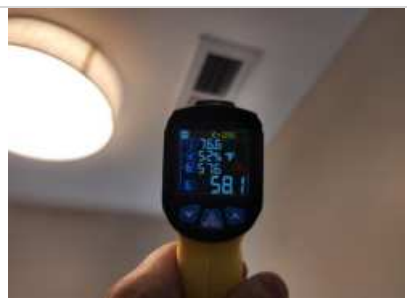
10. (1) The Primary unit is failing to achieve a sufficient air temperature drop, which could suggest a range of issues, including but not limited to low Freon levels, a dirty air filter, or clogged coils. When tested, the temperature differentials should ideally fall between 14 and 24 degrees; however, the current differentials measured only 12 degrees.

Consult a qualified licensed contractor to assess the areas of concern and perform any additional repairs deemed necessary during their evaluation.

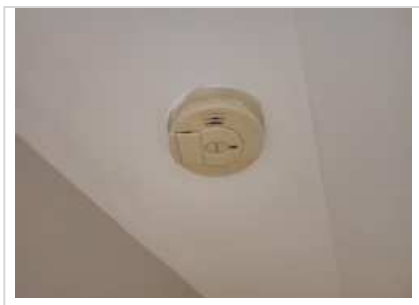
12. (1) For safety, it is advised to replace all outdated or older smoke and carbon monoxide detectors with new ones. Most smoke detectors have a lifespan of around 10 years, after which they should be replaced to ensure optimal functionality and safety.

Consult with a qualified licensed contractor to evaluate the area(s) of concern and make any additional repairs as deemed necessary during their evaluation.

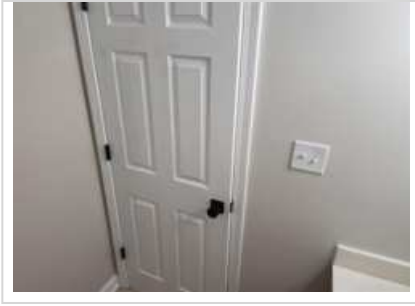
15. (4) There are door stops missing/damaged behind doors in areas throughout the home; replacement needed to prevent possible damage to the walls behind the doors.

Consult with a qualified licensed contractor to evaluate the area(s) of concern and make any additional repairs as deemed necessary during their evaluation.

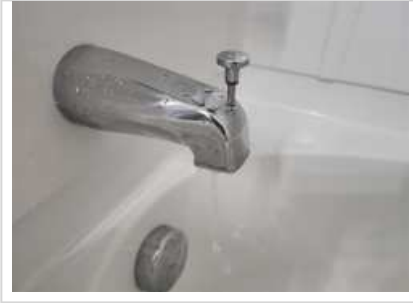
17. (1) The shower diverter is not functioning properly and needs repair/replacement. The diverter still allows water to flow out at the tub faucet when switching to the showerhead. Corrections and repairs are needed.

Consult with a qualified licensed contractor to evaluate the area(s) of concern and make any additional repairs as deemed necessary during their evaluation.

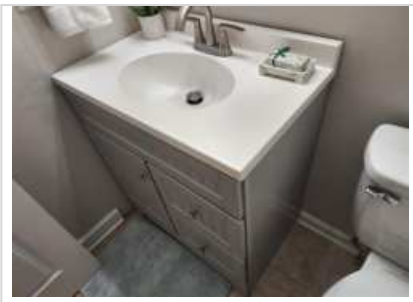
21. (1) The sink cabinet was loose at the floor or wall at the time of inspection and needs to be secured properly.

Consult with a qualified licensed contractor to evaluate the area(s) of concern and make any additional repairs as deemed necessary during their evaluation.
